# HA'APAI AID

**CRI TONGA**  
in partnership with

**OMNI SERVICES TONGA**  
& The Church of Jesus Christ Latter Day Saints

## Assessment: FALELOA

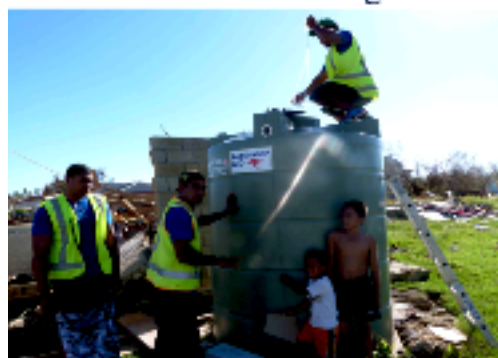
OMNI team preparing to sanitize a 5,000lt tank for a local family that had their house completely destroyed. They are now, like many others, living in a blue tent

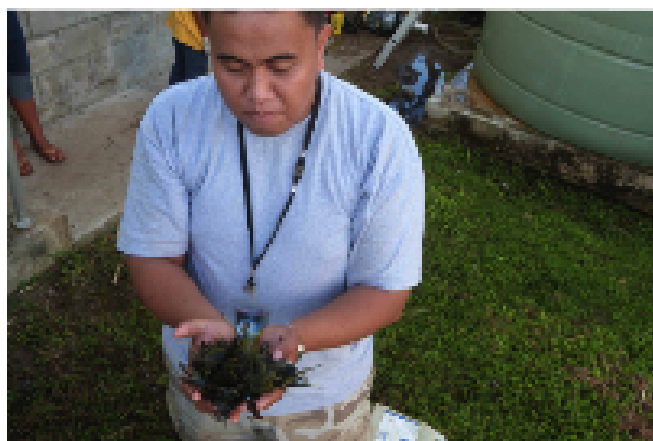
OMNI Executive Mumui Tautua'a extracting the debris from the motor of the water pumps as it clogged up.

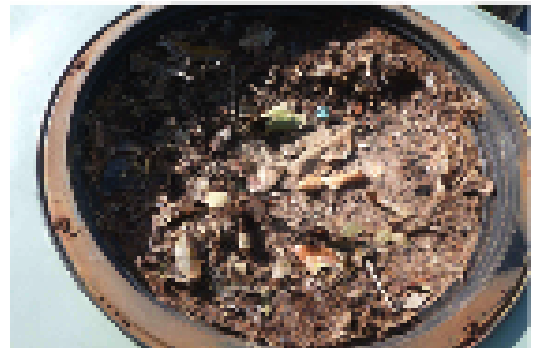
Every tank we came across with netting was in a state much like this

They all need to be cleaned out properly and then sanitized again. Also, gutters to be cleaned. Gutters should be checked and netting put up in places needed. Overhanging trees need to be cut down or removed, and members and community need to be taught how to maintain their water tanks and the surrounding areas to keep their drinking water healthy for all concerned.

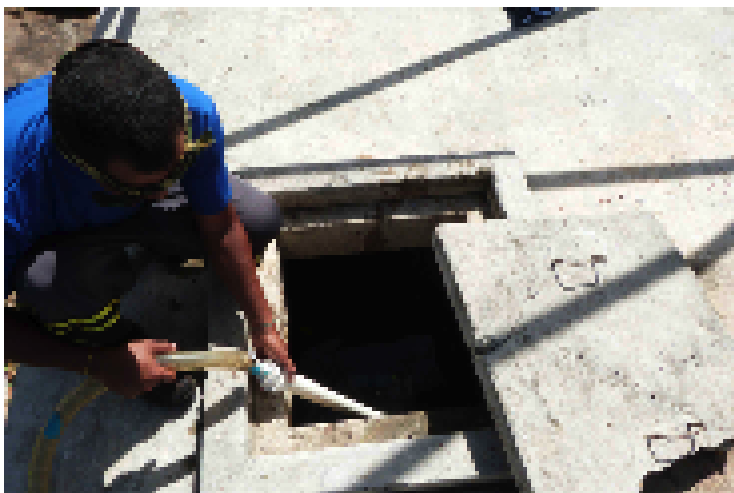
Helani Vacuuming a 40,000lt Square Cement Tank

Notes: Started vacuuming but there was so much sludge and dirt at the bottom of the tank that the vacuum has stalled numerous times. We've decided to stop vacuuming and just sanitize the tank. We sanitized the tank Wednesday, Thursday & Friday. Total hours of Sanitizing were 12 hours. Screen has been added to the opening of the tank to keep the majority of the dirt and leaves from inside. The results are that the water is clear and there is no odor, and the texture is better.

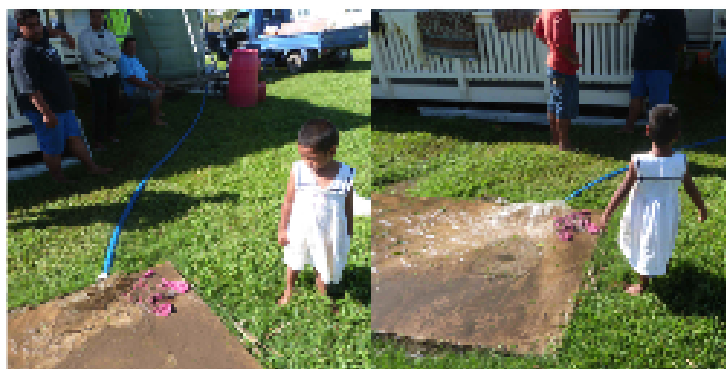
3yr old girl looking on as the grime being vacuumed from the tank comes out pure water. Indicating that the grime is all out of the tank, and ready to be sanitized.

Notes: Thick sludge at the bottom of the tank. No clear visual of the bottom. Smell of rotted eggs. Texture sticky. Water testing done and saved. We found out about local tanks that have been used to serve the community. This came as a recommendation.

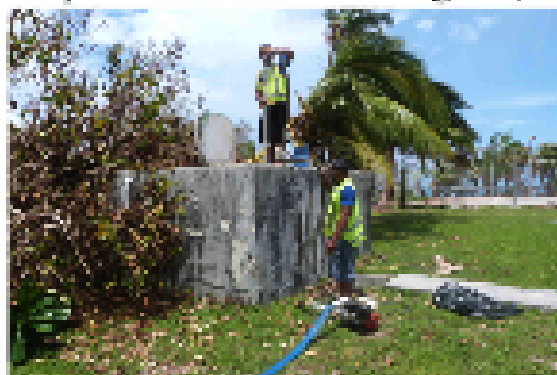
This is the grime that came out when we vacuum the sludge from the bottom of the water tanks.

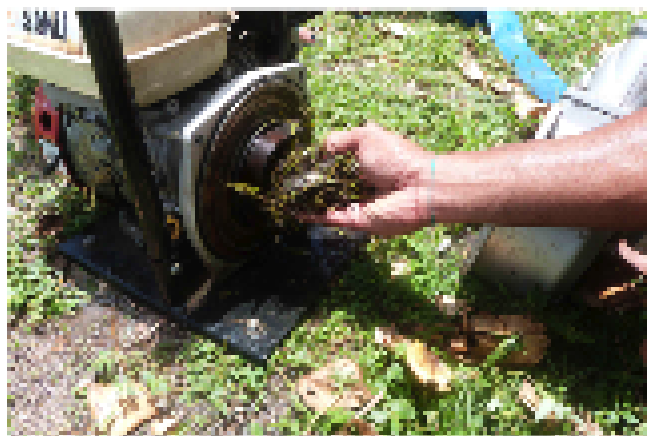
The amount of debris in the tanks was constantly clogging the pumps up.

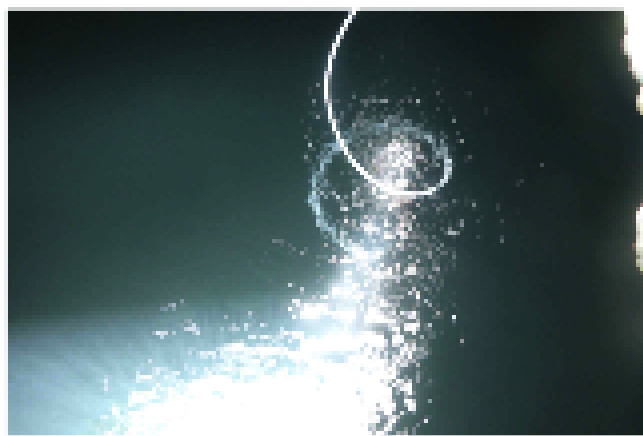
Sanitizing the water tanks with Ozone pumped

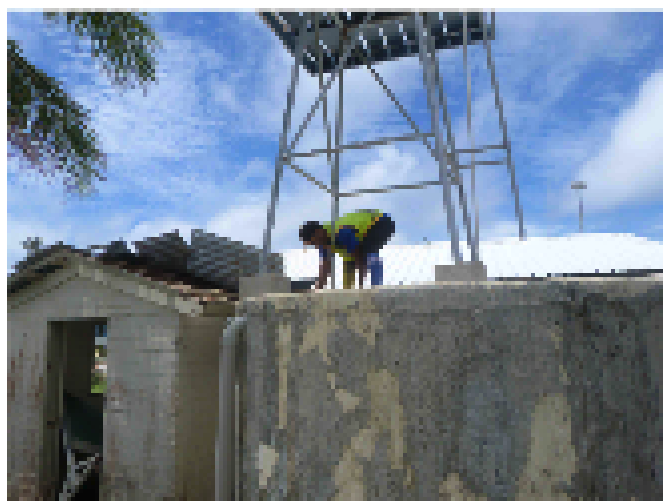
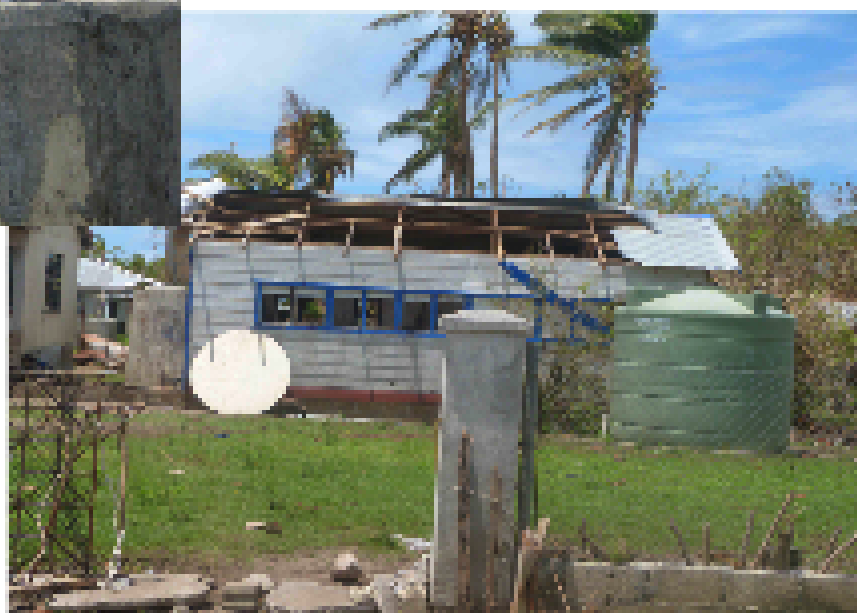
Top left & bottom right: The before and after picture of the tank we vacuumed in Ha'apai
