September 10, 2019

Excerpts of the report by fluidfreeride engineer in relation to caliper malfunctioning of Mercane WideWheel electric scooter

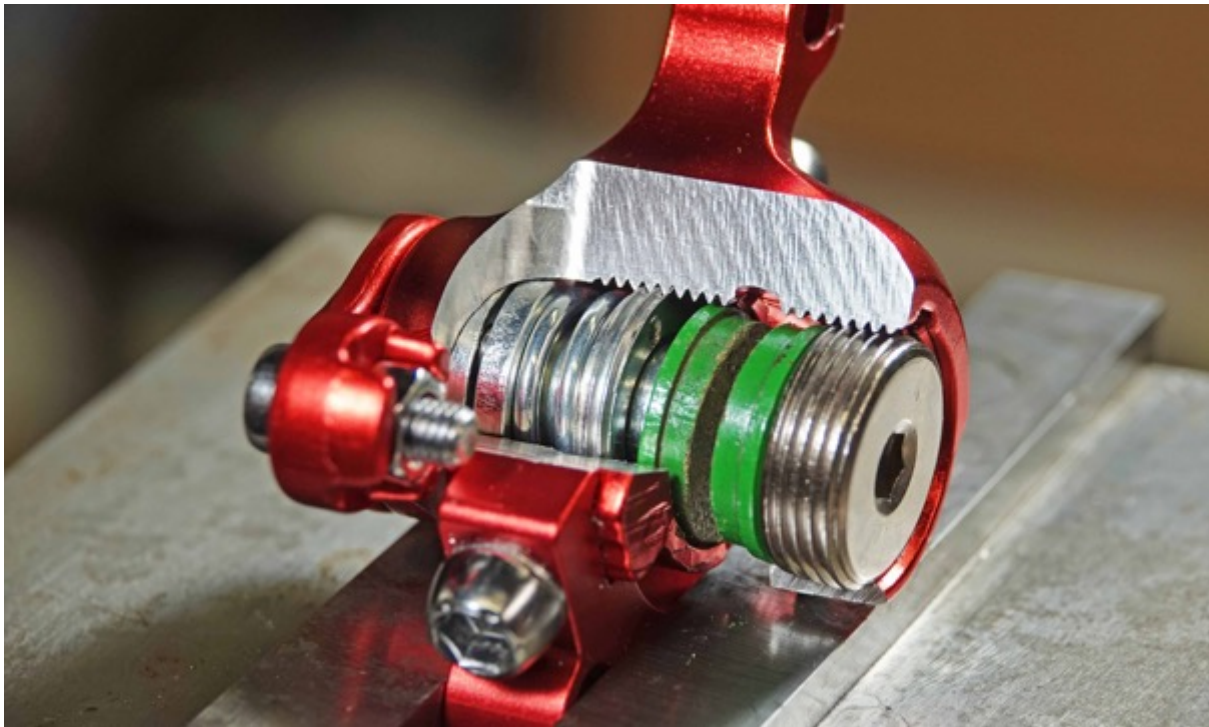
6. The Retention Ring keeps the spring, Piston Cam, Arm Cam and thrust bearing retained inside of the caliper housing.
 7. Most importantly, the axial position (or tightness) of the Retention Ring determines how far the Piston and the attached Piston Cam can move. See figures 6 and 7 below. The limit is reached when the spring binds, or is fully compressed against the Retention Ring.

Figure 6 Arm in the relaxed position.

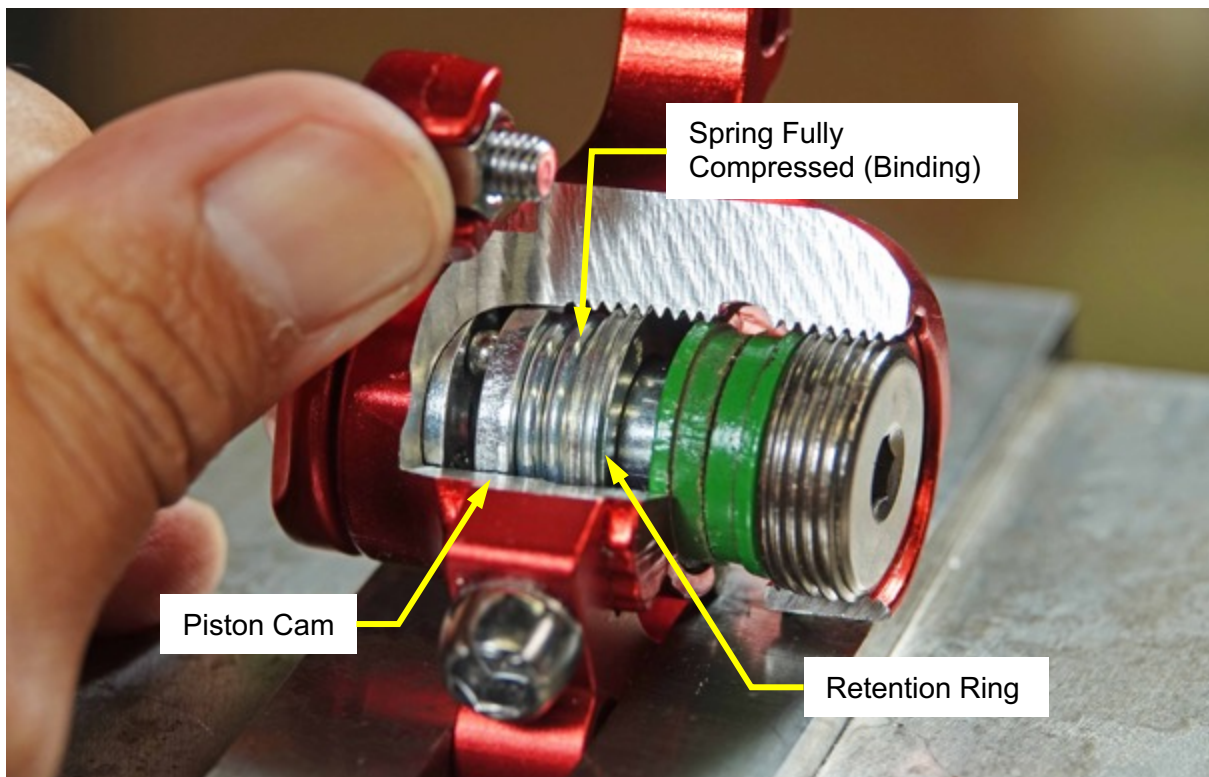
9. When the Retention Ring is installed too loosely, the Arm correspondingly can be observed to move excessively forward, closer to the cable adjuster.

Figure 7 Arm in the fully actuated position.

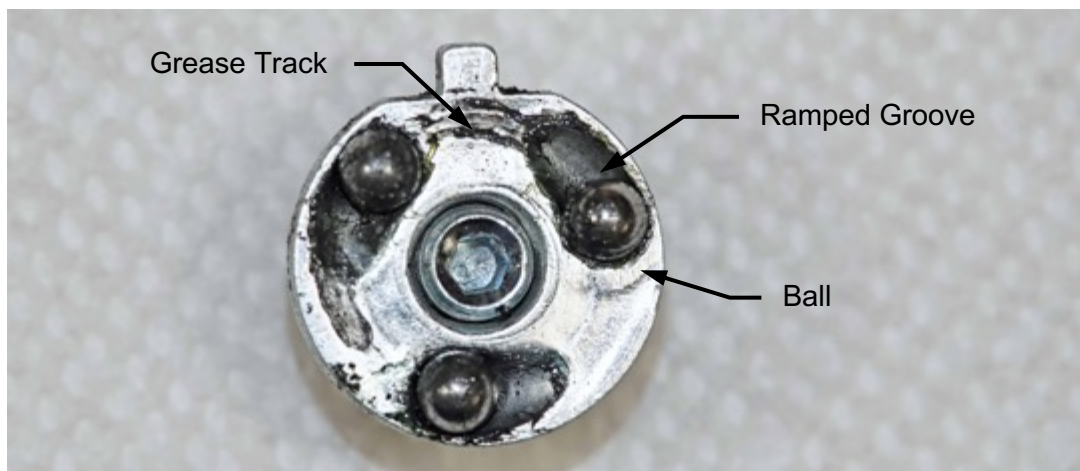
The problem is caused by improper installation of the retention ring during assembly of the caliper at the factory.

When the Retention Ring is backed out too much during assembly, the Piston is allowed to move inward (towards the rotor) more than the design is intended for which results in the three ball bearings riding up and out of the ramped grooves in the faces of the Arm Cam and the Piston Cam. Figure 8 shows the face of the Piston Cam on a defective caliper. Note the grease tracks which indicate that the balls had ridden up and out of the ramped grooves and onto the relatively flat face of the cam.

Figure 8 The face of the Piston Cam from a defective caliper.

The snapping sound occurs when the balls ride up out of the ramped grooves and onto the relatively flat cam face.

The relatively flat cam face also explains why the mechanism sticks. In conjunction with the spring, the ramped grooves provide for the return action of the Piston and Arm. When the balls are on the flat portion, the return mechanism does not work. The Arm can be rotated manually and returned to the resting position, which re-seats the balls.

The loss of braking, or the inability to increase braking force occurs when the balls are up on top of the flat portion of the cam faces. The axial (in and out) motion of the Piston depends on the angle of the ramped grooves. Without the ramped surfaces, further rotation of the Arm does not result in additional movement of the Piston.

The key solution here is to limit the axial movement of the Piston Cam so that the balls are never allowed to ride up out of the ramped grooves. This can be achieved by properly installing the Retainer Ring during assembly.
