**Middle Fork Mods**

## Service BULLETIN

Reference: MFSBA-2501 Rev 00

Alert Service Bulletin - Kit for STC SA011869WI

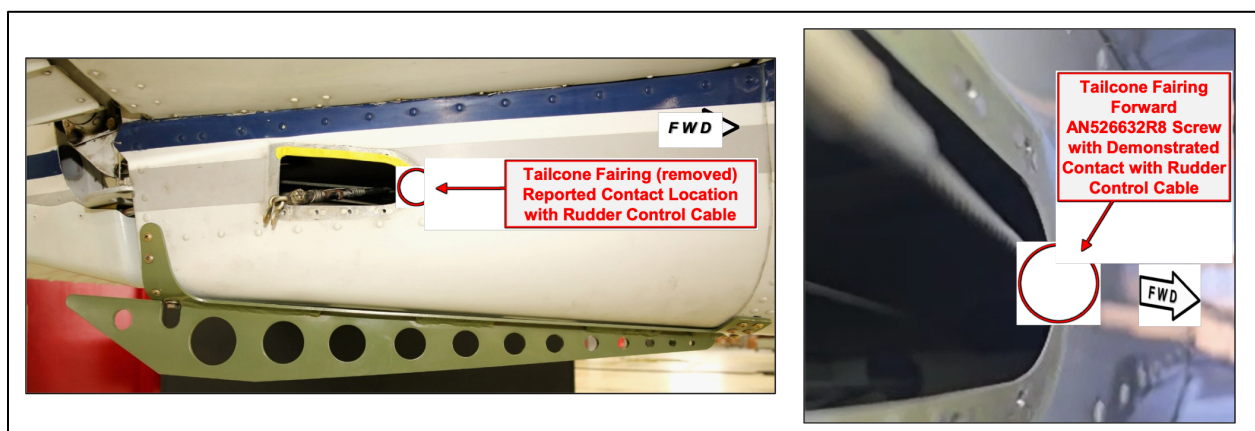
*Figure 1: Affected Area*

There is a potential safety issue regarding the installation of the Tail Tie-Down Assembly interference with the rudder control cable. Two incidents have been reported in which the installation of this modification results in the rudder control cable contacting a fairing screw installed by this Kit. This condition could result in severance or fraying of the cables with loss of rudder control. Figure 1 identifies the area in question.

Tail cone fairing fasteners are to be inspected for damage and wear and replaced if such is found. Rudder control cable assemblies shall be inspected for separation, broken wires, fraying of cables and wear. Inspect the rudder flight control cable installation to see if any damage or changes exist outside the modifications introduced by this Kit that would change the location of the rudder control cable.

Worn or damaged rudder control cables shall be replaced. There shall be positive clearance between any item on the aircraft and the rudder control cable.
