# Aqua Lung America

## ***TECHNICAL BULLETIN***

June 15, 2013  
No. 39

**SUBJECT: LEVER HEIGHT ON LEGEND LX  
AND LEGEND LUX**

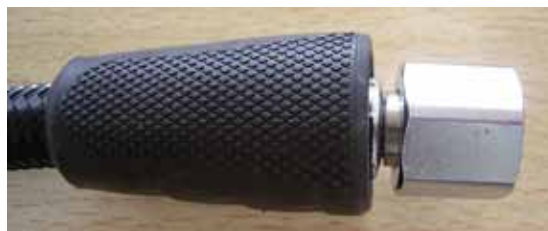
It was possible for the hose, which travels through the second stage swivel nut, to penetrate far enough into the second stage for the hose fitting to interfere with the crown orifice and turn it inwards. This, in turn would lower the lever.

The hoses that can allow this situation to occur have a swivel nut on them with smooth sides as shown here:

If you are aware of a Legend LUX or Legend LX with this situation, we ask you to readjust the lever height by using the procedures described in the Legend LX and Legend LUX repair courses and repair manuals AND put the second stage hose protector in place following the procedure below:

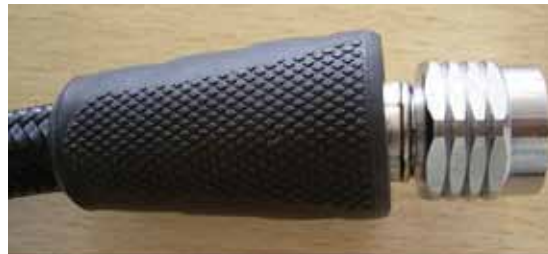
Hoses with this style swivel nut are not concerned with the above issue.

To eliminate this possibility in the future, we have corrected the hose, given it the p/n 129807, and have identified it by adding ribs to the swivel nut as seen here:
