TECHNICAL BULLETIN

SUBJECT: Regulator Lubricant

PRODUCTS AFFECTED: All Apeks First & Second Stages

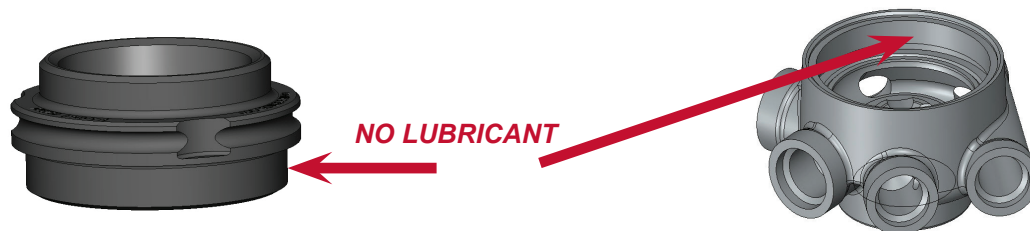
It has come to our attention that during the servicing of regulators, lubricant is being added to the diaphragm clamp threads and other parts of the regulator that require tightening with a torque wrench.

The addition of lubricant to any thread allows any torque value to run out of specification, allowing the overtightening of the component. This can result in the potential failure due to increased stresses applied to the component in question.

The images below have been used as an example to demonstrate the areas which lubricant must NOT be applied during servicing.

It is imperative that no lubricant whatsoever is applied to any part of the regulator unless specified by the manufacturer and detailed in the relevant technical maintenance manuals.
