TECHNICAL BULLETIN

SUBJECT: Replacement of Flight Composite Diaphragm Clamp

PRODUCTS AFFECTED: Apeks Flight First Stage & Service Kit

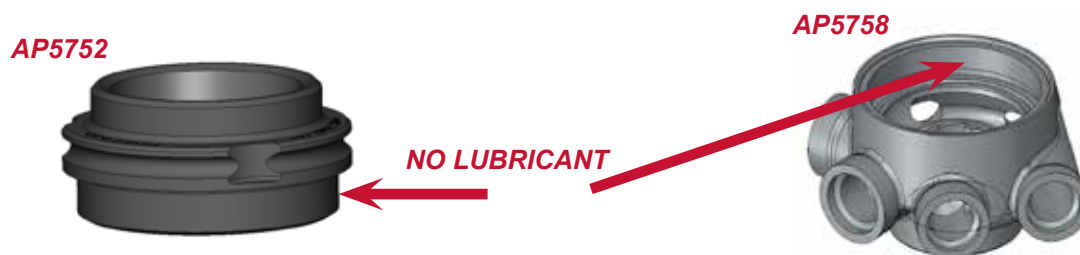
It has come to our attention that during the servicing of Flight first stage regulators, some service technicians may have added lubricant to the threads of the composite diaphragm clamp (AP5752) or the threads on the main valve body (AP5758).

The addition of lubricant to any thread allows any torque value to run out of specification, allowing the overtightening of the component. This can result in the potential failure due to increased stresses applied to the component in question.

The images below have been used as an example to demonstrate the areas which lubricant must NOT be applied during servicing.

RE-WORK: The diaphragm clamp must be replaced as damage may have occurred even if not visible or obvious. Prior to reassembly, the valve body should be cleaned and all traces of lubricant must be removed.
