This Service Information bulletin replaces SI B11 08 15 **dated June 2017**

SITUATION

PROCEDURE

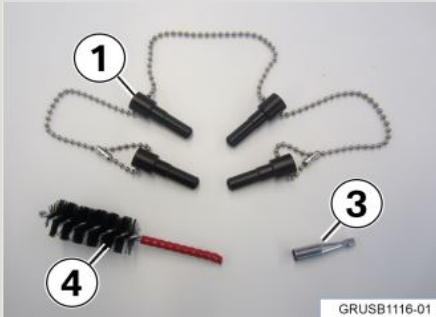
GRUSB1116-01

N63/S63 Valve Seal Replacement Tool Update Kit
 P/N 83 30 2 443 944
 Oil return plugs (1)
 Brush (2)
 Valve seal install tool (3)
 Refer to SI [B04 15 15](#) for additional ordering information.
