## N63, N63TU, S63 and S63TU Engines: Oil Leak from the Rear of the Engine and Transmission Bell Housing

This Service Information bulletin replaces SI B11 09 16 **dated May 2016**

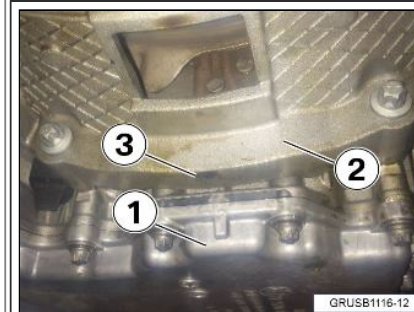
Customer complains that engine oil is leaking from the center of the vehicle. When verified, the engine oil residue can be seen leaking from between the engine and the transmission bell housing.

Engine oil pan (1)  
Transmission bell housing (2)  
Engine oil residue (3)

If the engine oil leak diagnosis described in the attachment supports the removal of the transmission, replacement of the end cover, rear and the crankshaft seal.
