## INSPECTION NOTICE – LADSAF X3+ IMMEDIATE ACTION REQUIRED

November 23, 2016

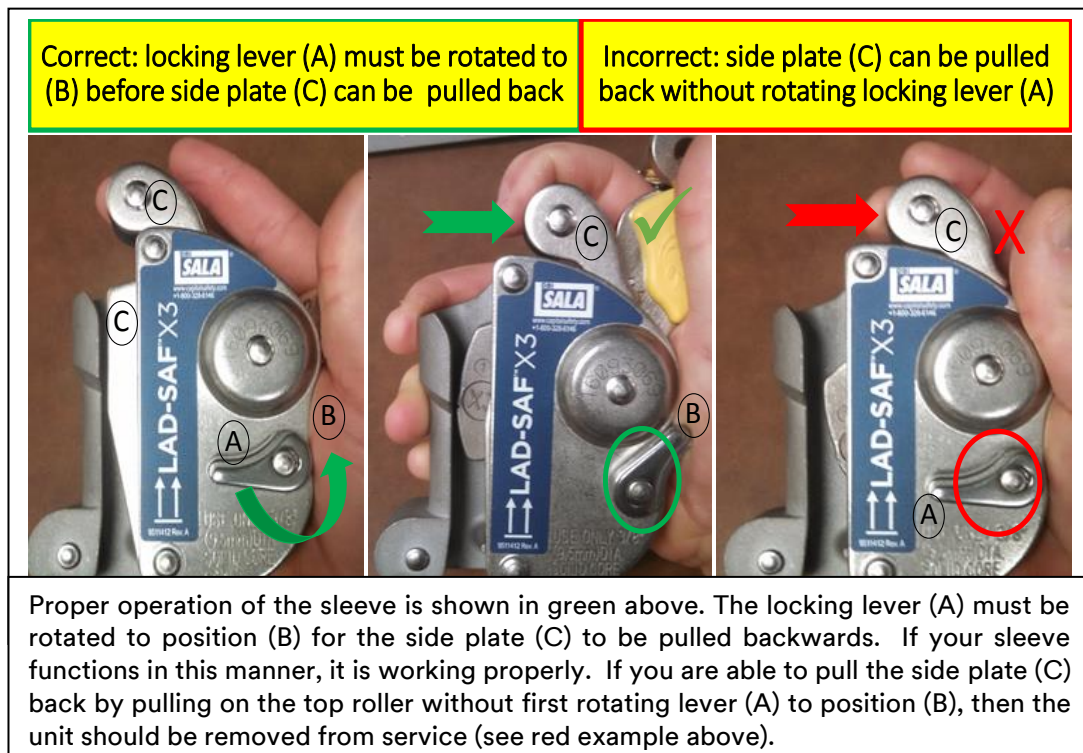
3M Fall Protection/Capital Safety has identified a limited number of Lad-Saf X3+ sleeves with the locking lever not working properly. This condition can allow the sleeve to disengage from the cable during use. The assembly error is believed to affect only a limited number of units and has been corrected. There have been no accidents or injuries related to this issue.

End-users: Immediately conduct an inspection (see below). This inspection is part of the pre-use inspection recommended for all X3+ (#6160052) sleeves as described below. If you find an affected sleeve, remove the sleeve from service and contact our Customer Service department at Australia: 1800 245 002 or New Zealand: 0800 252 627 or email [LADSAFANZ@mmm.com](mailto:LADSAFANZ@mmm.com) to obtain a return authorisation. Upon receipt of the affected sleeve, we will ship you a replacement sleeve at no charge.
