## User Inspection Notice

### ISC RP205 / RP209 Pip-pin Ropegrabs

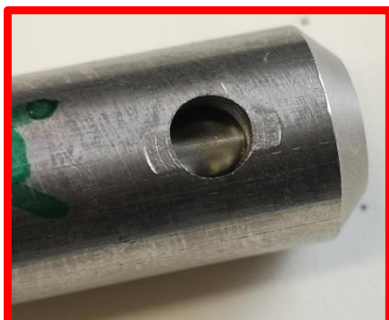
Not OK

If the ball-bearings are not present.

**REJECT**

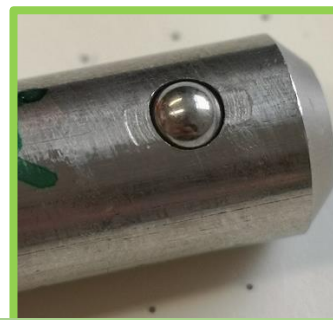
OK

If the ball-bearings are present please perform the inspection as specified in section 2.

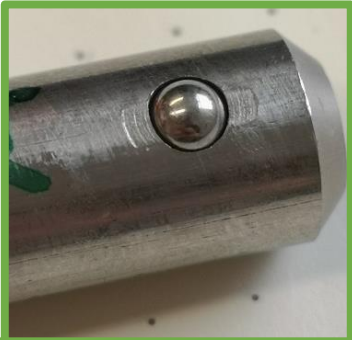
OK

If, following the inspection procedure, the ball-bearings have remained in place the rope grab is safe for further use.

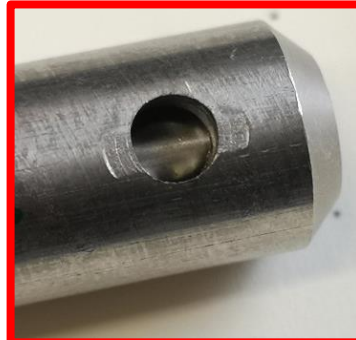
Not OK

If, following the inspection procedure, there is no evidence of peening and/or the ball-bearings do not remain in place then the device should be removed from service.

**REJECT**

**Please return, for immediate replacement, to:**
