## Fire Research & Investigation Unit

# Heads Up

### BACKGROUND

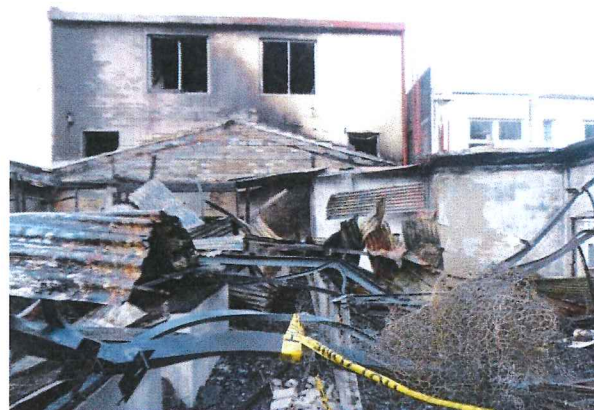
The second incident involved a building originally built in the early 1900s, and subject to multiple alterations and extensions over time, the latest in 2001. However, none of the consented works included the conversion to residential use. The building included a single storey workshop adjoined to a two-storey commercial unit. Occupants of both the workshop and upper level of the commercial unit had converted these spaces to permanent accommodation. The workshop was fitted with automatic detection, but the rest of the building was only provided with manual call points. The use of the building as residential premises was also in breach of the district plan for the area. The Territorial Authority had issued several notices to the building owner, including two Dangerous Building Notices, listing necessary remediation works which had only been partially completed. Therefore the notices remained valid at the time of the fire.

Figure 1 - Second Incident: Rear facade of commercial unit overlooking the burnt out workshop

In the second building, the upper level unit was not appropriately fire separated from either the ground floor commercial unit or the adjacent single-storey unit. In addition, automatic detection was only provided in the single storey unit. The Building Code would have required both adequate fire separation and automatic smoke detection to protect the sleeping risk.

- Where sleeping accommodation is introduced in an existing building, automatic fire detection and alarm systems throughout are essential to ensure the safety of occupants and should therefore be provided as part of the conversion works.

- Adequate fire separation is also critical between sleeping areas and other parts of the building. Where existing partitions do not provide the required fire resistance, they should be replaced/upgraded as required.

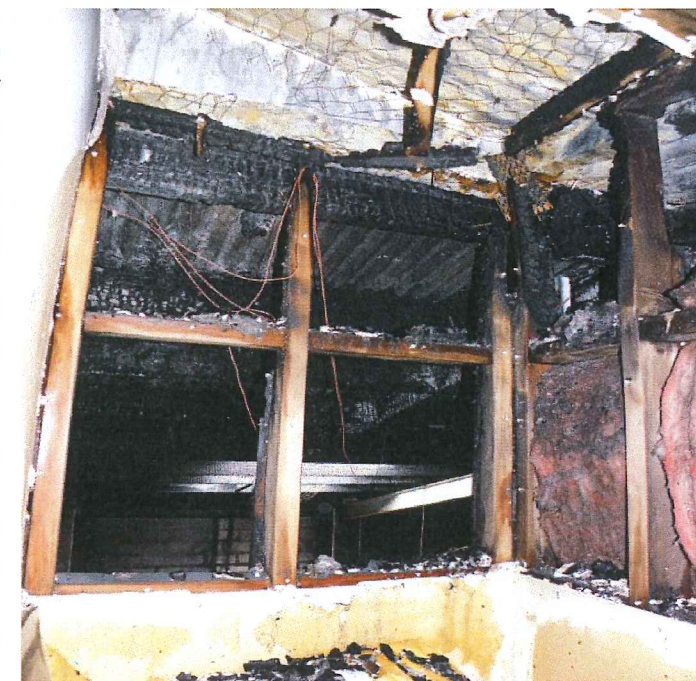
In the first building, the walls of the upper level unit were constructed with standard 12.5mm Gib board mechanically fixed to the timber frame. There were a number of penetrations through these walls which had not been fire stopped. Therefore the upper level unit containing the sleeping risk was not adequately fire separated from the ground floor spaces. The structural steel beam supporting the floor did not appear to have any fire protection. Finally, no automatic detection and alarm system was provided. All these features would have been required under the Building Code

Figure 2 - First Incident: remnants of the wall separating the kitchen of the residential unit from the workshop
