# PERMAFYX L271 CASE STUDY

## PORTSMOUTH COUNCIL NORTHARBOUR SPUR

Portsmouth Council, Northarbour Spur, PO6 3TU

Applied on 10<sup>th</sup> April 2020

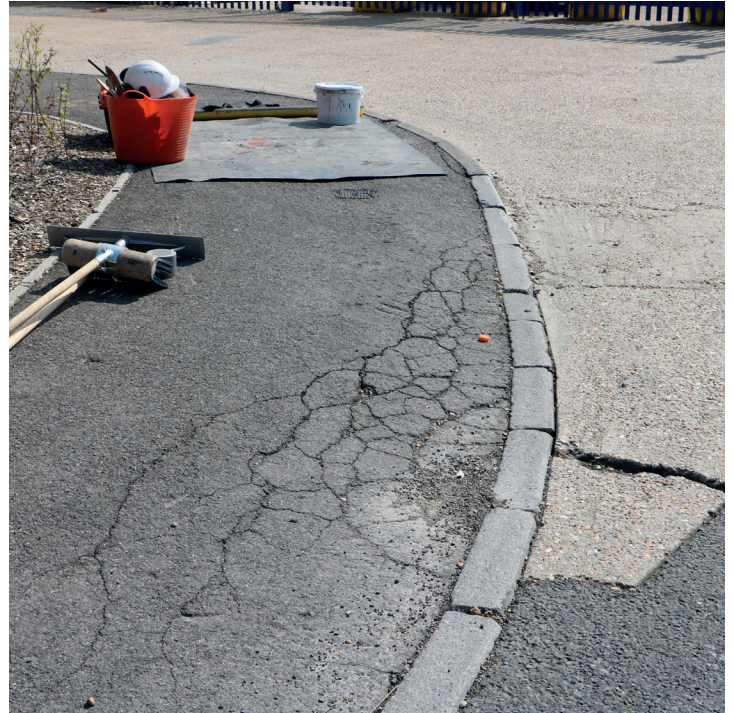
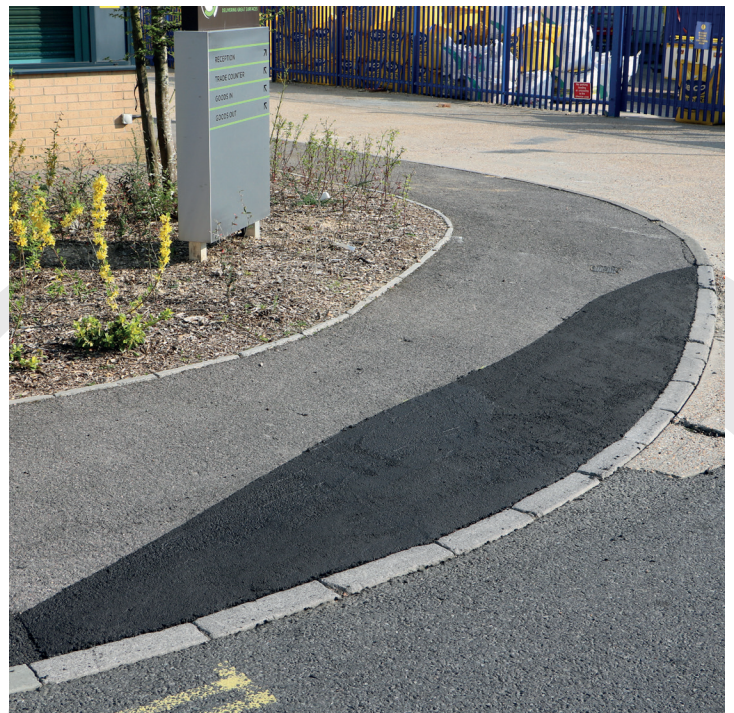
The footway corner adjacent to Unit 2 was regularly trafficked by heavy goods vehicles reversing into the neighbouring building supply facility. The bedrock in the area is soft clay and the asphalt surface had broken and subsequently sunk under the heavy load of the vehicles. With a scheme proposed to place a physical bollard to prevent the trucks mounting the area, a temporary repair was required to ensure the section of footway was safe, and to prevent the problem escalating.

The situation was assessed and it was concluded that due to the high stress of HGV tyres, standard footway materials wouldn't hold up for very long. Cementitious repair options were considered and then the PermaFyx L271 was recommended as a suitable option and should be placed on a trial basis. The deepest section had sunk by nearly 80mm, these areas needed to be built up using a 6-10mm bulk mix, screeded and feathered using a 1-3mm blend and then finally overcoated against a taped edge using 2.5mm mix.

The finished result looked great. There was no excavation, no cutting, no compaction, no noise and the repair has been subject to scuffing HGV tyres daily. It has held up for 7+ months, with minimal signs of deformation. As a result, the repair scheme has been deferred, allowing stretched budgets to be invested into other safety critical schemes.
