Sunbeam Service Sheet No. 1

Subject: **To prevent breakage of the rear engine mounting damper plate (Model S.7)**

Date: **September 1948**

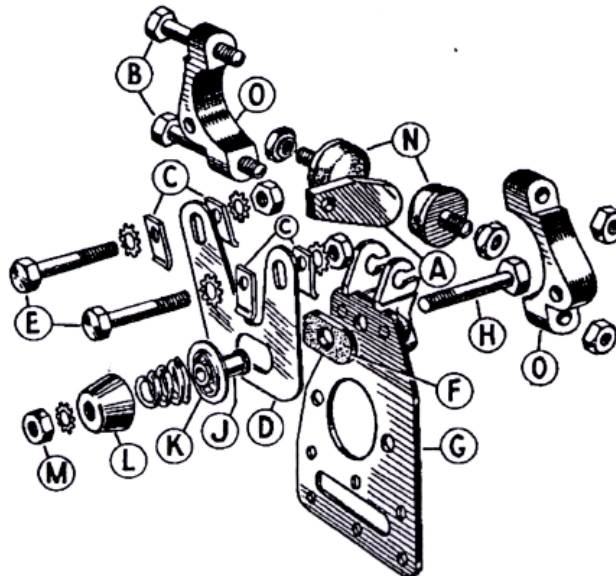
To obviate the possibility of the Engine Mounting Damper Plate breaking in the vicinity of the lug attachment bolts, reinforcement plates are fitted to all models after Engine Number S7-712. These plates have the effect of laminating the damper plate and should be fitted to all earlier models.

It is important that this procedure is followed carefully, particularly in connection with the positioning of the damper plate against the friction disc and the centralizing of the distance piece **J**. Incorrect assembly of the damper mechanism may result in fracturing of the damper plate.

Remove the petrol tank and the plate attachment bolts **E** and replace the two distance pieces by the four reinforcement plates **C**, noting that these are fitted with the bevel away from the damper plate. Unscrew nut **M** and take off cap **L** and washer and spring **K**.

Slacken the nuts on the clip bracket and holding the friction disc **F** in position slide the bracket along the frame top tube until the damper plate just touches the friction disc.

Replace the bolt **H** and the distance piece **J** and position the damper plate **D** so that the distance piece is located centrally in the hole in the damper plate. Note that the bolt holes in the damper plate are elongated to allow movement. Refit the washer and spring **H**, cap **L**, and nut **M**, tightening the latter until the cap is locked against the distance piece **J**.

Tighten the nuts in the clip bracket starting with the lower nut to ensure that the tongue **A** is firmly held.

After reassembly it is essential that the engine mounting is readjusted. Should it be necessary to move the clip bracket **O** to obtain correct clearance between the tongues **A** and the rubber buffers **N** the nuts on the bolts **E** should first be slackened so that the clearance of the distance piece in the hole in the damper plate is not affected.
