# STEWART ENGINEERING

## Sunbeam Service Sheet No. 11

**Subject: Timing Chain Tensioner fitted to Engines with S.8 Prefix**

**Date: July 1951**

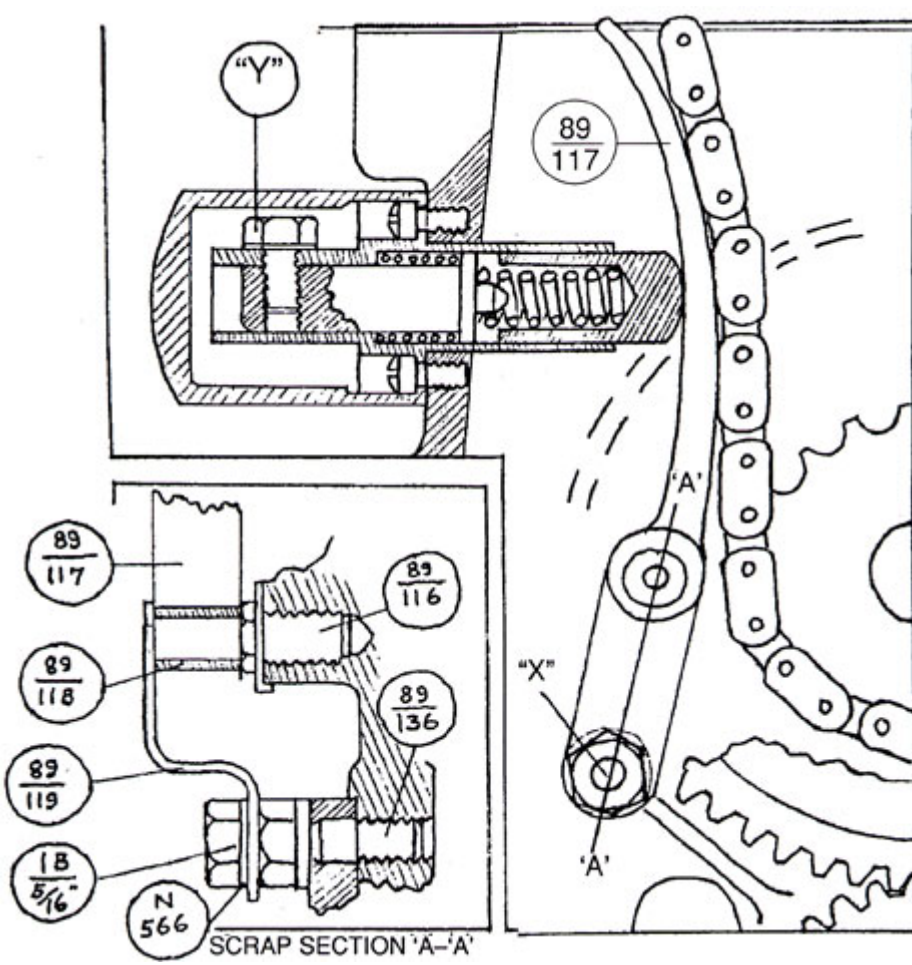
To overcome premature failure of the tensioner and spring, the complete assembly has been redesigned. The modified components can be fitted to all engines bearing the S.8 prefix.

Remove the nut and spring washer from the end cover stud immediately below the pivot pin (*marked "X" in drawing overleaf*) and extract the stud. Replace with the new stud 89-136 and replace the original nut and spring washer.

Slacken off the  $\frac{1}{4}$ " bolt (*marked "Y" in drawing overleaf*) and screw the assembly into the crankcase using the fibre washer originally removed from the inspection plug.

Turn the engine until either of the exhaust valves is partly open then tighten bolt "Y" securely.
