Sunbeam Service Sheet No. 12

Subject: Timing Chain *Tensioner fitted to Engines with S.7 Prefix*

Date: April 1952

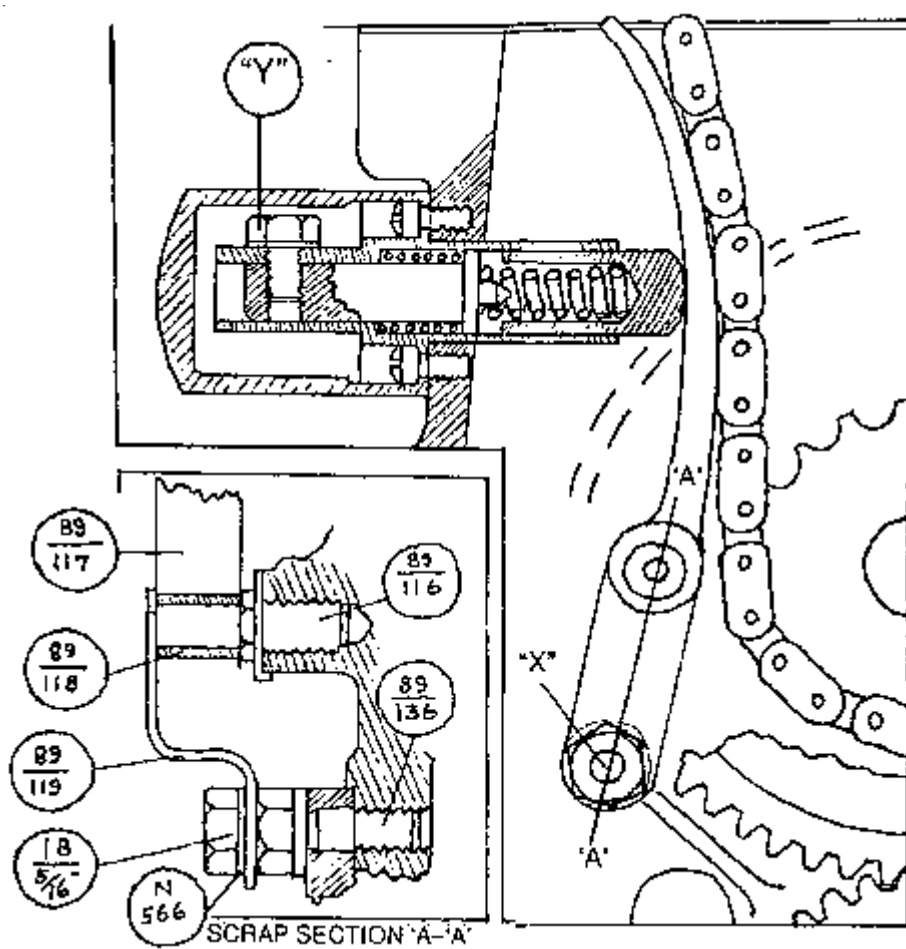
To overcome premature failure of the tensioner and spring, the complete assembly has been redesigned. The modified Chain Tensioner Conversion Set complete, Part number 89-165, can be fitted to all engines bearing the S.7 prefix. For engines bearing the S.8 prefix see Sunbeam Service Sheet No. 11.

Remove the nut and spring washer from the end cover stud immediately below the pivot pin (*marked "X" in drawing overleaf*) and extract the stud. Replace with the new stud 89-136 and replace the original nut and spring washer.

The retaining clip 89-119 can now be fitted over the end cover stud and pivot pin and secured by nut 1B - $\frac{5}{16}$ " and spring washer N 566, as shown in scrap section "AA"

Slacken off the $\frac{1}{4}$ " bolt (*marked "Y" in drawing overleaf*) and fit the assembly into the crankcase using the two screws originally removed from the inspection cover to secure it in position.

Turn the engine until either of the exhaust valves is partly open then tighten bolt "Y" securely.
