Sunbeam Service Sheet No. 18

Subject: Crankshaft Regrinding

Date: December 1956

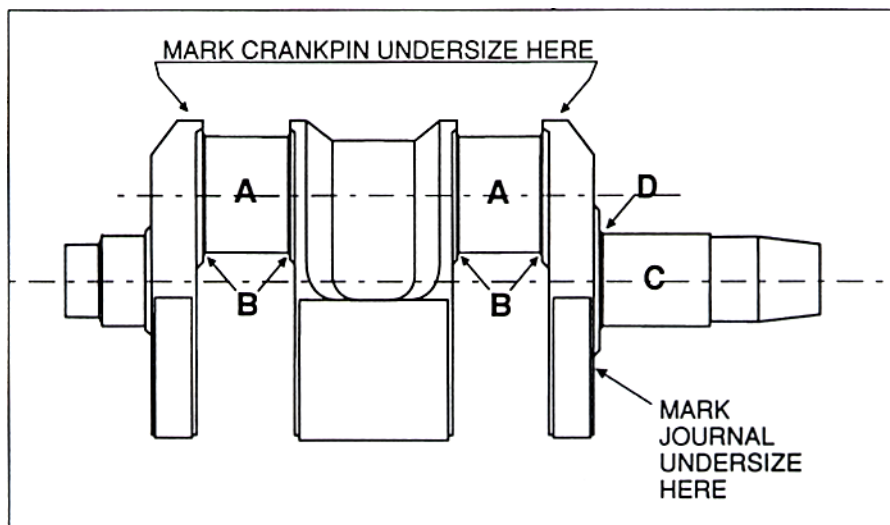
If the overall wear on the crankpins or rear journal exceeds .002", or if the bearing surfaces have been damaged, it will be necessary to re-grind the crankshaft to the dimensions given below.

Grind the crankpins 'A' to 1.6150"/1.6145" with a face radius at 'B' of .125"/.129". Mark the tops of the webs - .010". Use undersize bearing shells, Part No. 89-695.

Grind the crankpins 'A' to 1.6050"/1.6045" with a face radius at 'B' of .125"/.129". Mark the tops of the webs - .020". Use undersize bearing shells, Part No. 89-81.

Grind the journal 'C' to 1.4895"/1.4890" with a face radius at 'D' of .125"/.129". Mark the side of the web - .010". Use undersize bearing bush, Part No. 89-89.
