DeatschWerks Technical Service Bulletin (TSB)

Bulletin No: TSB-22-10-14

Subject: Prefilter does not fit tight on DW200 & DW300 fuel pumps

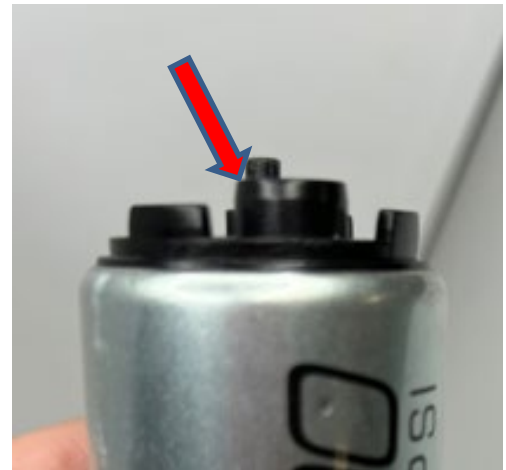
Certain pre-filter sock part numbers do not fit tightly on certain DW200 & DW300 fuel pump lot numbers. The DW200 and DW300 fuel pumps with specific lot numbers have a tapered inlet fitting on the fuel pump that will not allow the pre-filter to lock into place causing the pre-filter to be extremely loose on the fuel pump. Refer to the part number list above for the pump & fitment kits that are affected by the tapered inlet.

The lot # format will be as follows: Lot# XXXX-221010, Please compare your lot number to the following list of lot numbers below. If your lot number is in the list below, compare your inlet fitting on the bottom of the fuel pump to verify you have a tapered inlet housing.

Option A: Use of the included start-nut pump filter retainer will keep the loosely fitting fuel sock in place. There are no known issues of pre-filter sock failures when installed with the star-nut retainer.

Option B: A properly fitting fuel pump pre-filter sock has been obtained by DeatschWerks and will be shipped to the effected customer at no charge. Please contact DeatschWerks technical support at 405-217-0701 or techsupport@deatschwerks.com for service.
