TREATMENT REPORT

Job No: 21.034
Date: 23 December 2021

ARTIST/ATTRIBUTION: [John Cleavelly (1747 – 1785)]

MEDIUM AND SUPPORT: possible aquatint on wave paper

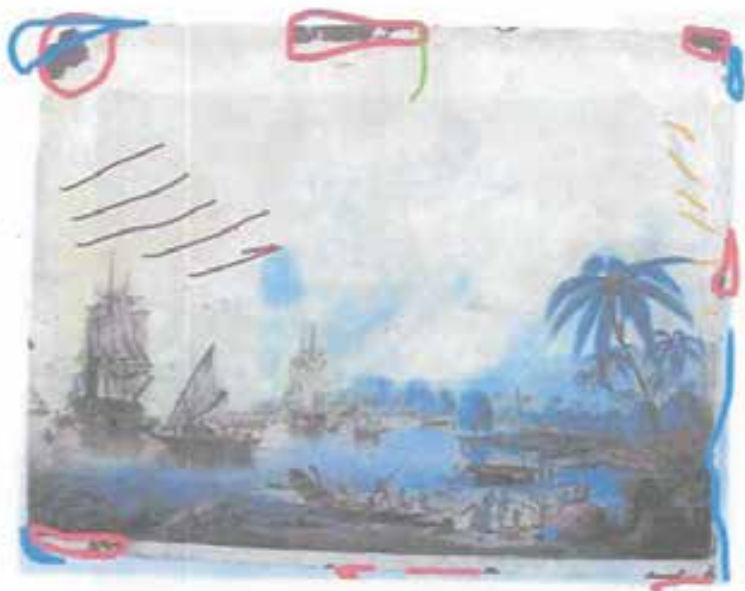
CONDITION:

Main issues are: staining, loss, tear, creases, foxing "bubbling" of substrate

- Wave paper
- Some overall discolouration
- May be attached to backing board
- Various areas of brown presumed past repairs to print.
- Area of abrasion
- Staining with tide lines

- Numerous losses of substrate
- "Bubbling" of substrate. Bubbling suggests that the art-work is attached to a secondary support and the "bubbling" is where the adhesion between the two is failing.
- Fading
- Creases
- Tear at top centre edge and right edge
- Areas of loss at corners and edges
