# CERTIFICATION TEST REPORT

CERTIFICATION TEST REPORT 16411-1  
MECHANICAL STRENGTH TESTS  
ON  
115-15 & 115-15-S 15-INCH CLEATS  
FOR  
ACCON MARINE, INC.

**REPORTNO.:** 16411-1  
**IMANNA JOB NO.:** 16411  
**CUSTOMER P.O. NO.:** Verbal  
**CONTRACT:** N/A  
**PAGES IN REPORT:** 4

**DATE:** Feb. 13, 2004

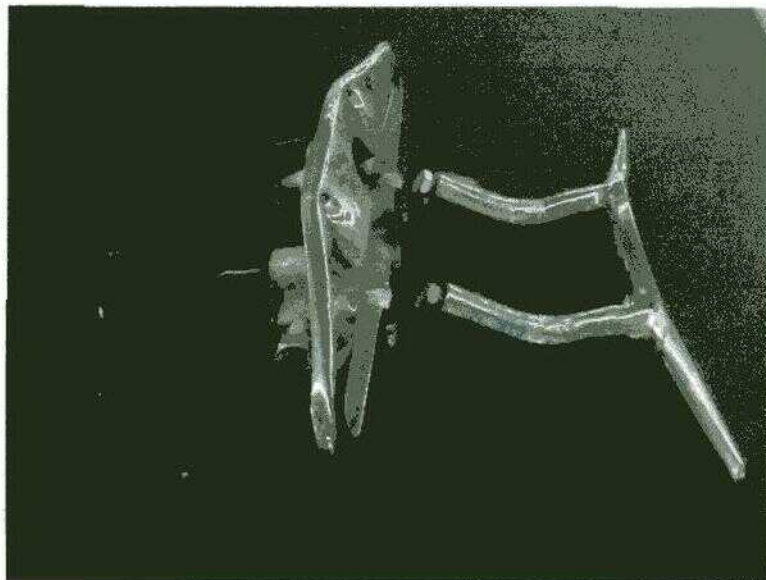
SAMPLE	MAX LOAD (lbs)	FAILURE MODE
1	65,640	CLEAT PULLED FROM ASSEMBLY
2	54,140	CLEAT PULLED FROM ASSEMBLY
3	64,660	CLEAT PULLED FROM ASSEMBLY
Average	61,480

Figure 1. 115 - 15 typical failure mode.

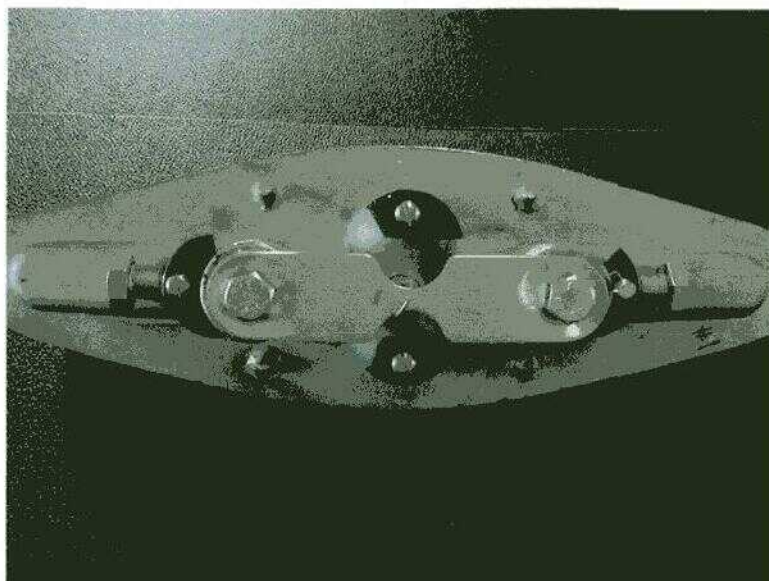
SAMPLE	MAX LOAD (lbs)	FAILURE MODE
1	36,680	FASTENER SHEARED OFF
2	29,830	FASTENER SHEARED OFF
3	28,810	FASTENER SHEARED OFF
Average	31,773

Figure 2. 115 - 15 - S typical failure mode (fastener failure).

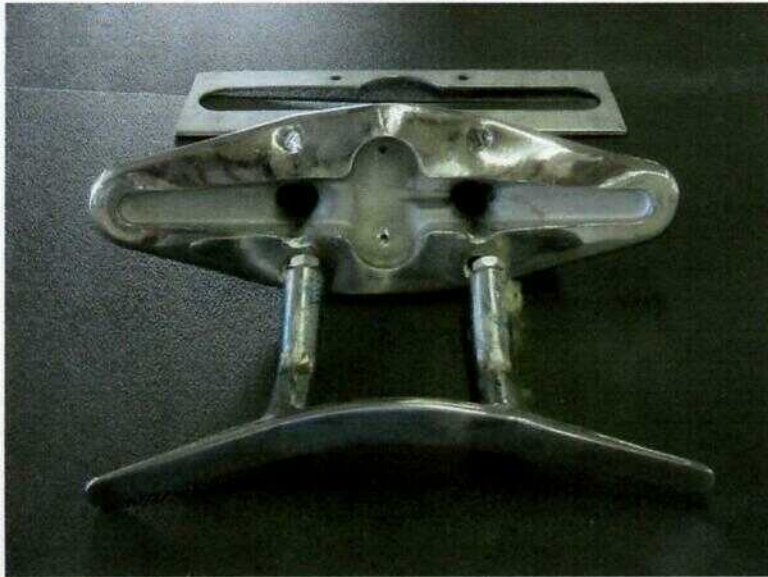
**Figure 3:** view of through **bolt** holes
