INTERMODAL MATERIÉL  
AND  
NAUTICAL/NUCLEAR ANALYSIS  
**IMANNA**  
LABORATORY INC.

CERTIFICATION TEST REPORT 15050-1  
OF  
MECHANICAL STRENGTH TESTS  
ON  
6-INCH SLIMLINE CLEATS  
FOR  
ACCON MARINE, INC.

**REPORT NO.:** 15050-1  
**IMANNA JOB NO.:** 15050  
**CUSTOMER P.O. NO.:** VERBAL  
**CONTRACT:** N/A  
**PAGES IN REPORT:** 7

**DATE:** April 19, 2000

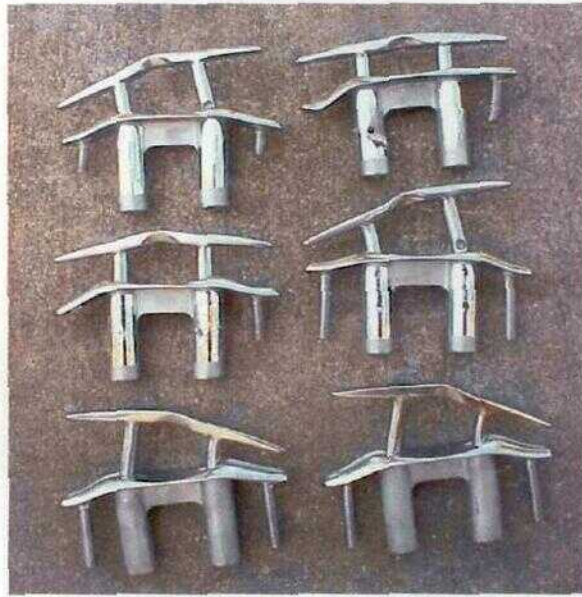
The typical first observed deformation appeared to be when the entire cleat-mounting base lifted up from the steel plate it was mounted to. Although this deformation occurred at an average of 50% of the Ultimate Failure load, it did not appear to significantly contribute to the ultimate failure of the system.

**Figure 1. Photo showing Slimline Cleats after Pull Testing,**

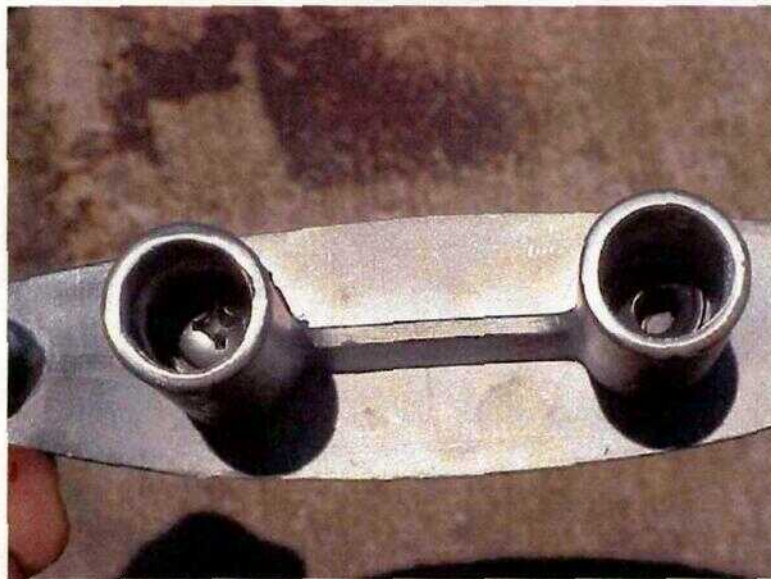
The typical ultimate failure was when one the Phillip's heads of the two cleat-retaining screws broke off(See Figure 2). Once this head broke off, the cleat retaining system became **unsymmetrical** and thus weakened the cleat system.

**Figure 2. Close-up showing typical failure of Phillips cleat-retaining screw head breaking off. Note the absence of the Phillips head in the right side sleeve.**
