**CERTIFICATION TEST REPORT** 16579-1 MECHANICAL STRENGTH TESTS ON 10-INCH STAINLESS CLEATS **FOR** ACCON MARINE, INC.

16759-1

**DATE:** Feb. 18, 2005

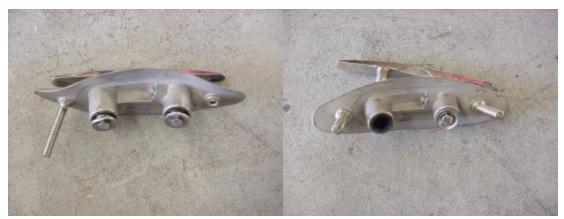
SAMPLE	MAX LOAD (lbs)	FAILURE MODE
1	29,430	1 mounting bolt sheered off of
		cleat body
2	33,360	cleat pulled from cleat body
3	30,580	both mounting bolt sheered off of
		cleat body
AVERAGE	31,123	see photos
