CERTIFICATION TEST REPORT 16046-2 MECHANICAL STRENGTH TESTS ON 6-INCH WIDE-LINE SERIES CLEATS #305-6 FOR ACCON MARINE, INC.

ACCON MARINE, INC. 13665 AUTOMOBILE BLVD. CLEARWATER, FL 34622

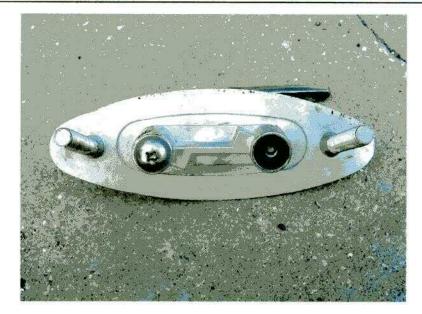
SAMPLE	MAX LOAD (Ibs)	FAILURE MODE	
1	6,075	RETAINING SCREW HEAD BROKE	
2	7,154	RETAINING SCREW HEAD BROKE	
3	7,369	RETAINING SCREW HEAD BROKE	
4	5,752	RETAINING SCREW HEAD BROKE	
5	6,686	RETAINING SCREW HEAD BROKE	
AVERAGE	6,607

Figure 1. Wide-Line cleat; Typical failure mode (screw head failure).

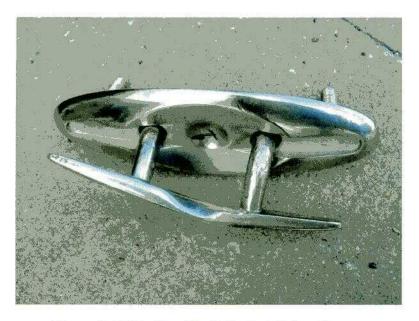
Figure 2. Wide-Line Cleat; Typical deformity.
