**DAM SAFETY REVIEW**

WILTON ROAD DAM

CATARAQUI REGION  
CONSERVATION AUTHORITY

MAY 2006

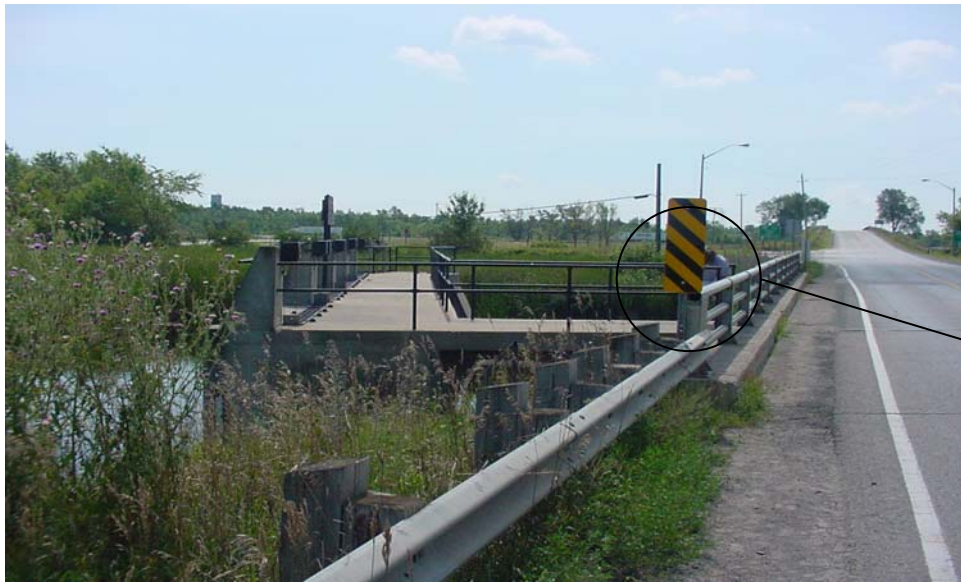
**PHOTO WIL-08: DAM DECK  
ACCESS OVER GUARD RAIL**

Access to the dam is along the road embankment and climbing over the guard rail of the Wilton Road bridge. The access is open to traffic and can be slippery during winter conditions. Concrete steps have been constructed on the north side of the dam parallel to the bridge headwall to gain access to and for reading the staff gauges.

AWKWARD  
ACCESS IN  
SLIPPERY  
CONDITIONS

Access to the Wilton Road Dam is along the shoulder of the road. Staff members park their vehicles on the gravel shoulder. A portable flashing light set on the roof of the vehicle should be turned on in this instance. Preferably, vehicles should be parked off the road at a farm or other entrance. Operators should wear safety vests. Warning signage should be set beyond the limits of the dam should maintenance staff be making several trips between the vehicle and the dam. Staff members are required to step over the guide rail to access the dam. A support (post or railing) should be installed at the guide rail to reduce the likelihood of slippage during wet or icy conditions.

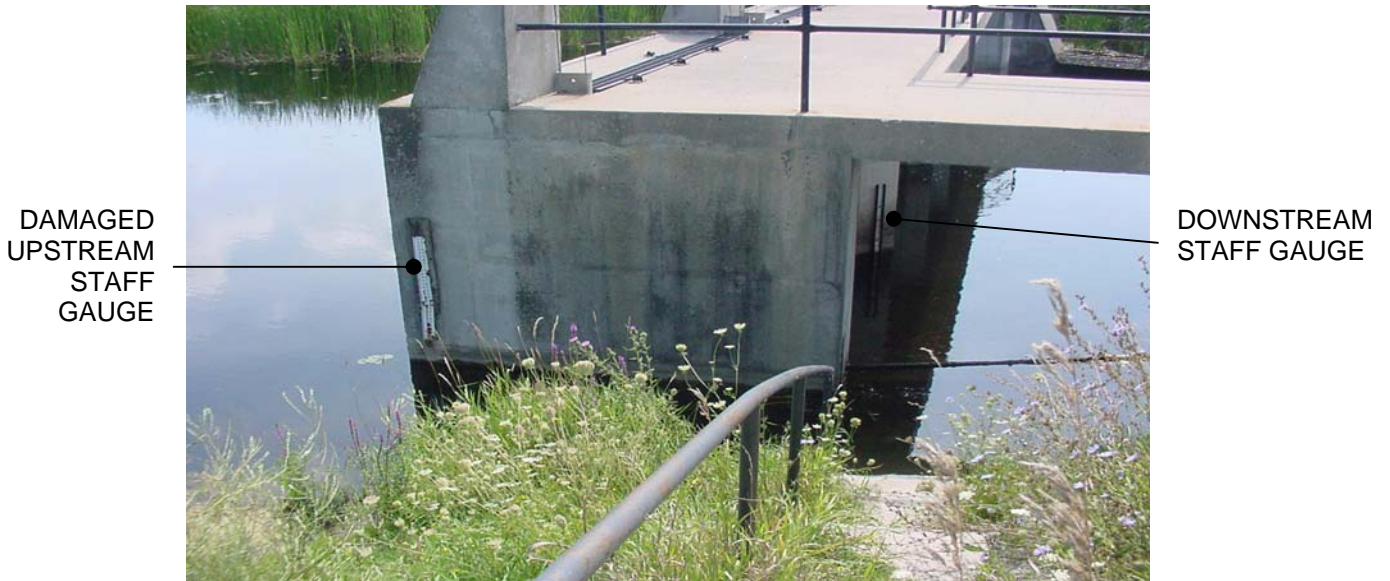
PHOTO WIL-09: STAIRS AND STAFF GAUGES

Two staff gauges are located at the Wilton Road dam site. One is located on the north pier facing the concrete steps. This gauge is tied to a geodetic datum, but has been damaged by ice. Its needs to be repaired and mounted in a location that is not impacted by drawdown at the weir and gate. The second gauge is on the downstream side of the southerly pier of Bay 1 which can be affected by flow over the gates.

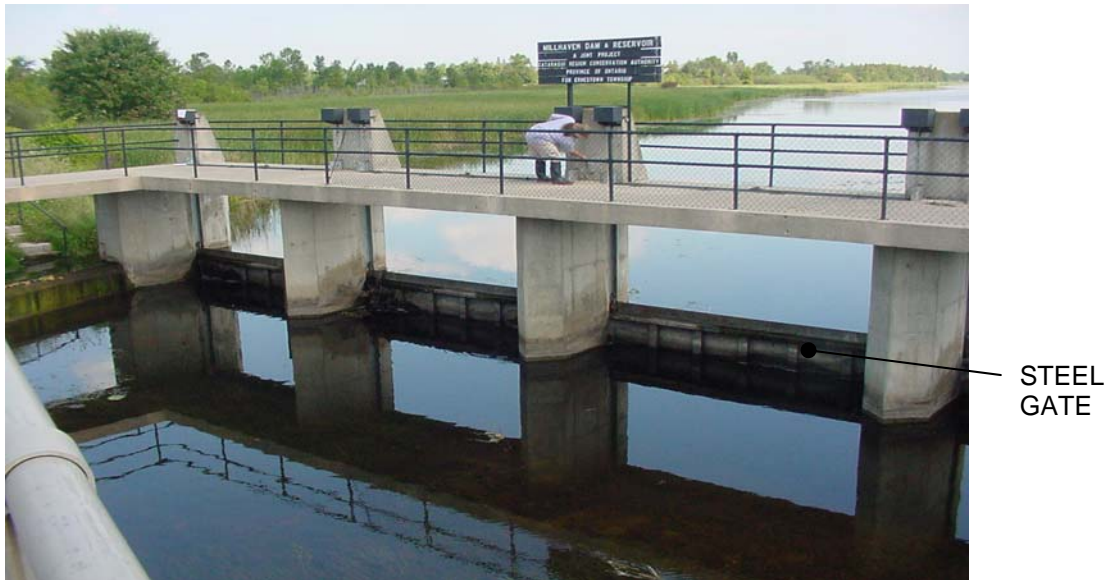
PHOTO WIL-10: STEEL GATES IN BAYS

The present methodology of suspending the gates on the winch cables during the winter period needs to be reviewed. This provides stress on the cables. A device to lock the gates in the fully open position would provide the cable with a longer life expectancy and reduce the likelihood of damage as a result of vandalism (i.e. persons cutting the cable).

The steel gains appear to have a protective coating and show little deterioration or rust at the waterline.

Inspection of the gates needs to be done yearly in the winter months when they are in the open position. The gains should be checked at the same time. When the gates are fully closed during low flow, they should be inspected for leakage.

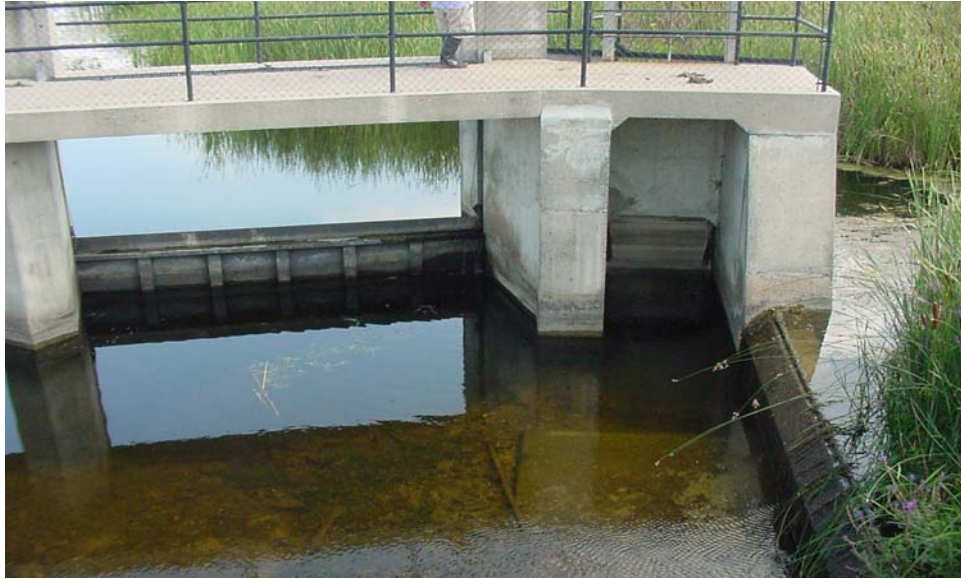
PHOTO WIL-11: LOW FLOW (GATE) VALVE (DOWNSTREAM VIEW)

MISSING  
JOINT  
SEALANT

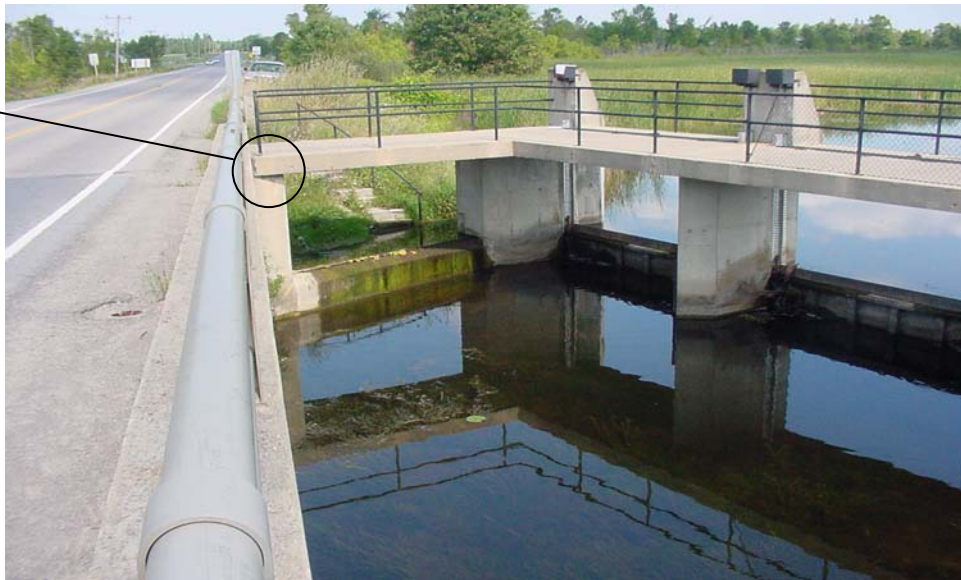
PHOTO WIL-12: NORTH SIDE WEIR

Stability assessments undertaken have concluded that the dam meets the draft Ontario Dam Safety Guidelines. The north overflow weir does not meet the minimum factors of safety for sliding; however as it is joined to the control structure piers as well as the Wilton Road bridge, it is considered to be stable.

The safety factor for sliding was found inadequate under all conditions. The resultant is also out of the mid-third under normal conditions. Note: we have ignored the anchor bolts shown on the drawing. However, considering the structure as a whole, the weir is short, anchored to the bridge and control structure piers so it is considered to be safe.

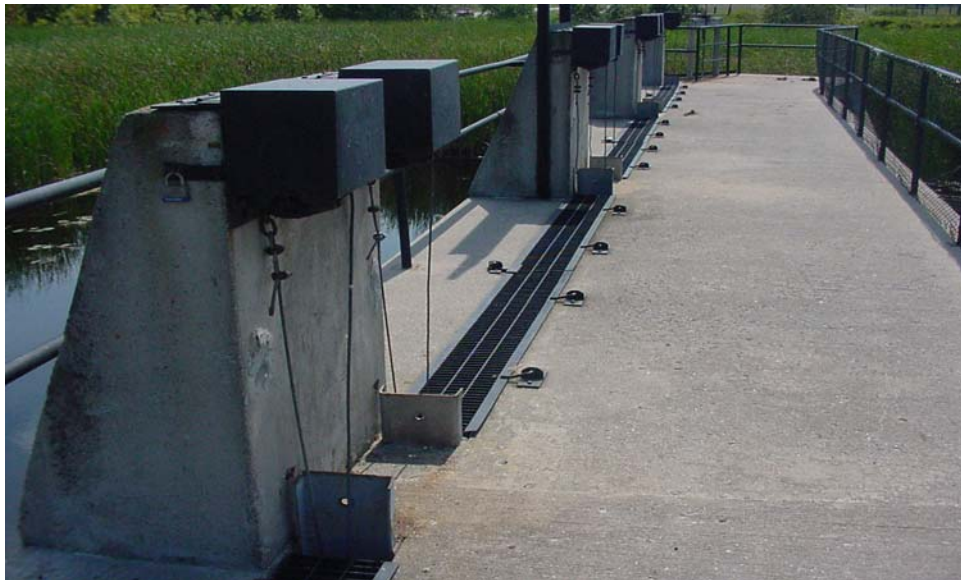
**PHOTO WIL-14: WINCH PEDESTALS, GAIN COVERS, DECK, HANDRAIL WITH WIRE MESH (DOWNSTREAM SIDE ONLY)**

A small area of concrete at winch pedestal 3 has been repaired. This patch has a drummy sound and the patch has not bonded to the underlying concrete.

There is no fall arrest system on the control deck. However, a fall arrest system is not necessary for Wilton Road Dam as the lake level is generally shallow and maintenance is performed in the water during low flow conditions. It should be noted that the Wilton Road Dam Operations Manual recommends the use of a fall arrest system. In place of a fall arrest system, personnel can attach themselves to the handrails but the handrails were not designed for this purpose (i.e. loading) and are currently deficient in height with respect to the Occupational Health and Safety Act (OHSA).
