Ontario Structure Inspection Manual (OSIM)  
Bridge Inspection Report  
Township of Stone Mills

Prepared by:  
Jewell Engineering

Dated October 22, 2020

RE: Cataraqui Region Conservation Authority  
2020 OSIM Bridge Inspection Submission  
Our File No. 200-9678

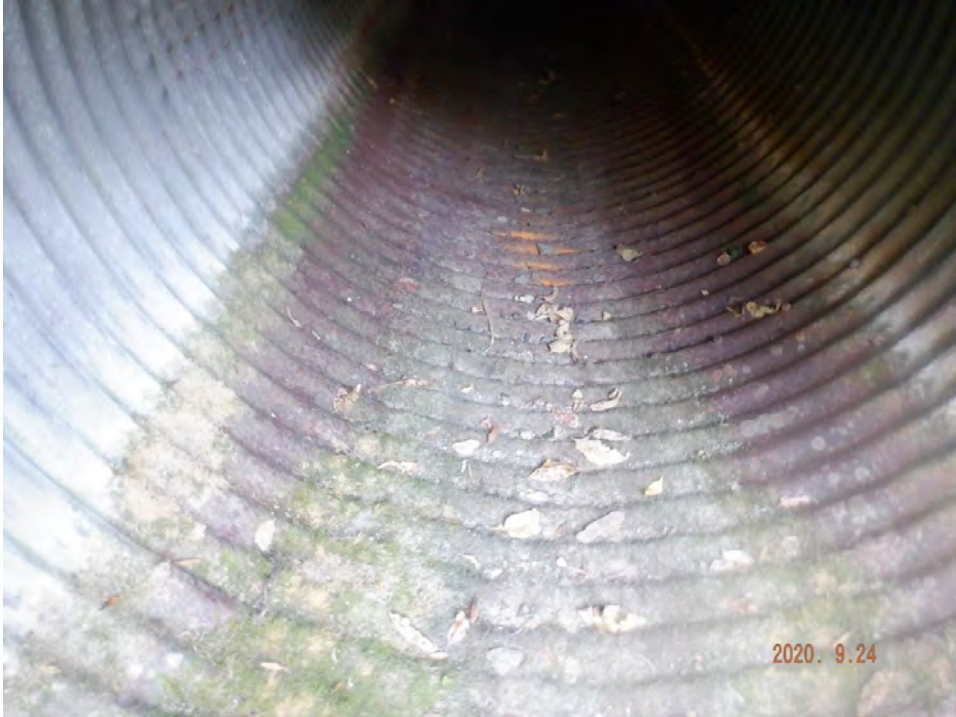
Typical corrosion in culvert floor

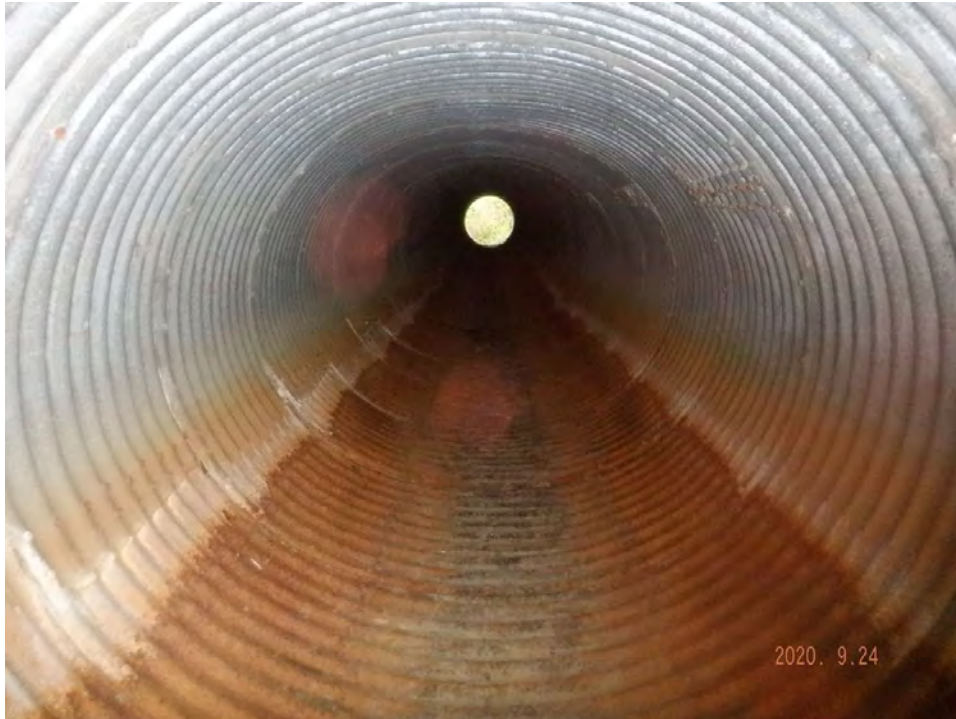
Deformation of barrel at mid length

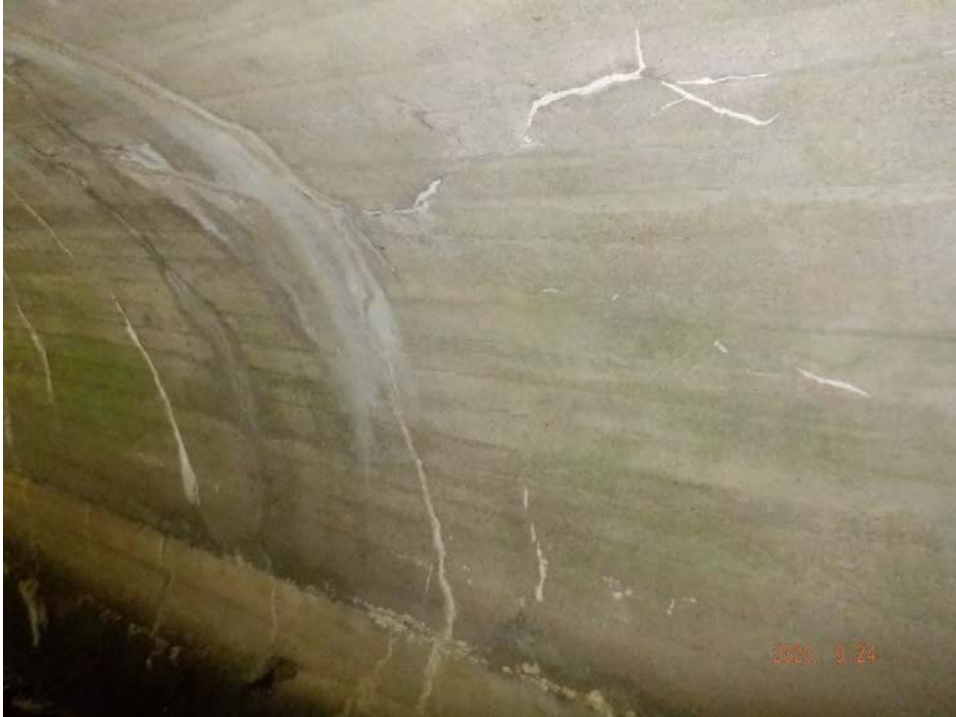
Structure has some cracking with efflorescence and delamination in walls. Overall structure remains in servicable condition.

Cracking with efflorescence in west wall

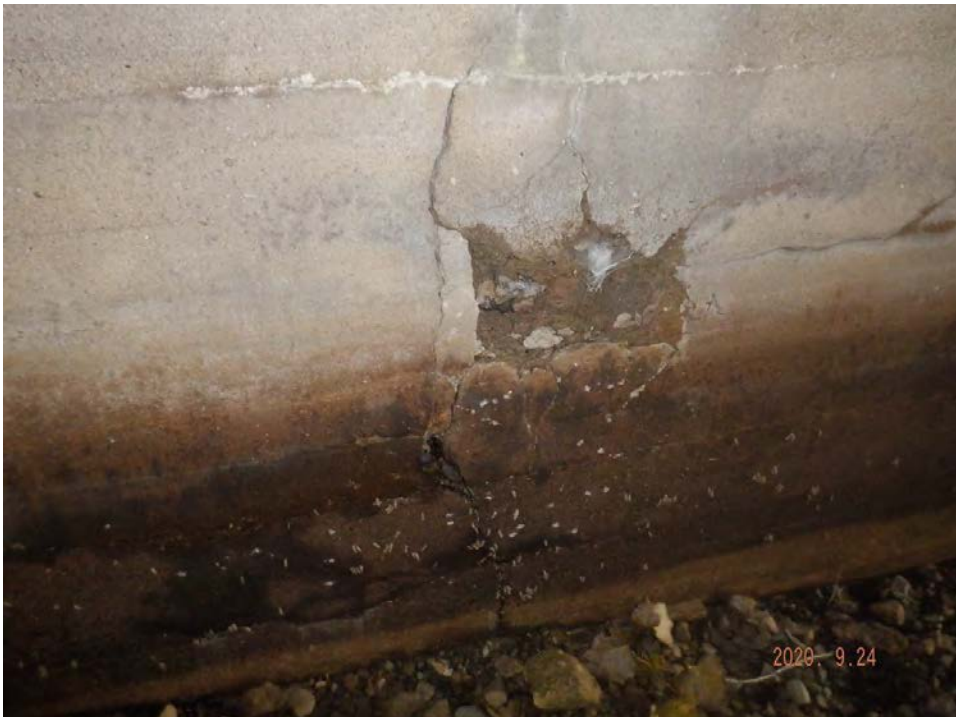
Spalling and delamination in east wall

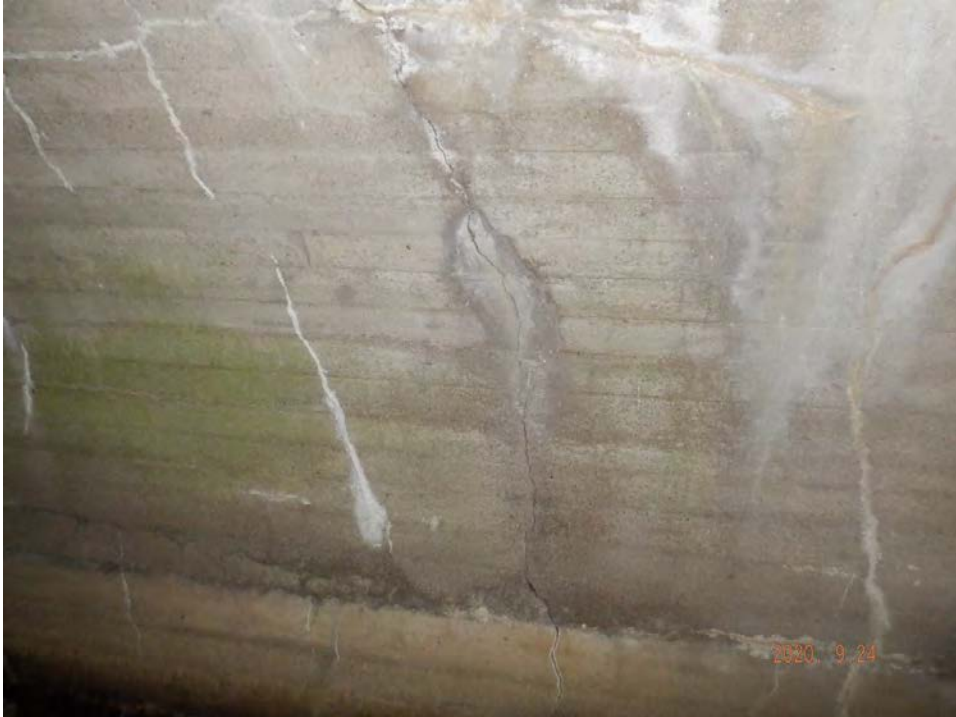
Cracking with efflorescence in west wall

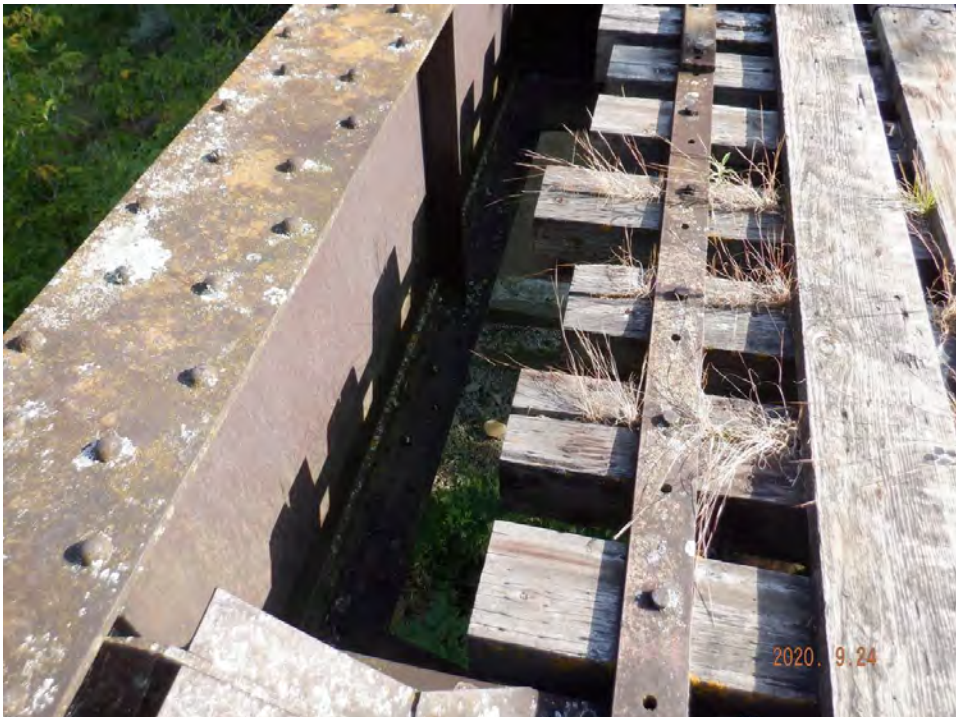
Gap between girder and deck edge

Recommended Work	Description	Timing	Estimated Cost
Major Rehab	Install Railing System	Within 1 Year	\$15,000.00

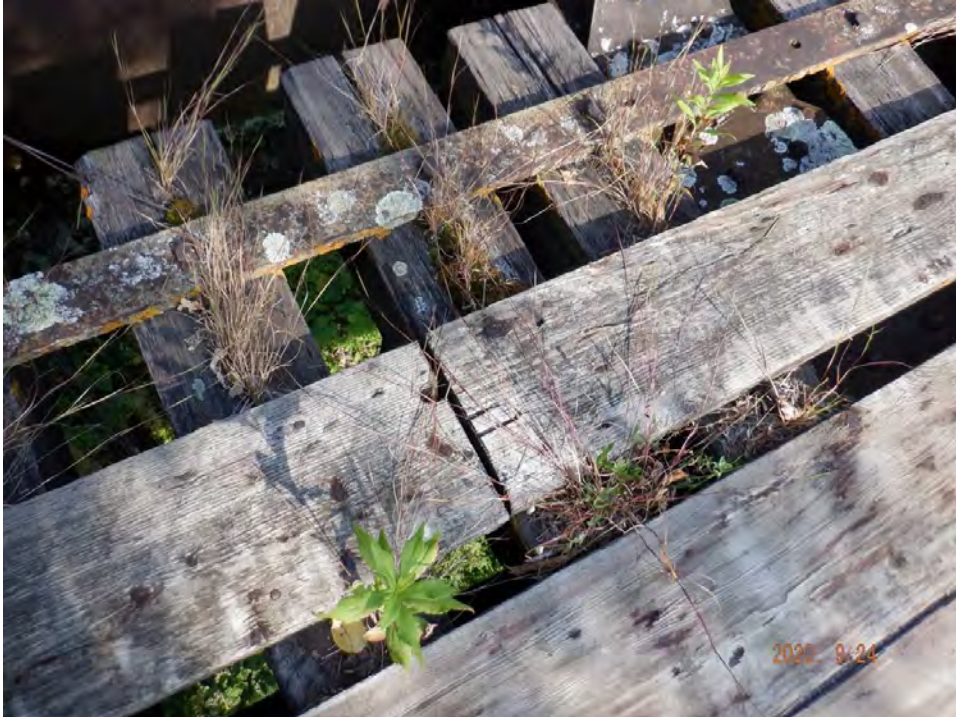
Indications of rot noted in numerous railway ties. Vegetation growing through checks and splits. One split railway tie at the east end of deck.

Rot and vegetation growth in railway ties

Replace deck

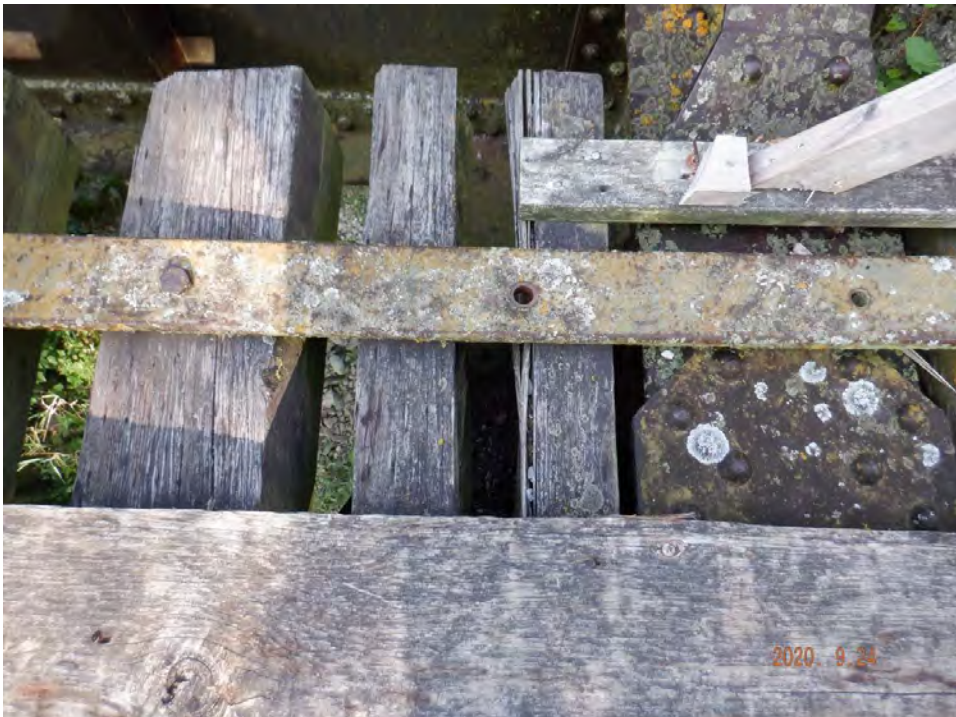
Split Railway tie in northeast

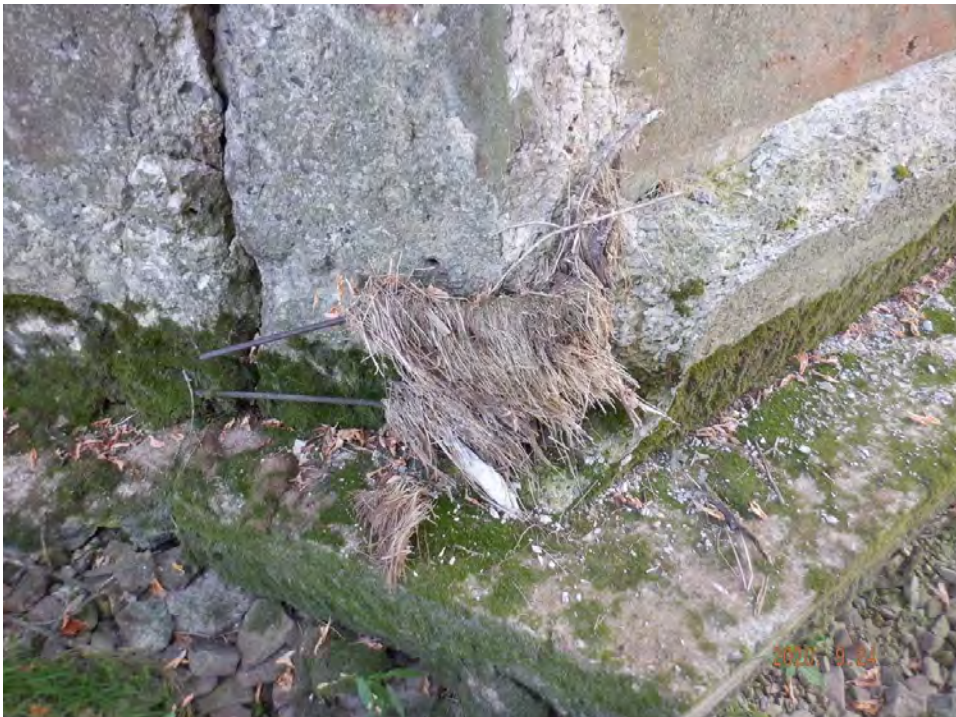
Light to moderate scaling throughout. Cracking with efflorescence in south end of east abutment. Light to moderate disintegration in west wall at south end. Spalling with exposed rebar in north end of east footing.

Spall in northeast footing

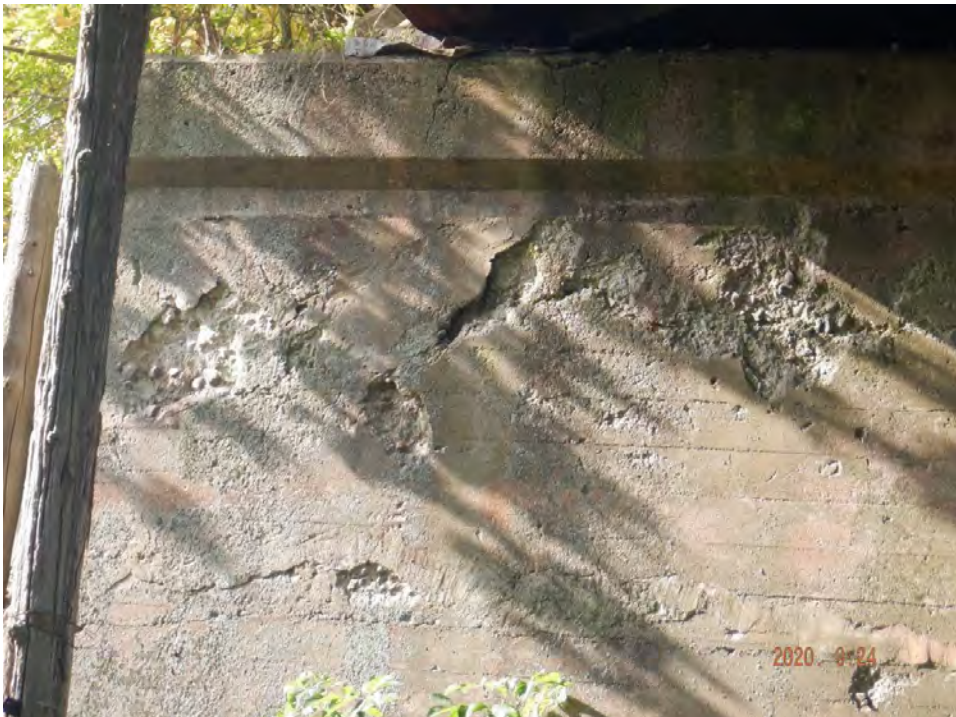
Disintegration in northwest abutment wall

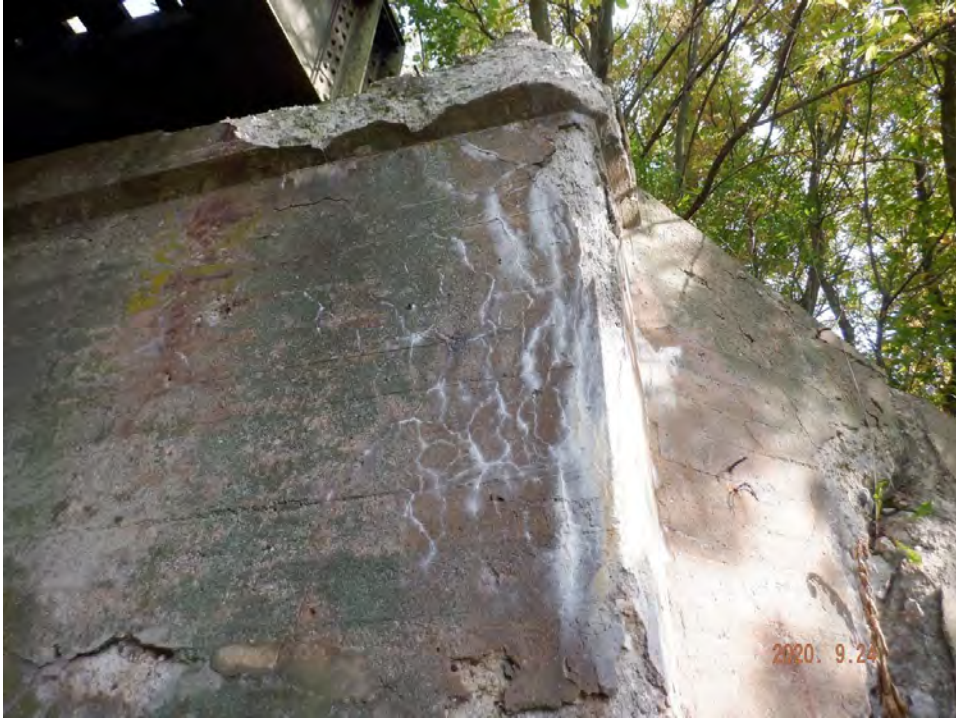
Cracking with efflorescence in southeast abutment

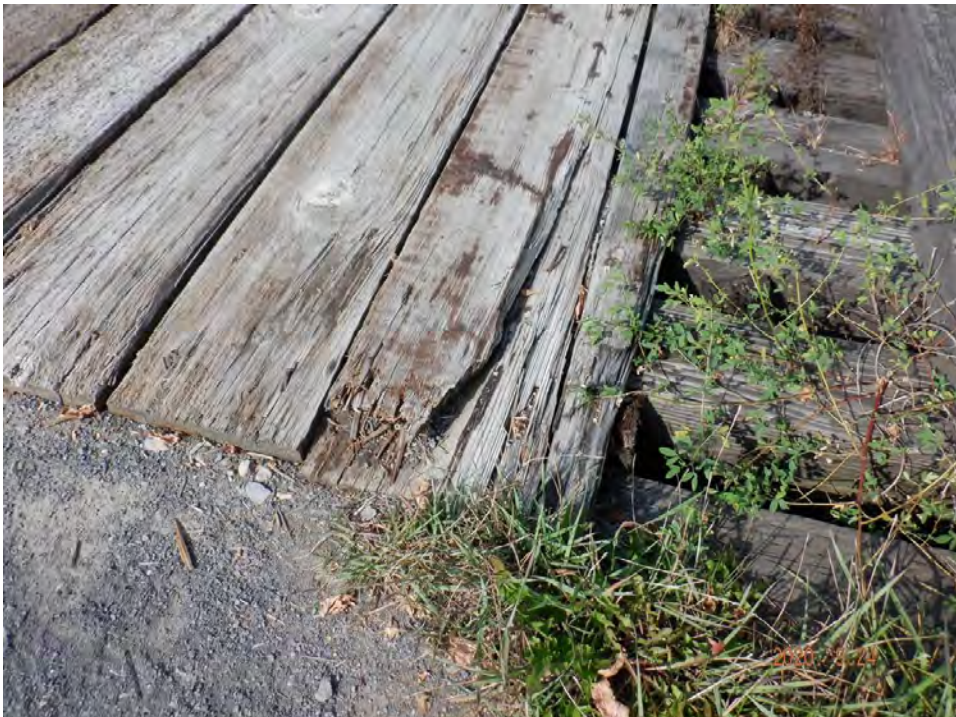
Wearing surface has light to moderate checks and splits. Some loose boards.

Split board in northeast

Replace wearing surface (costed under deck)

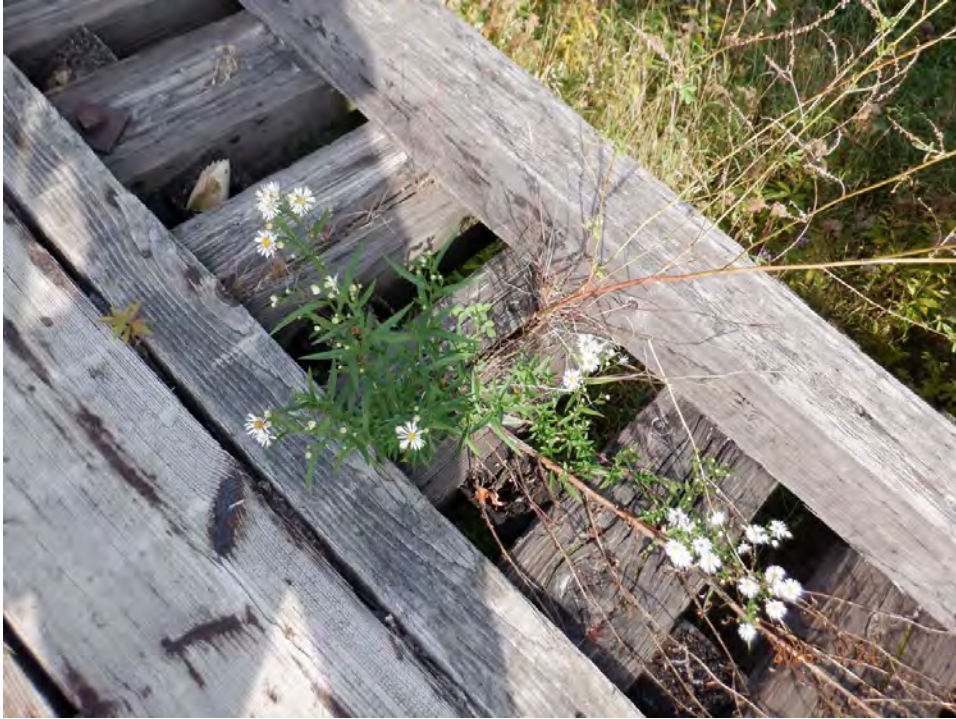
Light to moderate checks and splits and railway ties. Vegetation growing from cracks indicate rot within the ties.

Vegetation growing in railway tie

Replace deck

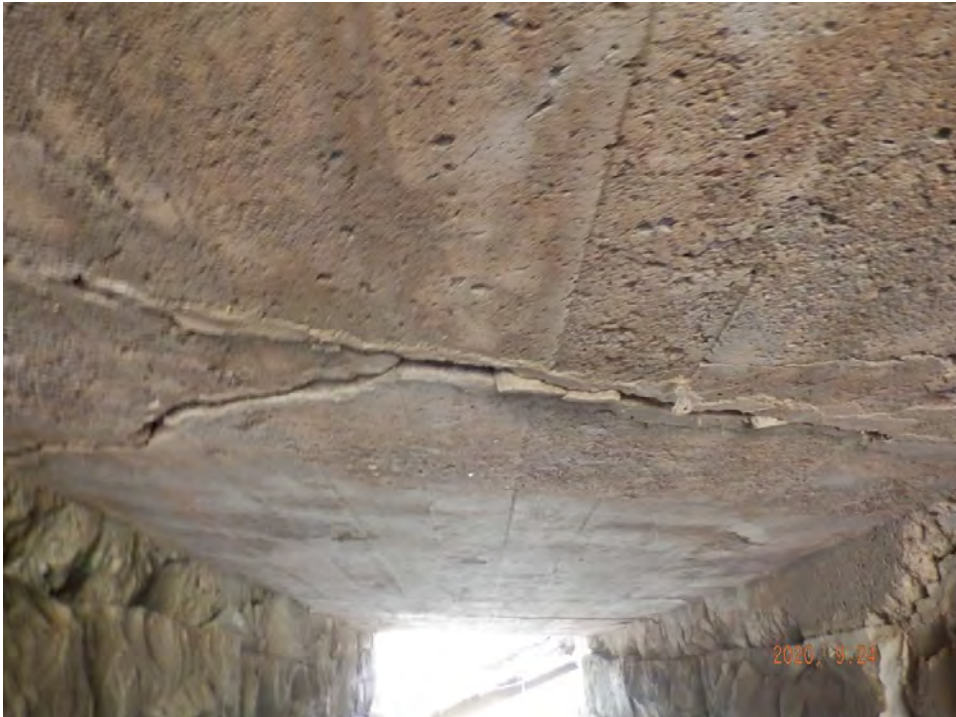
Concrete slab on masonry walls. Generally in good condition. Medium to wide cracks in slab.

Cracking in soffit

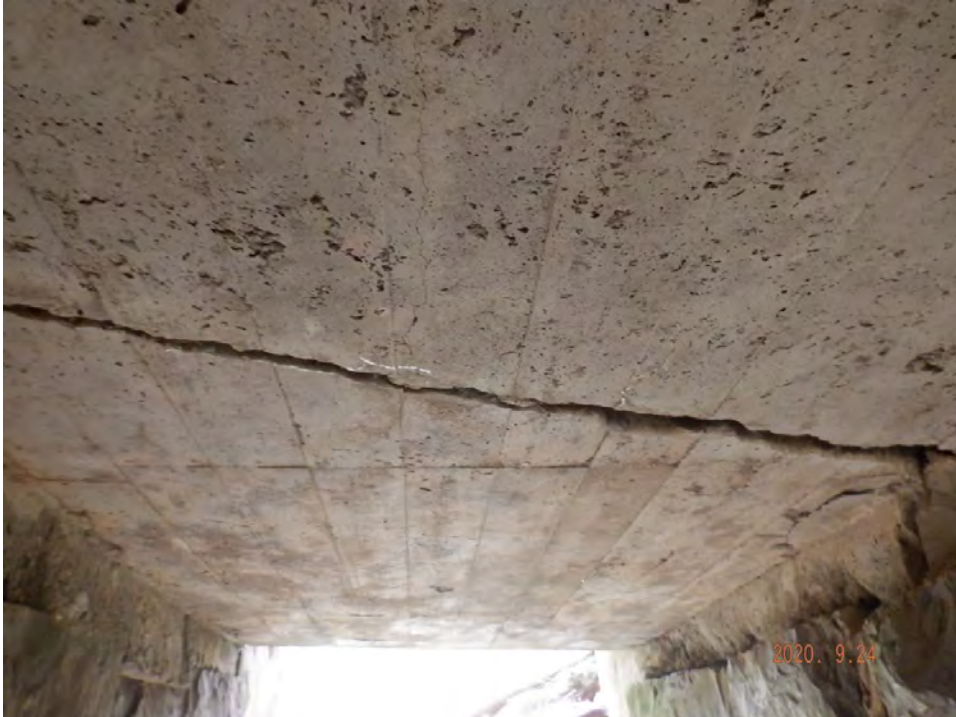
Wide crack in soffit

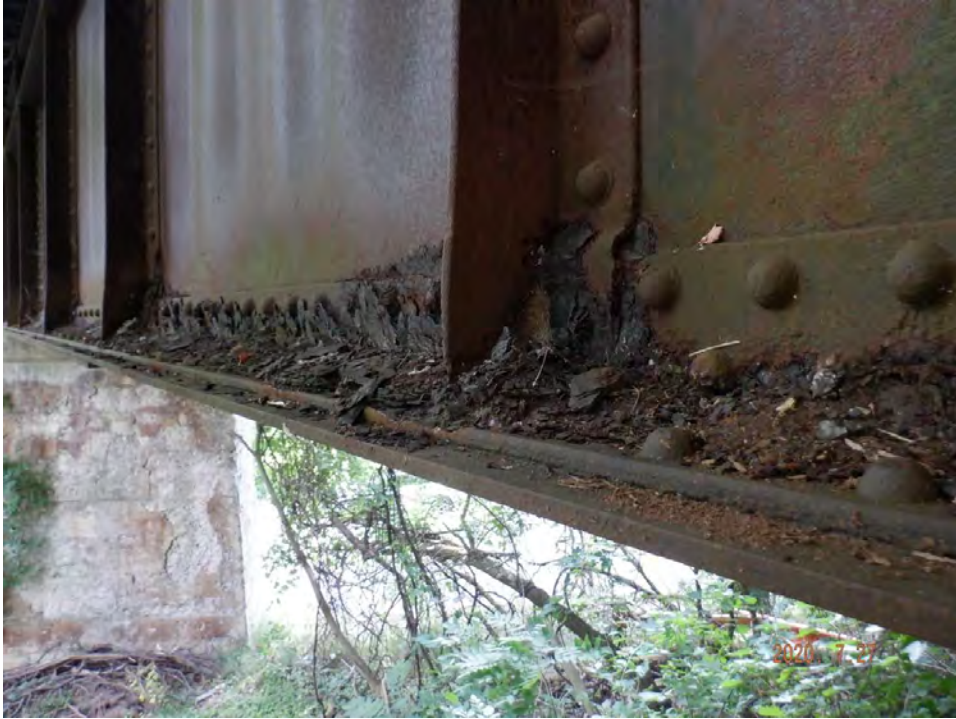
Perforated girder stiffeners in northwest

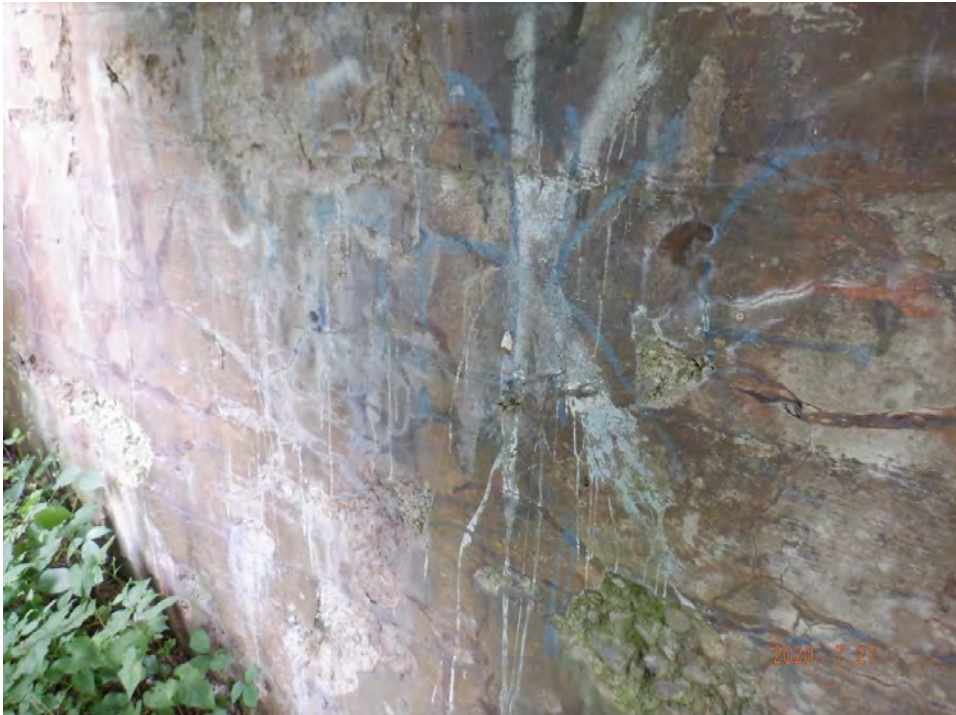
Light cracking and disintegration in west abutment wall

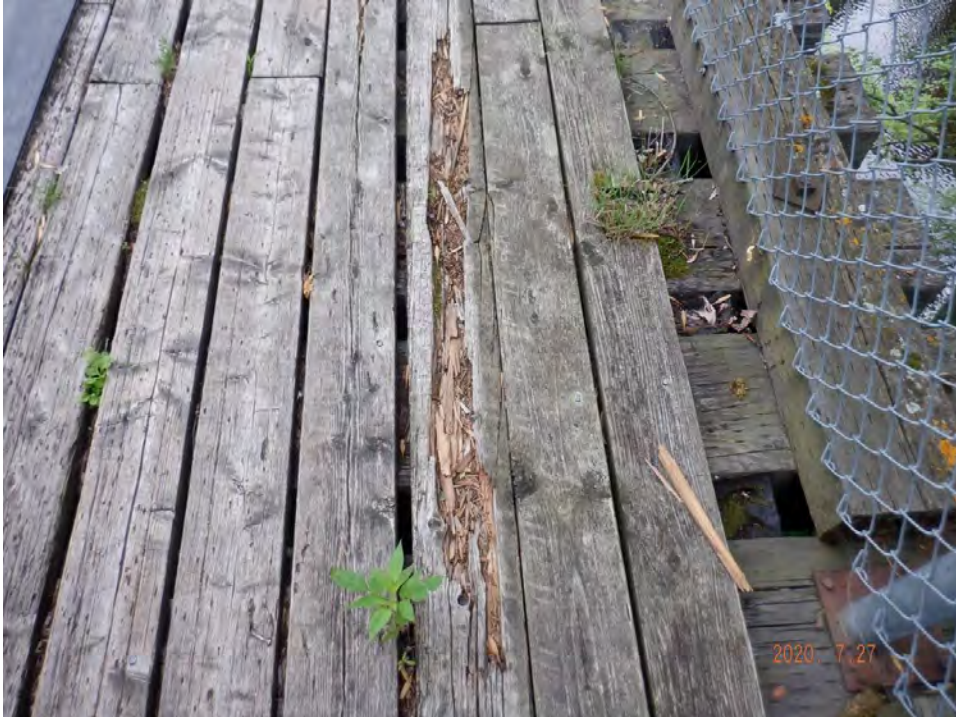
Rot in deck boards

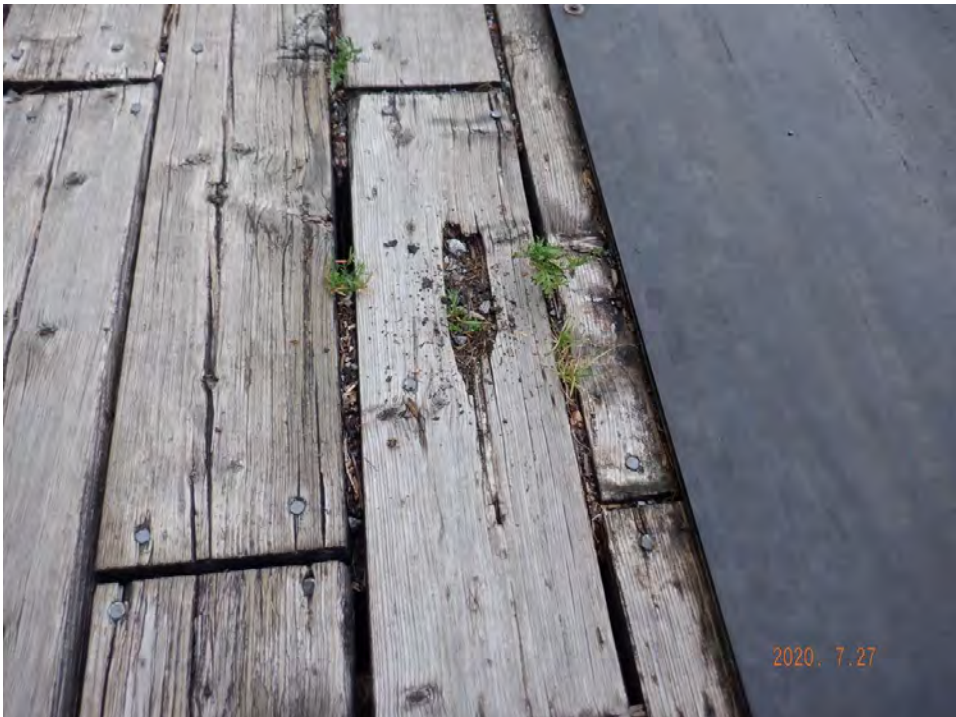
Rot in deck boards

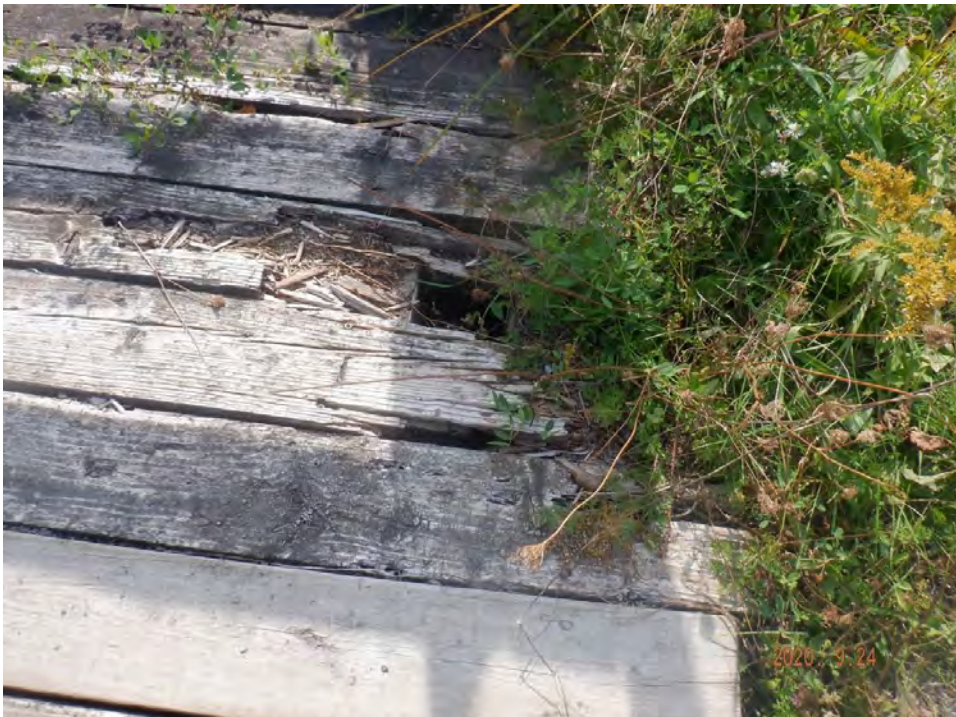
Rot in deck surface

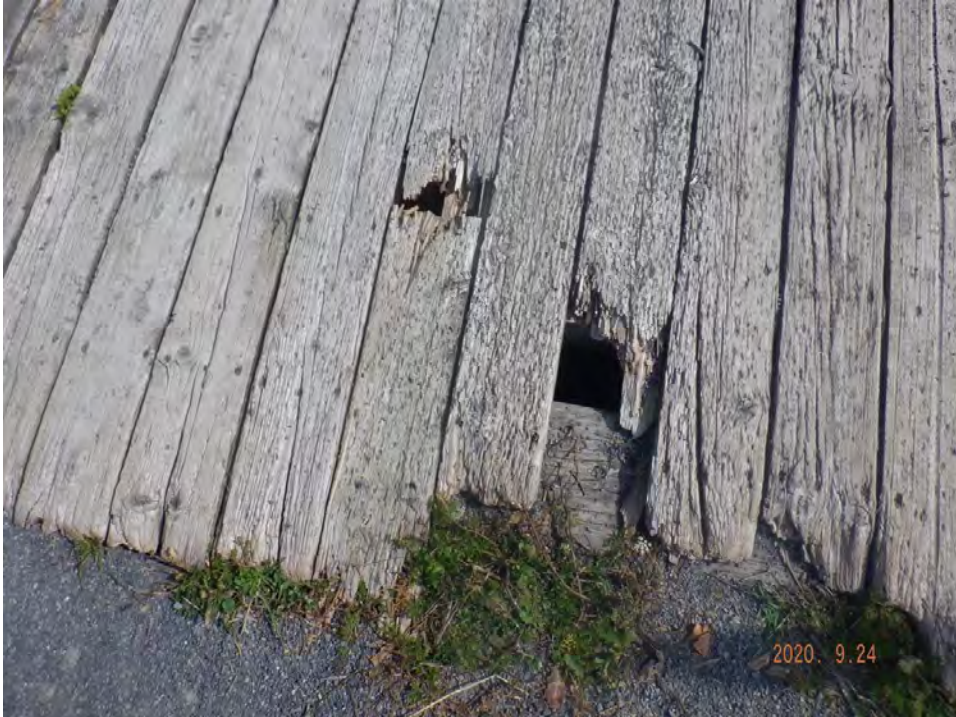
Rot in west deck end

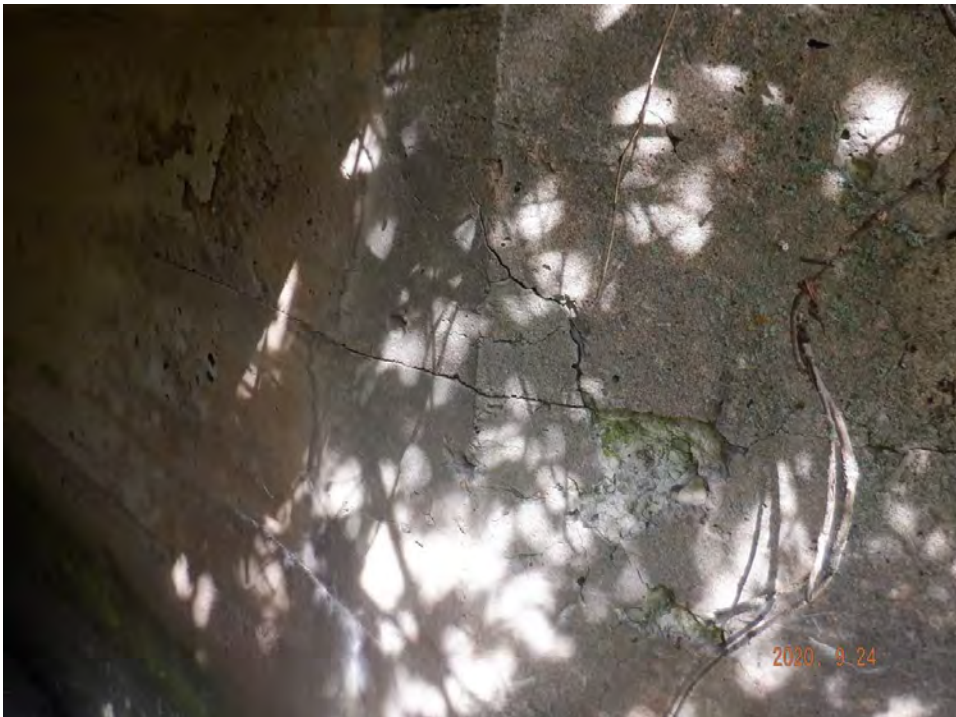
Cracking in southeast

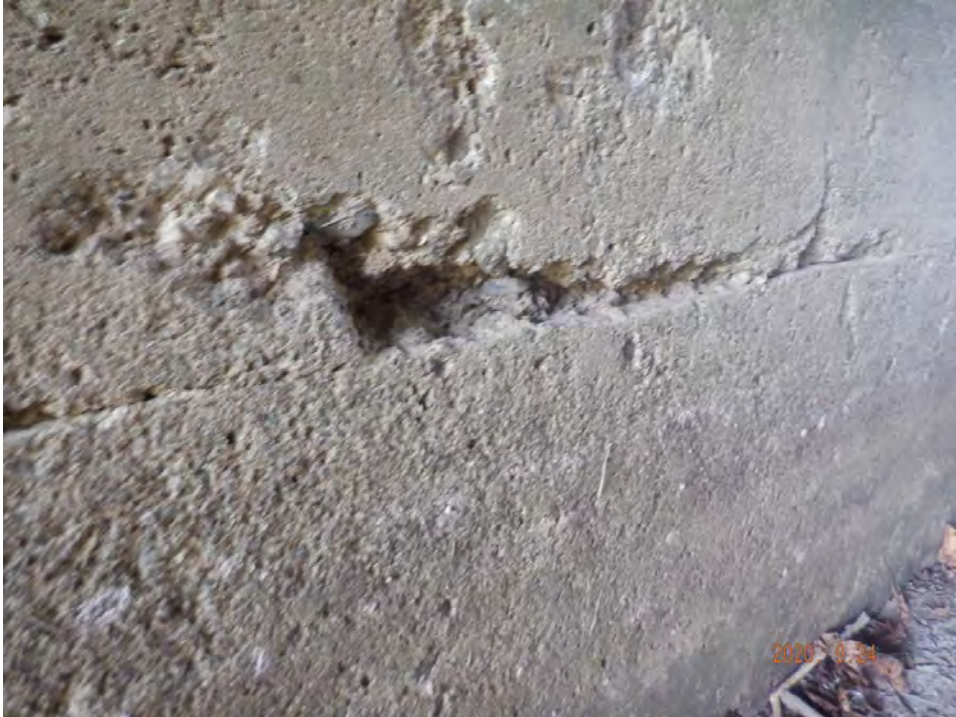
Honeycombing in east wall
