Ontario Structure Inspection Manual (OSIM)
Bridge Inspection Report
Township of South Frontenac

Prepared by:
D. M. Wills Associates Limited

Dated November 21, 2019

**Re: 2019 OSIM Bridge Inspection Report
D.M. Wills Associates Project No. 16-9206**

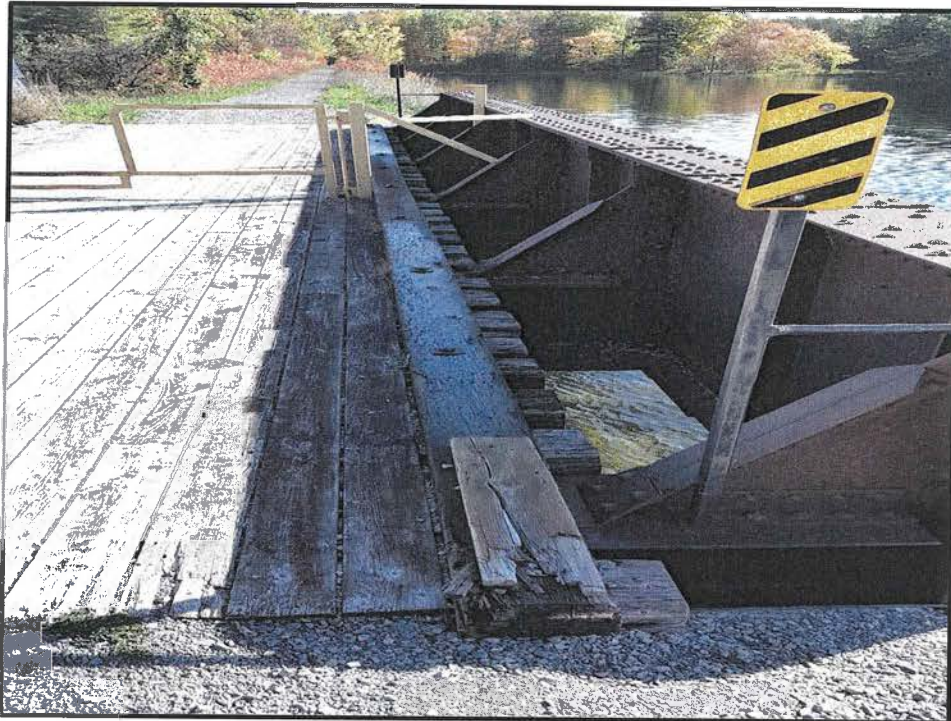
Deck to Truss Gap (To Be Filled or Guarded with Rail)

Recommended Work
 Add railing between gap of deck and truss for safety.

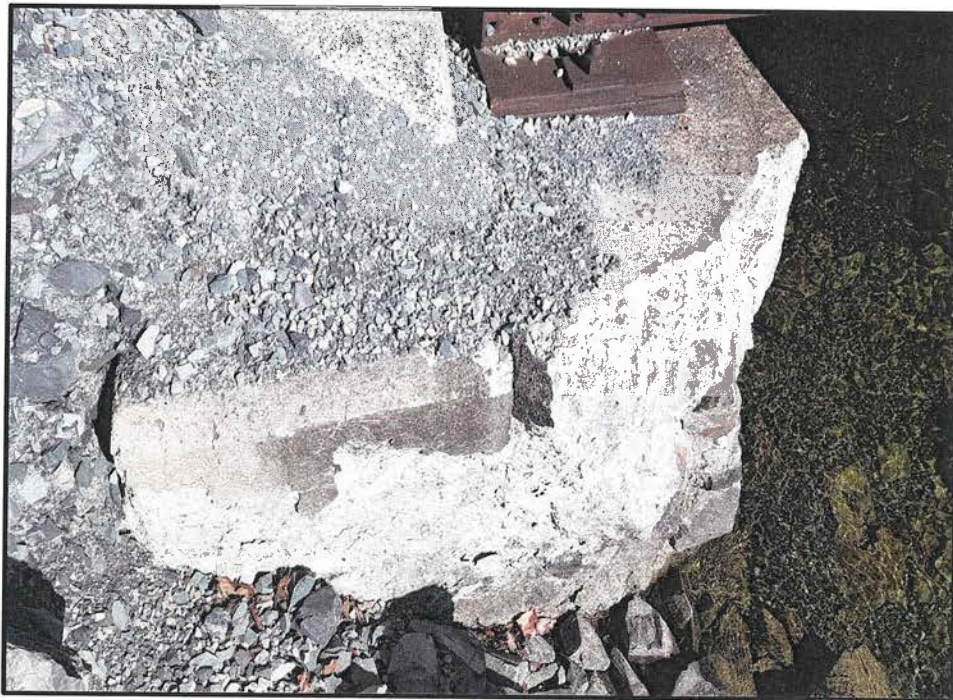
Severe Cracking and Spall at SW Abutment Wall

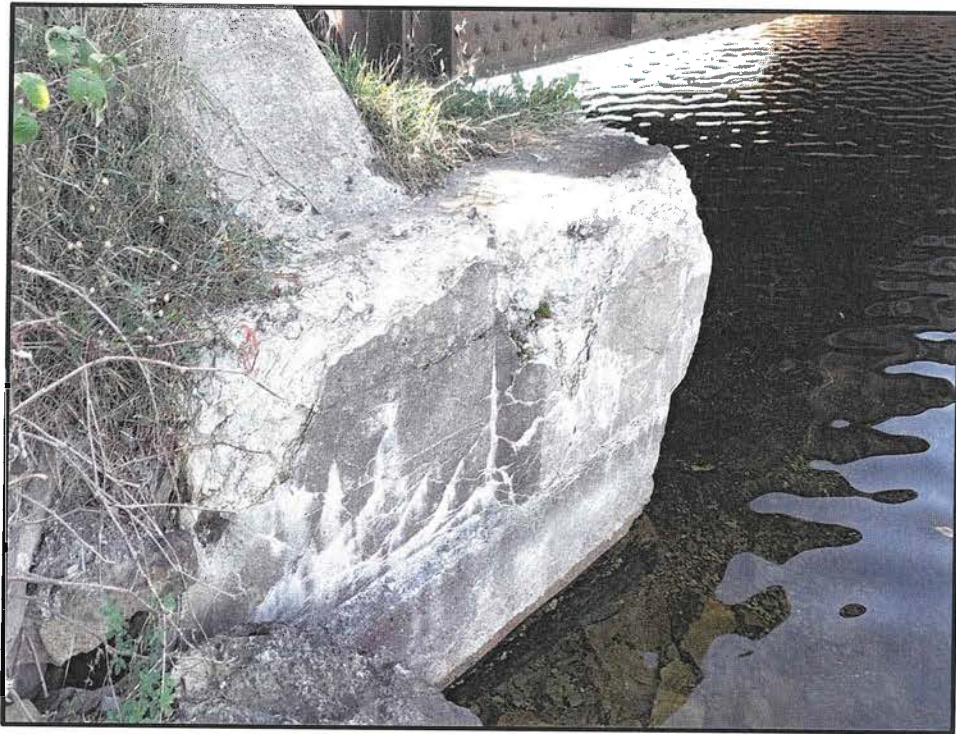
Deterioration of Abutment

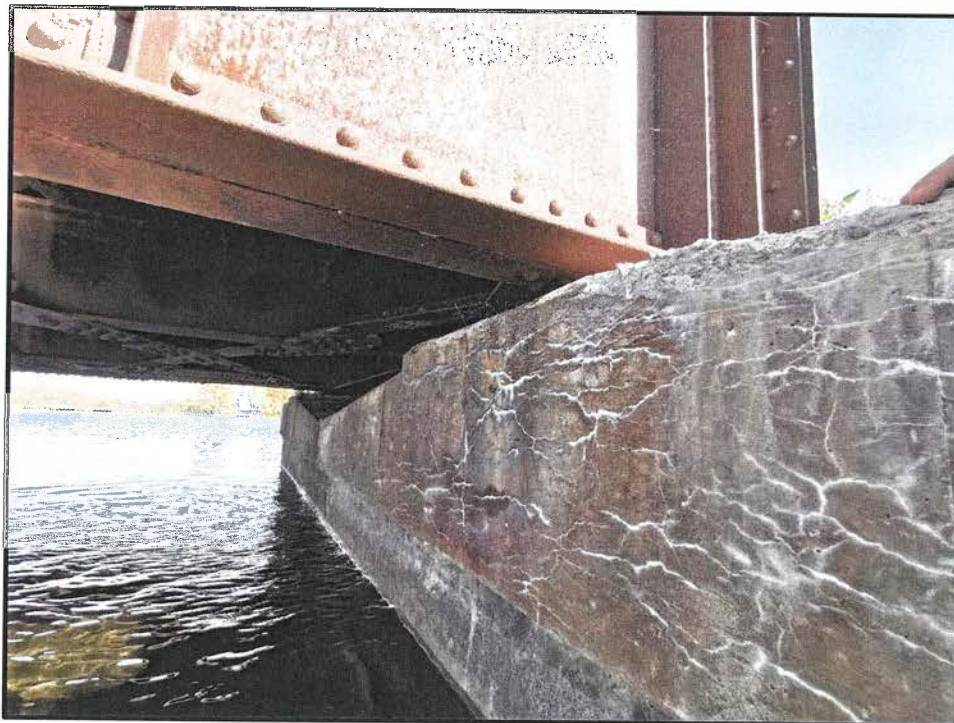
Map Cracking and Efflorescence of Abutment

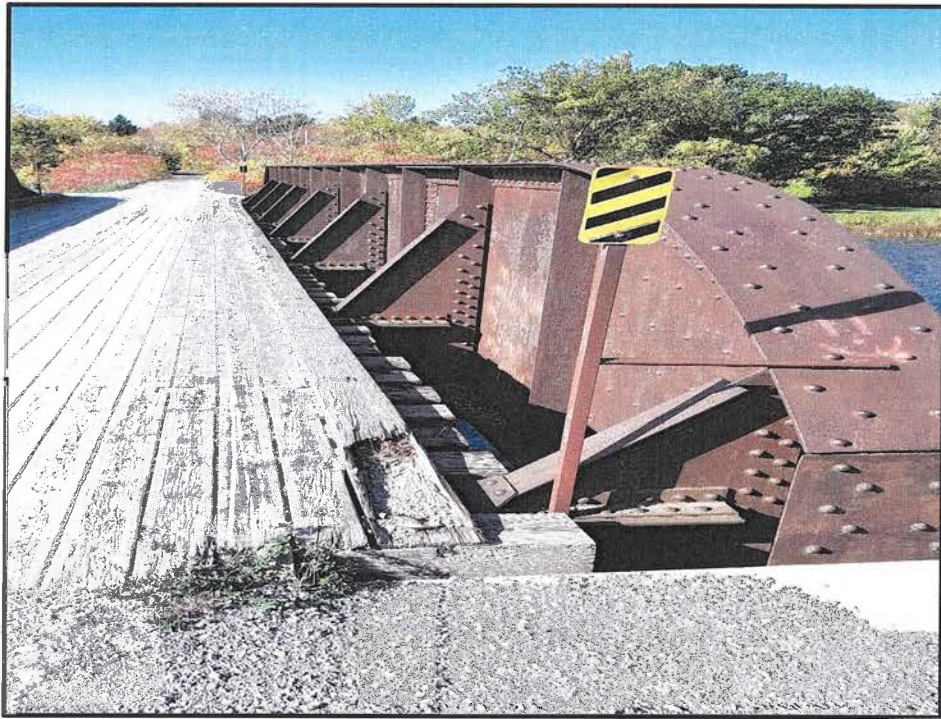
Damaged NE Corner of Timber Curb

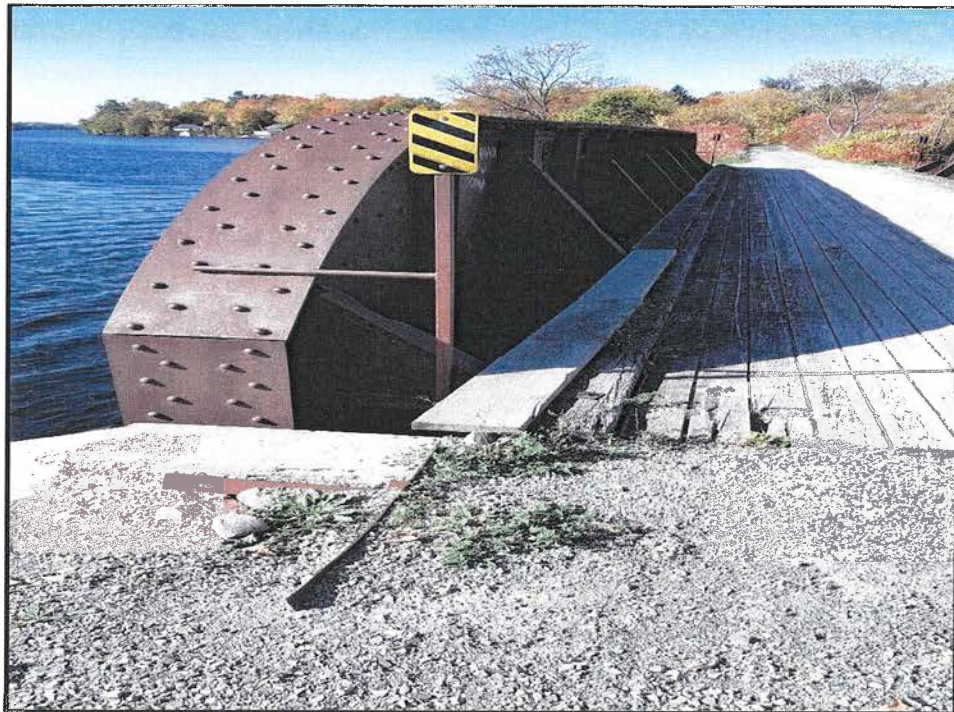
Deteriorating Wood of SE Deck Corner

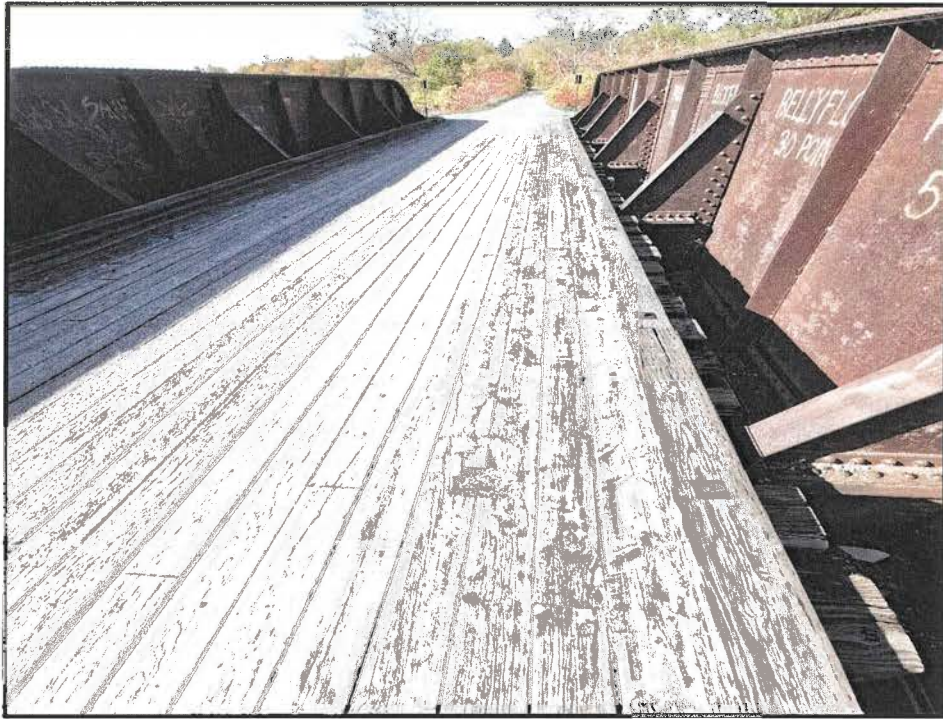
Worn Deck Top

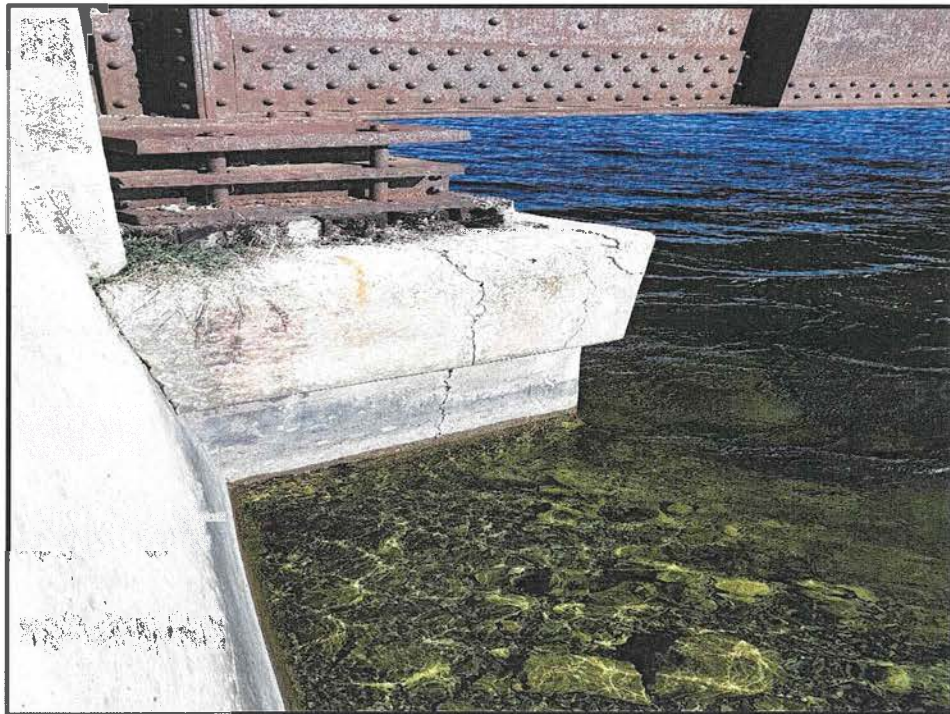
SW Bearing in Poor Condition

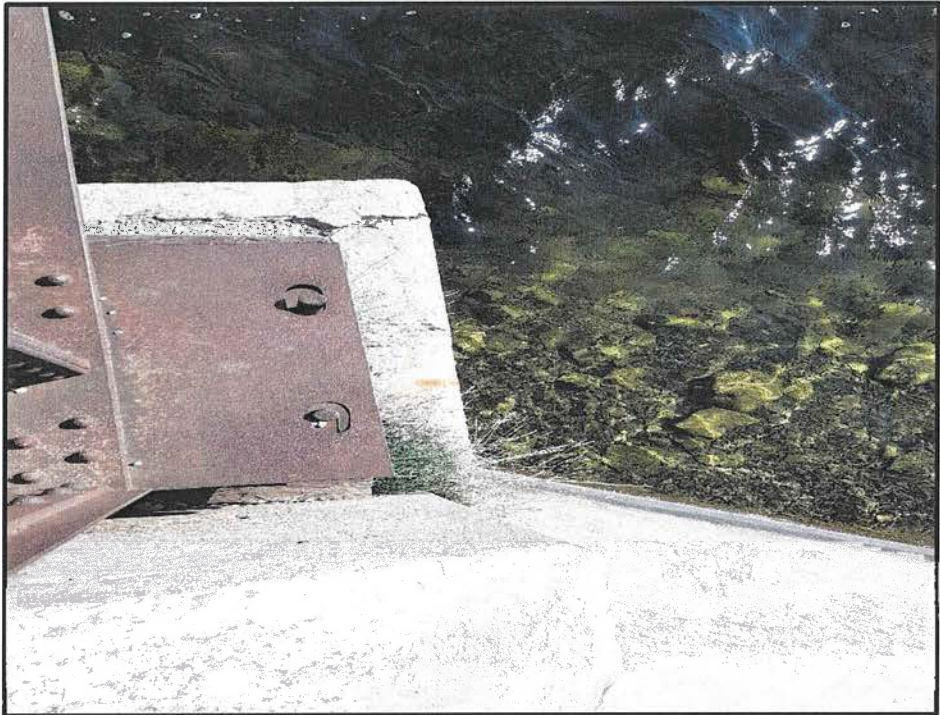
Severe Cracking on SW Bearing Seat

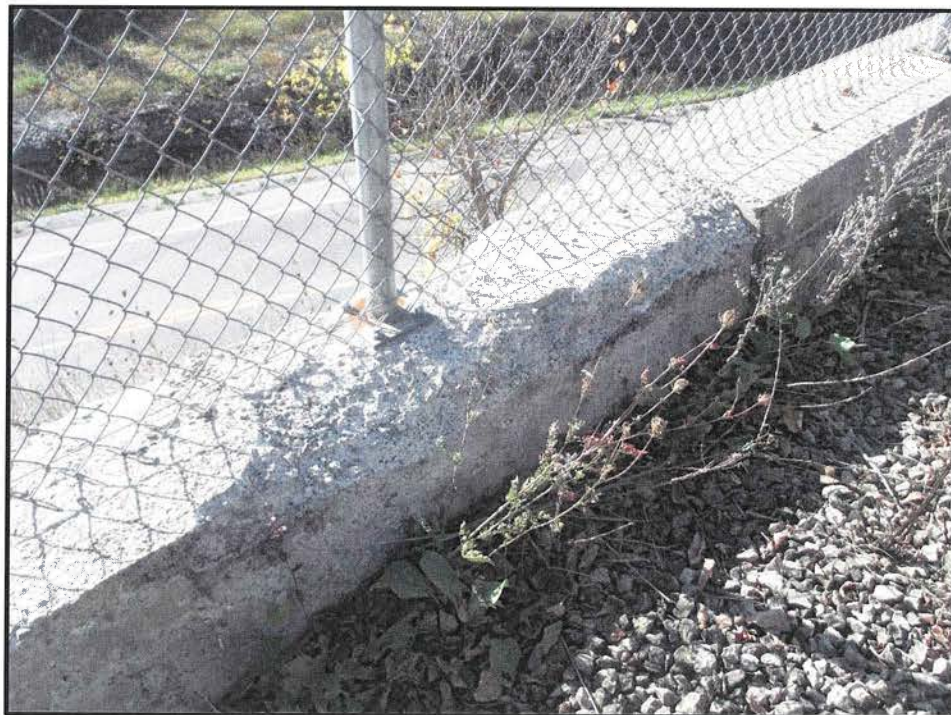
Scaling on Expose Top Section of NE Wingwall

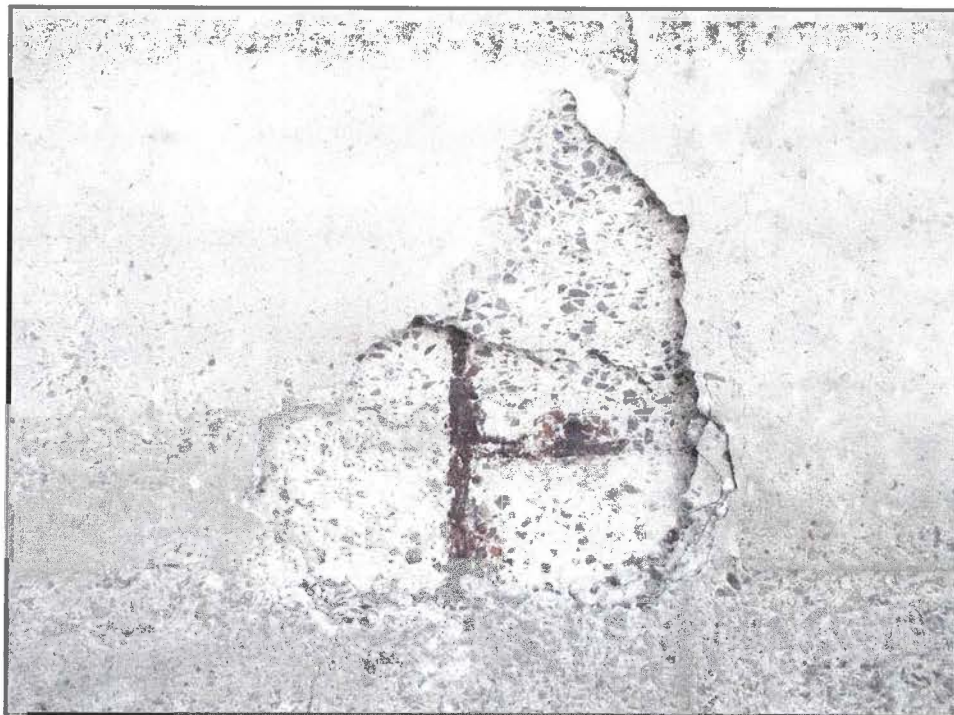
Severe Delamination on South Abutment Wall

Condition Data:	Units	Exc	Good	Fair	Poor																								
	Sq. m			34.64	29																								
Maint. Needs	Other																												
Perform. Deficiencies																													
Estimated Construction Cost:	\$50,000.00																												
Priority	None																												
	6-10 yrs																												
	1-5 yrs																												
	Within 1 yr																												
	Urgent																												
<p>Comments</p> <p>Some efflorescence visible near the top of the north abutment wall. Severe delamination of south and north abutment walls. (S - 45 Sq.m, N - 6 Sq.m)</p> <p>Recommended Work</p> <p>Chip and Patch delaminated concrete on abutment faces.</p>

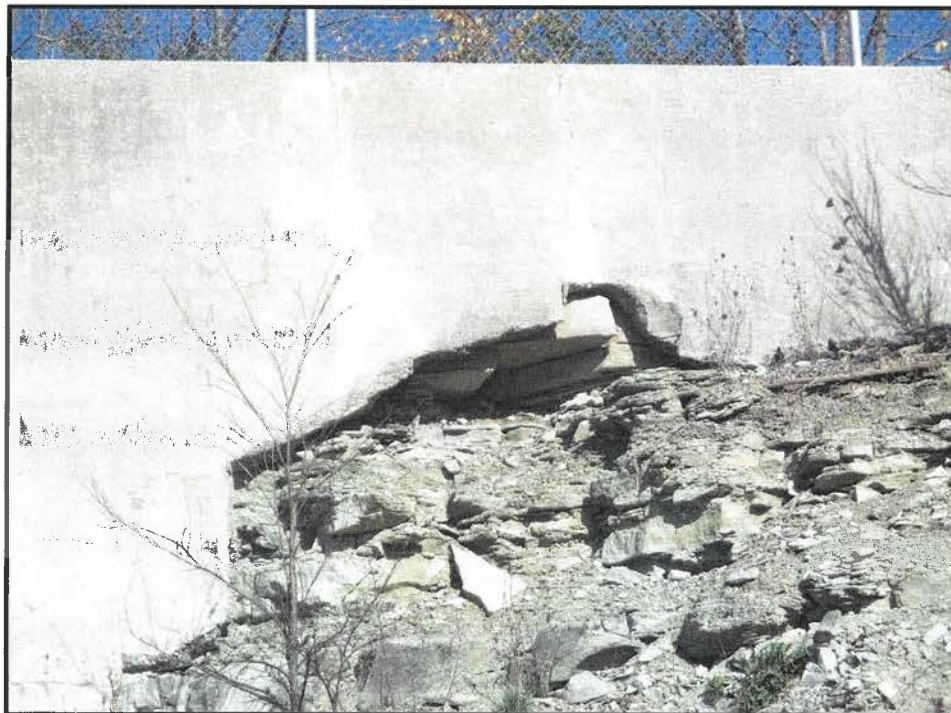
Section of NE Wingwall Undermining

Condition Data:	Units	Exc	Good	Fair	Poor																								
	Sq. m		38.18																										
Maint. Needs	Other																												
Perform. Deficiencies																													
Estimated Construction Cost:	\$6,000.00																												
Priority	None																												
	6-10 yrs																												
	1-5 yrs																												
	Within 1 yr																												
	Urgent																												
<p>Comments</p> <div style="border: 1px solid black; padding: 2px;">Section of wall undermined. Deterioration along top section.</div>																													
<p>Recommended Work</p> <div style="border: 1px solid black; padding: 2px;">Underpin and repair concrete.</div>
