Leadloch, North Lanarkshire: Historic Environment Assessment & Survey

Appraisal

issued 19th April 2022

on behalf of Mark Hamilton Landscape Services

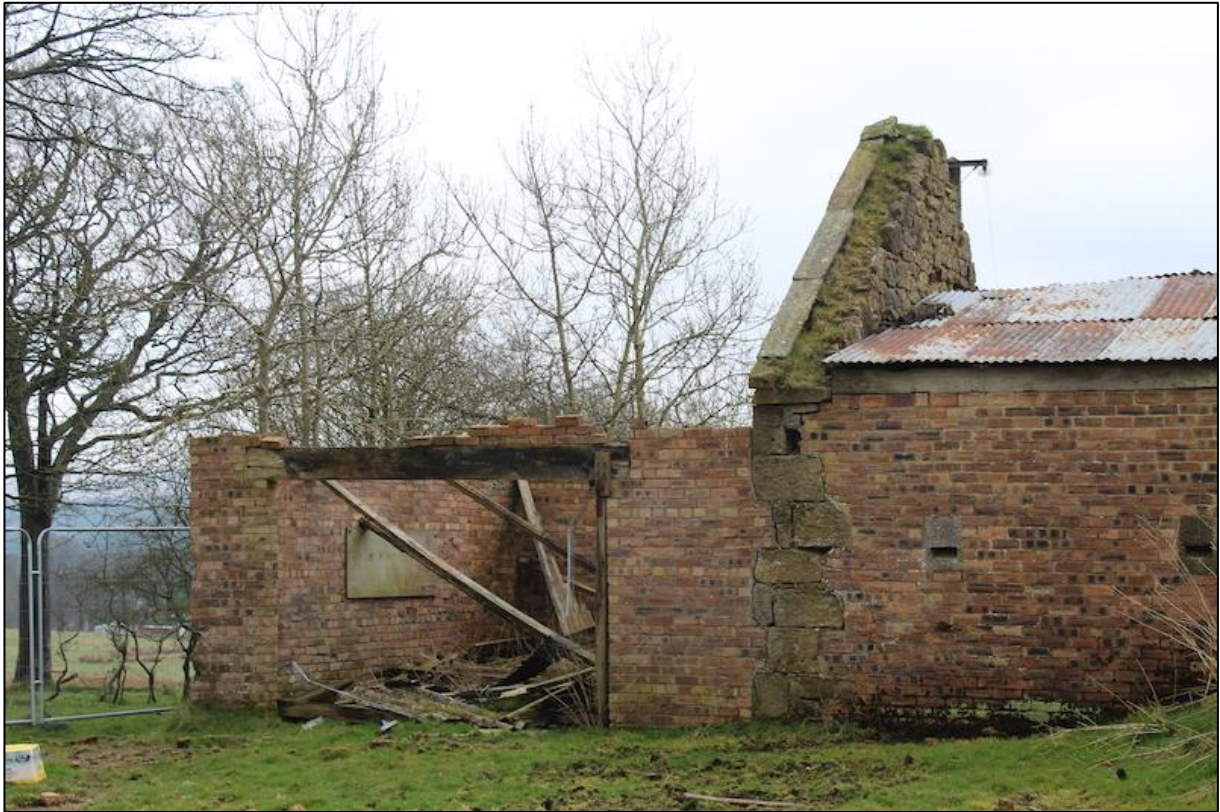
46. Leadloch Farm **S1** was identified through historical mapping and identified during the walkover. The farm is in an advanced state of dilapidation. The main house is constructed from yellow sandstone and comprises a ground level and one upper level which has long since collapsed. The S face of the building contains a door with a crest above, rounded finials and squared ashlar surrounding the doors and windows. The N face is large intact

Figure 3a: Outbuildings to the S of the main house showing reuse of gable end wall.

50. Leadloch farmstead **S1** is an example of an historic farmstead with mid 19th century elements although currently in a partially collapsed state. Hence this site both contributes to the historic character of the landscape and will contain complex archaeological information. It has been ascribed Regional significance. It should be **protected** with a 10m buffer and retained as part of a building complex.

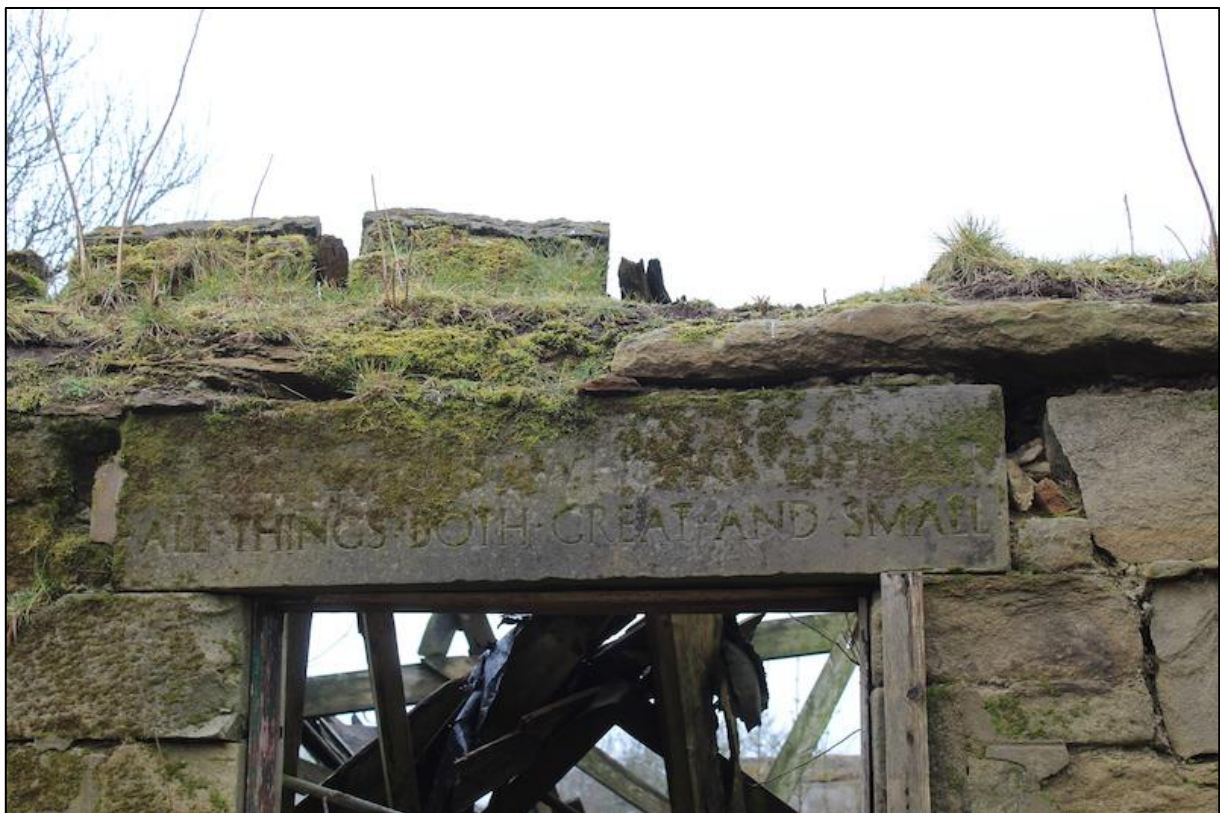
Figure 3b: Example of inscribed stones reused as lintels

with a modern brick built and rough casted outhouse containing a toilet. At the W of the main building is a later, sandstone extension with stones inscribed in relief that look to have been reused. Attached to the W of the extension is a two-compartment building with stalls and water feeds for livestock. Neither compartment is roofed. The outbuildings to the S comprise yellow sandstone with stones inscribed in relief used as or above the lintels of the doors (see Figure 3b). They contain stalls and water feeding trays for livestock. There is evidence of modern brick repair and extensions although the gable end wall of the original structure is visible and looks reused (see Figure 3a). There is a two-compartment modern barn the to the W of the main complex which is roofed with corrugated metal sheets.

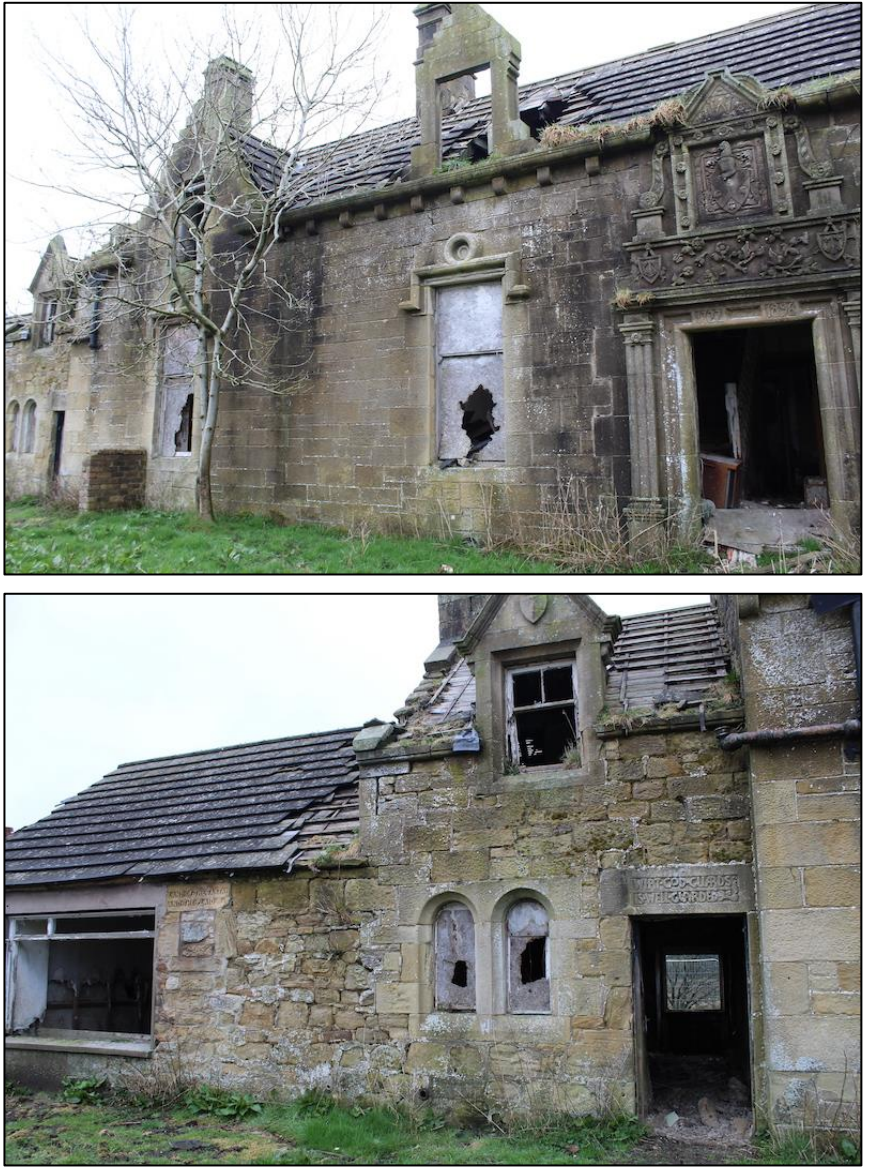
No	Site	HER Ref:	Description	NGR	Image from Site Inspection
S1	Leadloch; Farmstead	Canmore: 227887 WoSAS: -	<p><i>Desk Based Assessment</i> Leadloch Farm was first clearly identified on Ainslie's map in 1821 as a substantial farm comprised of five structures within an enclosed landscape, although an earlier farm shown on Roy 1752-5 that bears an illegible name may also be Leadloch. The farm remains mostly constant in size in subsequent mapping and continues to be depicted in all subsequent Ordnance Survey mapping and appears through aerial imagery to be an abandoned farm.</p> <p><i>Walkover Survey</i> The main structures and outbuildings of Leadloch Farm still survive although in a very dilapidated state. The main house comprises the original farmhouse building with an extension and livestock barns to the W. The outbuilding to the S is in an advanced state of disrepair. The modern outbuildings to the W are still roofed with corrugated metal sheets.</p>	NS 9160 6000

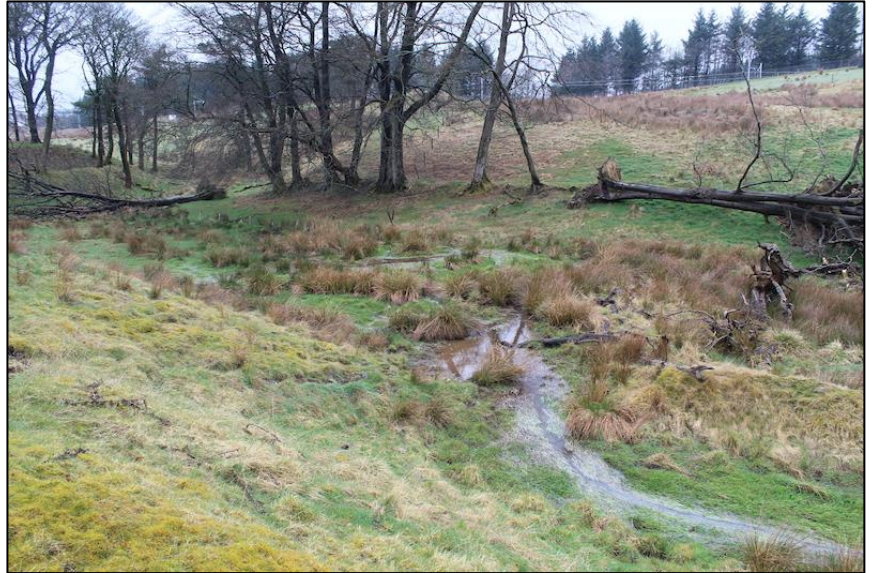
44. The quarry **S3** was observed as a single large deep bowled quarry with a depth of approximately 4m on its SSW side. The quarry is turf covered and has a small burn running through it. Site **S3.1** was also identified as a single bowl quarry which has been cut into the hillside. Oval in plan, it measured approximately 3m deep and had an ephemeral entrance to the N that measured 3.5m wide. A further quarry **S4** was also observed that was covered with woody vegetation and lined with trees. The bowl measured approximately 3.5m deep with its entrance to the N measuring 1.6m wide.

52. The quarries **S3**, **S3.1** and **S4** were observed during the walkover and make a minor contribution to the historic landscape character and are unlikely to embody complex archaeological information. On account of this and their comparatively recent origin, they have been ascribed Other significance and **no action** is recommended.

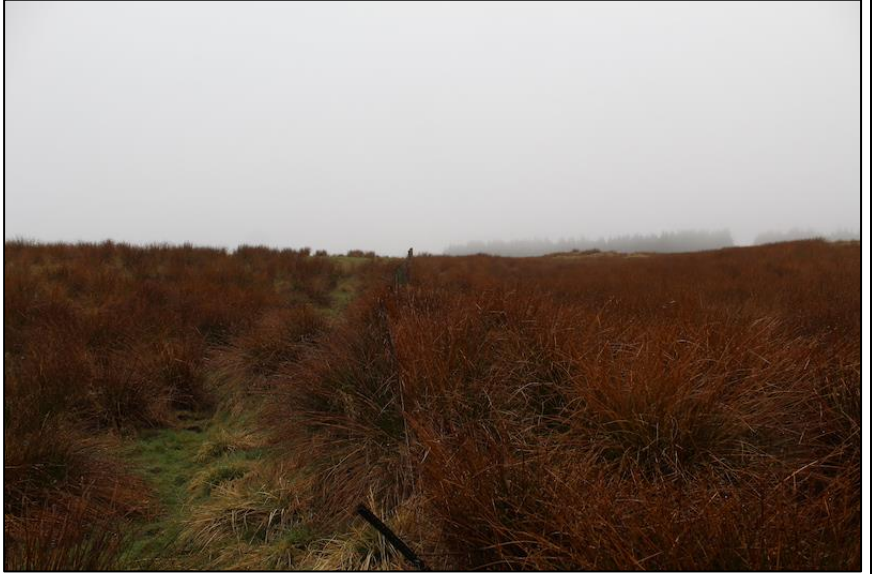
39. The bank **S7** was identified as a relict field boundary with the remains of wooden posts still in the ground. The bank measured 1.93m wide, between 0.05 and 0.31m high and ran in an ENE – WSW direction for approximately 111.3m.

No	Site	HER Ref:	Description	NGR	Image from Site Inspection
S7	Leadloch; Bank	Canmore: - WoSAS: -	<p><i>Desk Based Assessment</i> A bank was identified through LiDAR and aerial imagery but not observed on any historical or modern mapping. The bank was depicted adjacent to the east of S8 and S8.1.</p> <p><i>Walkover Survey</i> The bank S7 was identified as relict boundary post and wire fence line. It measured 1.93m wide, 111.3m long and between 0.05m and 0.35m high.</p>	NS 9120 5600 to NS 9130 5600

53. The banks **S5** and **S7** were identified on the walkover as relict subdivisions of the 19th century field pattern. They provide a minor visual contribution to the historic landscape character and are unlikely to embody complex archaeological information. Given the survey record of their location and extent, they have been ascribed Other significance and **no action** is recommended.

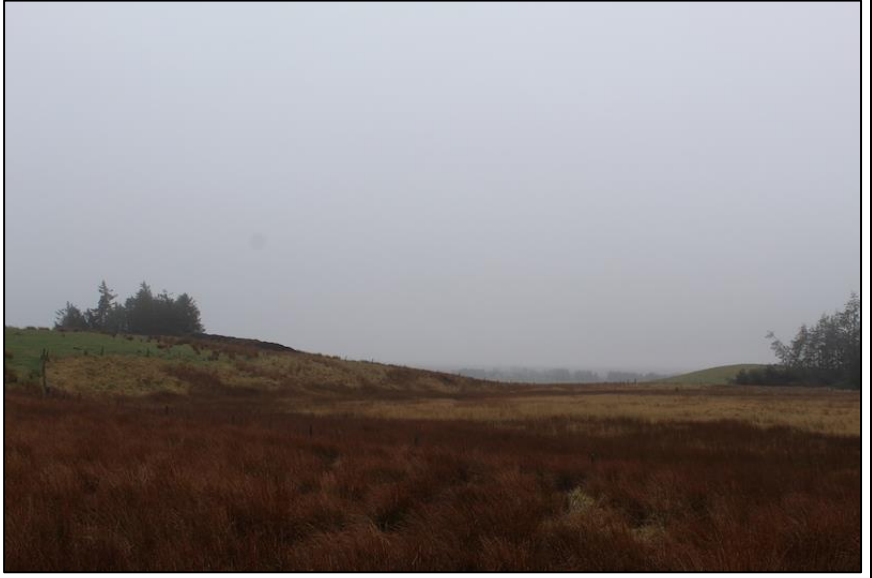
40. The reservoir **S8** was identified on the walkover as a large depression covering an area of approximately 2.64ha. The ground was boggy and very overgrown with reeds. Bank **S8.1** comprises a relict wooden fence on an earthen mound which follows the contour of **S8** to the N and the forestry plantation to the S. The bank is 2.4m wide, approximately 0.66m high and runs 196.9m.

55. The reservoir **S8** was identified during the walkover as a large, heavily overgrown depression in the landscape. It provides a minor visual contribution to the historic landscape character and is unlikely to embody complex archaeological information. Given the survey record of its location and extent, it has been ascribed Other significance and **no action** is recommended.

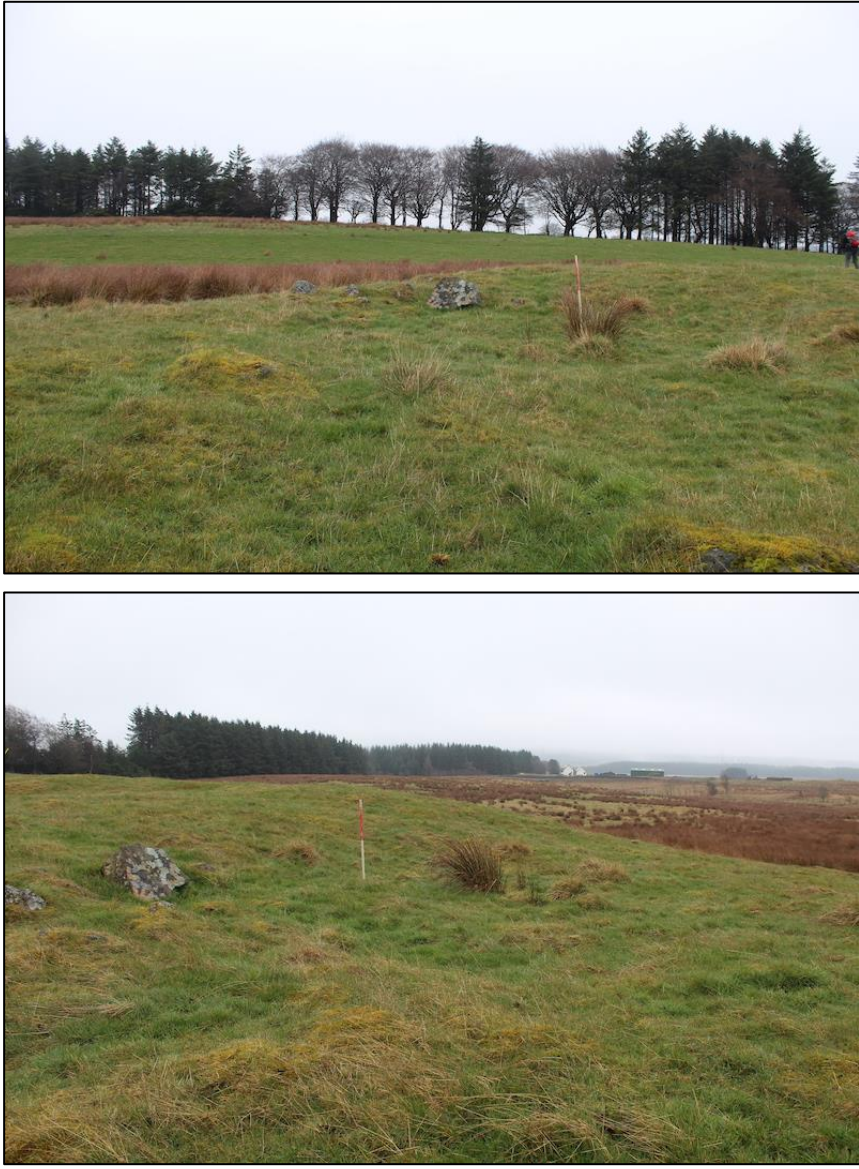
42. The enclosure **S9** was identified as a circular, turf covered, banked enclosure. The banks measured between 1.74m and 2.36m wide and between 0.09 and 0.15m high. The possible entrance to the S measured 1.46m wide. The middle of the enclosure is raised and contains stone. The height of the mound is approximately 0.2m high and 4.24m wide. The ditch between the mound and the banks measures to a maximum of 1.24m.

No	Site	HER Ref:	Description	NGR	Image from Site Inspection
S9	Wester Plantation; Enclosure	Canmore: - WoSAS: -	<p><i>Desk Based Assessment</i> A possible circular enclosure was identified through LiDAR and aerial imagery but not observed on any historical or modern mapping.</p> <p><i>Walkover Survey</i> A circular enclosure measuring approximately 8m wide with an entrance to the S and a central mound. The enclosure banks measured to a maximum of 2.36m wide and 0.15m high while the mound measured to a maximum of 0.15m.</p>	NS 9110 5960	 
S10	Wester Plantation; Sandpit	Canmore: - WoSAS: -	<p><i>Desk Based Assessment</i> A sandpit was identified on the 1st ed Ordnance Survey and is observed through LiDAR and aerial imagery but does not appear on any subsequent maps. It is located S of S9.</p> <p><i>Walkover Survey</i> The sandpit comprises two bowls that contain moss covered stones. The E bowl measured to approximately 0.56m high and contained some moderately large stones measuring approximately 0.40m by 0.26m by 0.37m. The bowl measured approximately 7.7m. The W bowl measured approximately 0.52m high and 8.2m long with large stones measuring to a maximum of 0.78m by 0.39m by 0.69m.</p>	NS 9120 5950

56. A circular banked enclosure **S9** with a probable entrance was observed during the walkover. Its proximity to two other features that were identified on LiDAR (NGR: NS 9120 5960) was investigated. These features were identified on the ground as modern supplementary livestock feeding stations, which overlay rig and furrow (identified through LiDAR). Due to the dissimilar nature of these features to the feature **S9**, they were discounted from the survey. Due to the circular nature of **S9** and its dissimilarity to the feeding stations to the E, it is considered to be a built enclosure and has been ascribed Local significance and a 5m buffer is recommended.

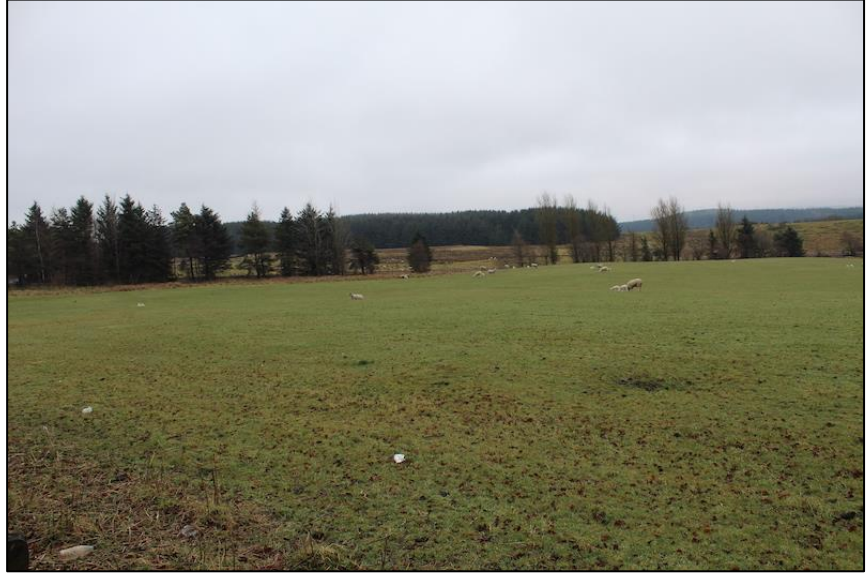
43. The bank **S11** was discernible, however, was observed from a distance due to the presence of nursing livestock within the field. The bank measured approximately 151m, but this was not verified.

No	Site	HER Ref:	Description	NGR	Image from Site Inspection
S11	Meadowfoot; Bank	Canmore: - WoSAS: -	<p><i>Desk Based Assessment</i></p> <p>A bank was identified through LiDAR and aerial imagery but not observed on any historical or modern mapping. The bank was depicted to the S of Meadowfoot to the SE of the assessment area.</p> <p><i>Walkover Survey</i></p> <p>The bank S12 was identified on the walkover although this was observed from a distance due to the presence of nursing livestock within the field.</p>	NS 9200 5980 to NS 9190 5970

58. The bank **S11** was identified and makes a minor contribution to the historic landscape character and is unlikely to contain complex archaeological information. Given the survey record of its location and extent, it has been ascribed Other significance and **no action** is recommended.
59. Banks **S12**, **S12.1** and **S12.2** were not identified during the walkover. Given the survey record of their location and extent, they have been ascribed Other significance and **no action** is recommended.
