This Service Information bulletin supersedes SI B11 04 04 **dated October 2004.**

Service Action: E46 M3 S54 Connecting Rod Bearings Replacement

E46 M3 coupe/convertible with S54B32 engine produced from 02/12/2001 up to 05/22/2003

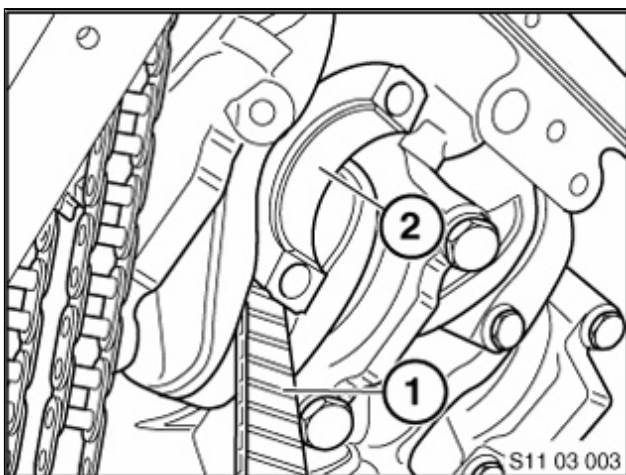
Note: If the removed connecting rod bearings exhibit signs of excessive wear (e.g.: exposed shiny, copper bedding on the inner surface; missing, sheared-off locking tabs; or deep, shiny grooves on the outer surface indicating "spinning"), then contact the Technical Hotline Drivetrain for further instructions.

29. Cut off a strip (1) from a clean and fiber-free cardboard with approximate dimensions of 20 mm x 150 mm. Use such a cardboard strip to protect crankshaft bearing surface.

30. After removing connecting rod cap, gently push connecting rod upwards, and then after securing enough clearance from the crankshaft, slowly pull it down in order to remove the upper bearing shell (2).

Important: Do not use sharp tools to pry out the bearing shells out of the connecting rod or cap.
