Troubleshooting a Two-Throw Compressor with the Model 333D01 Digiducer

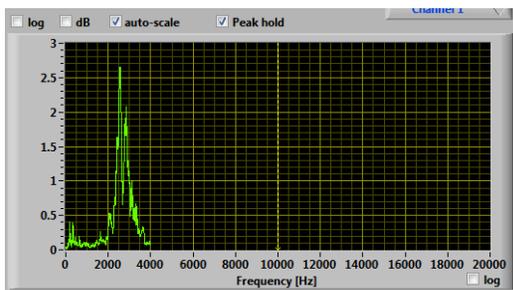
Figure 1: Good Data, No Alarms ($\frac{m}{s^2}$)

The test was completed twice, each time resulting in the same data. The plot for Throw #1 shows the worst output, where it was approximately 1.8 $\frac{m}{s^2}$ vibration on Throw #1 when in live mode. The supposed "bad" RMP was indeed reporting almost twice as much impact vibration as the "good" RMP. This data was taken over several minutes using the peak/hold function in shareware

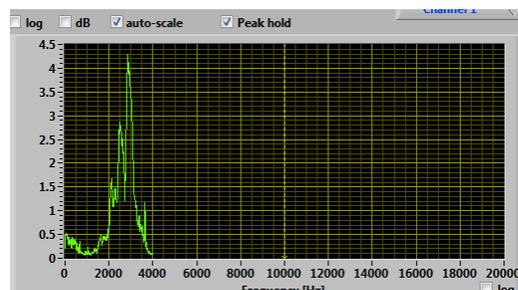
Throw 2: Supposed "Bad Data" ($\frac{m}{s^2}$)

The RMP counts the number of impacts during its sample window (determined by the compressor running speed) and adds mA to the signal output depending upon the severity of the impact. There are two thresholds. Throw #1's RMP was operating below the coupling current, thus no impacts were being counted and it was operating like a normal 4-20 mA linear sensor. As the data shows, Throw #2 was experiencing greater high frequency impacts, likely caused by a loose wrist pin and the impact of the piston against the side wall of the chamber.
