Flash

Sheet

Affects: F4-CVM03050-0x, F4-CVE03050-0P, JC-VAV1717-0, JC-VAV1732-0, and JC-VAV1507-0 controllers running 9.0, 10.0.0, or 10.0.1 firmware.

UPDATED: A loss of power during the startup sequence of an F4-CVM03050-0x, F4-CVE03050-0P, JC-VAV1717-0, JC-VAV1732-0, or JC-VAV1507-0 controller running firmware version 9.0, 10.0.0, or 10.0.1 can result in the loss of configuration.

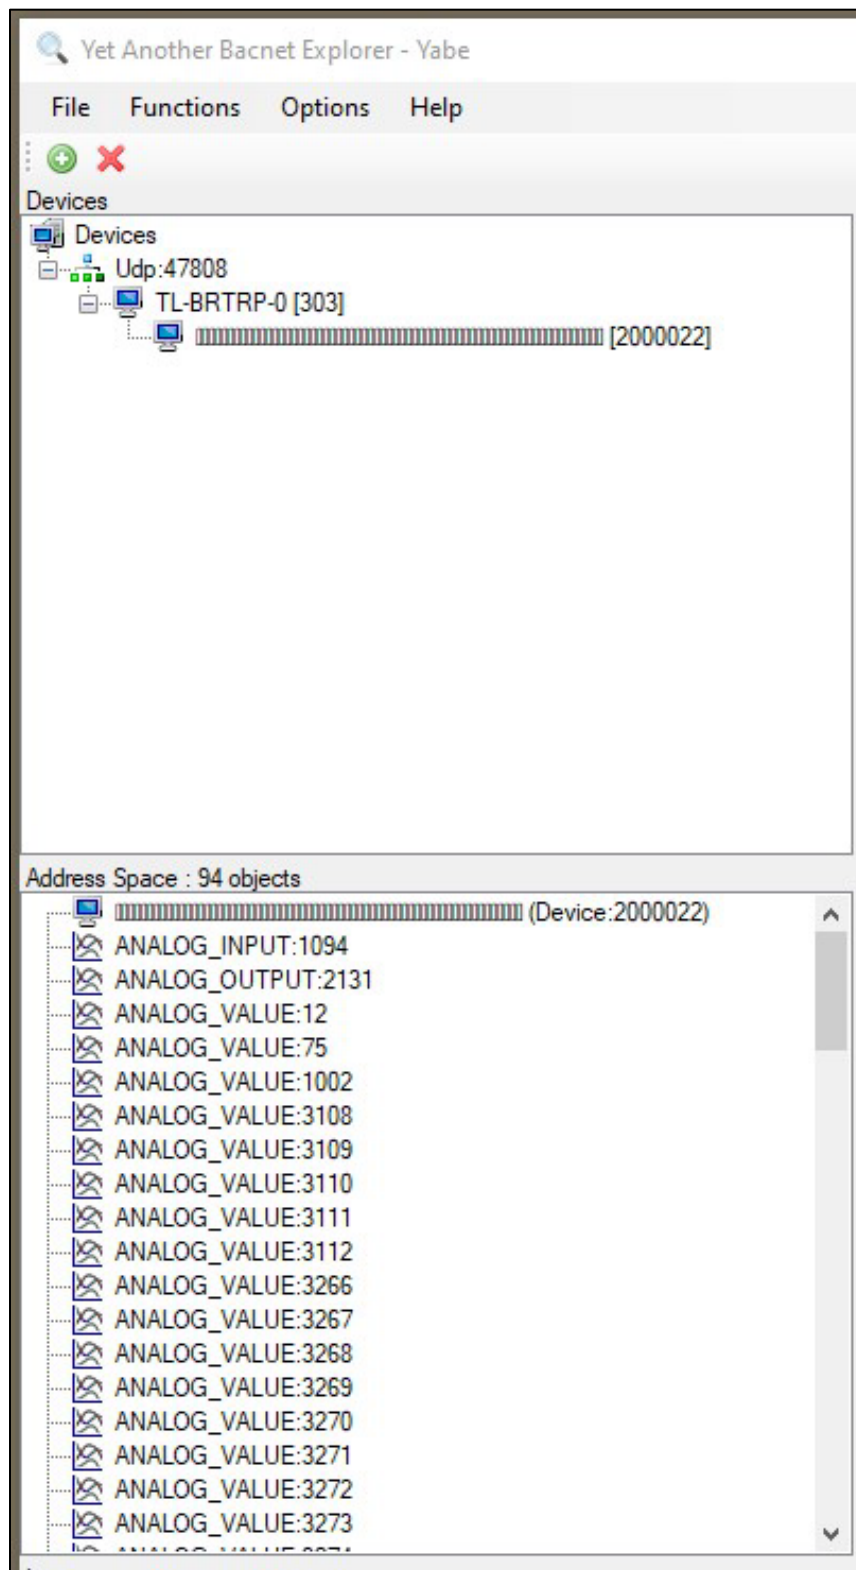
Figure 2: Devices and Address Space panes

6. After you click each device, you should be able to identify the BACnet router with its controllers in the tree. If the controller's name is populated with a string of thin rectangles, this confirms the device is affected by this issue and is recoverable. See Figure 2.

7. Select the controller that you wish to recover and scroll down in the **Address Space** pane that contains the list of objects until you find **MULTI_STATE_VALUE:1000**. Click on this object to have YABE update its name to **8-1/Preloaded App Loader.App Selector (Multi_State_Value:1000)**.
