Introduction

This a Case Study where one of their vehicles was driven in with a “Runs Rough” complaint. Which after further inspection, turned out to be more catastrophic than anticipated.

Engine: 2001 Chevy 3500 6.5 liter Diesel
Miles: 105,993

Complaint: "Runs Rough"

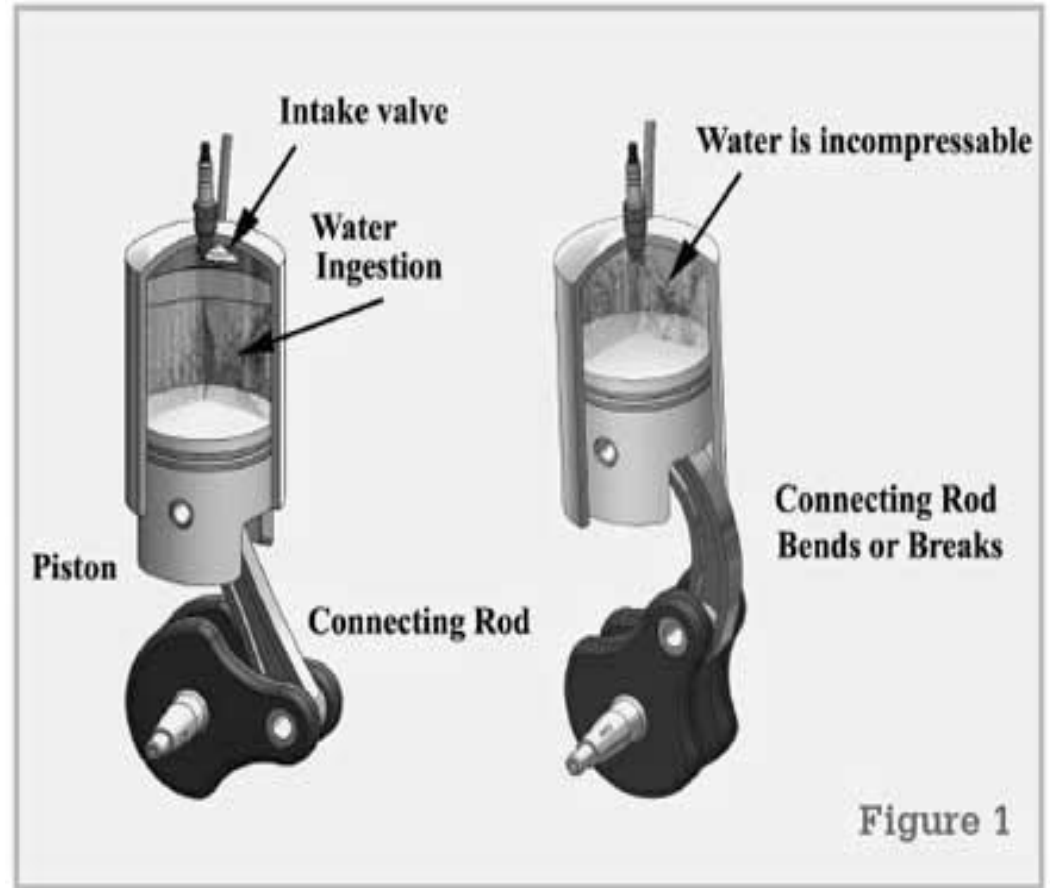
Hydrostatic Lock

Hydrostatic lock, hydraulic lock, or hydro-lock occurs when liquids enter an engine cylinder. Liquids are incompressible; the presence of a liquid in the engine cylinder during the compression stroke generates destructively high cylinder pressures.

The left drawing shows water entering a typical automotive engine cylinder during the intake stroke.

Water, unlike the fuel/air mixture, is incompressible and, during the compression stroke, locks the piston in place as shown in the drawing at the right of Figure 1.

This condition tends to overload the connecting rod, causing a bending failure of the rod and severe engine damage.

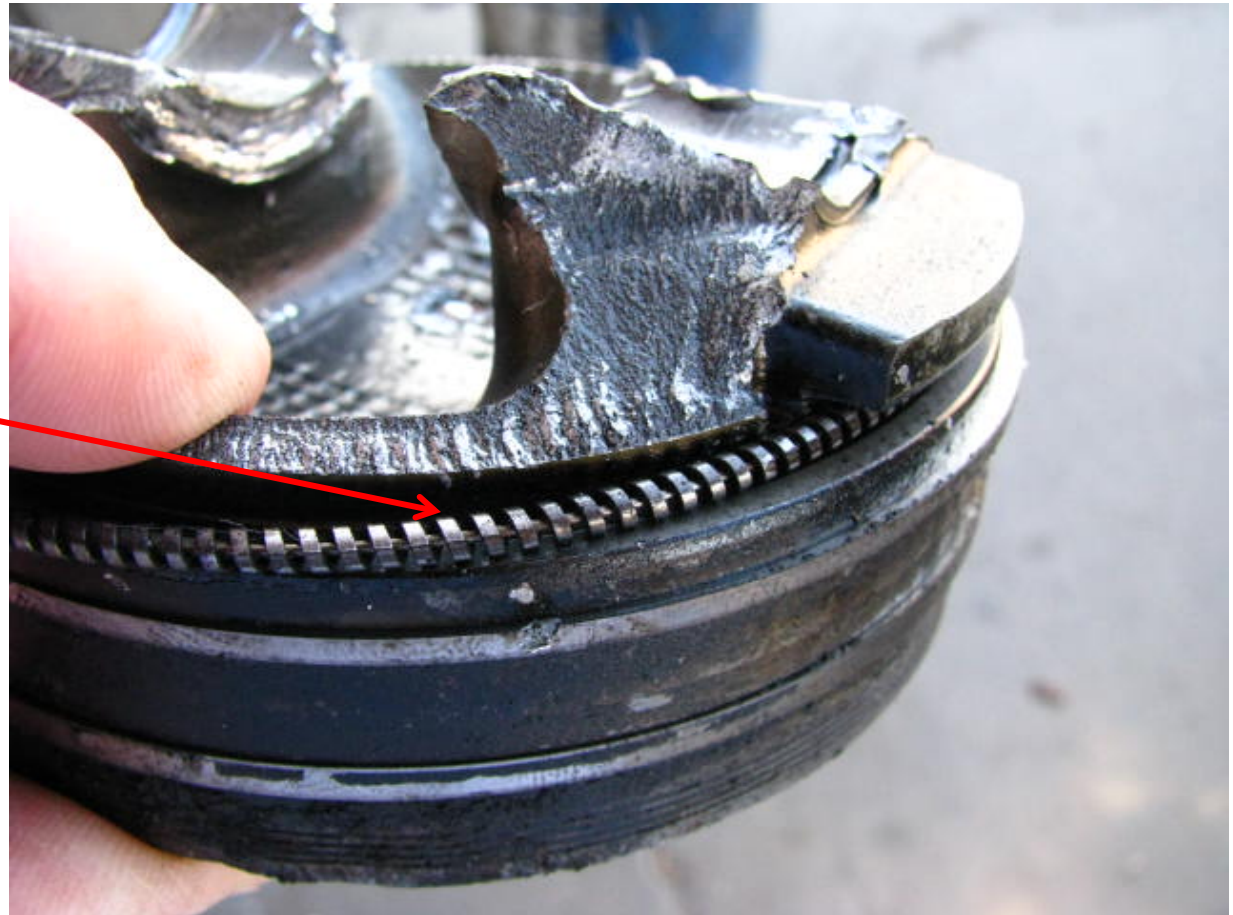
Piston Damage – Ring Condition

Here is the main failure. This is a side view of what is left of the piston.

The ring lands, oil ring, and compression ring are fairly clean with little carbon deposits and the sides of the crown are not scored or damaged.

The bad news is we are missing 75% of the piston and there is no rod, wrist pin or keepers attached to the piston.

Remember that this unit was DRIVEN into the shop in this condition. This piston was not moving for several miles even though the engine was running!

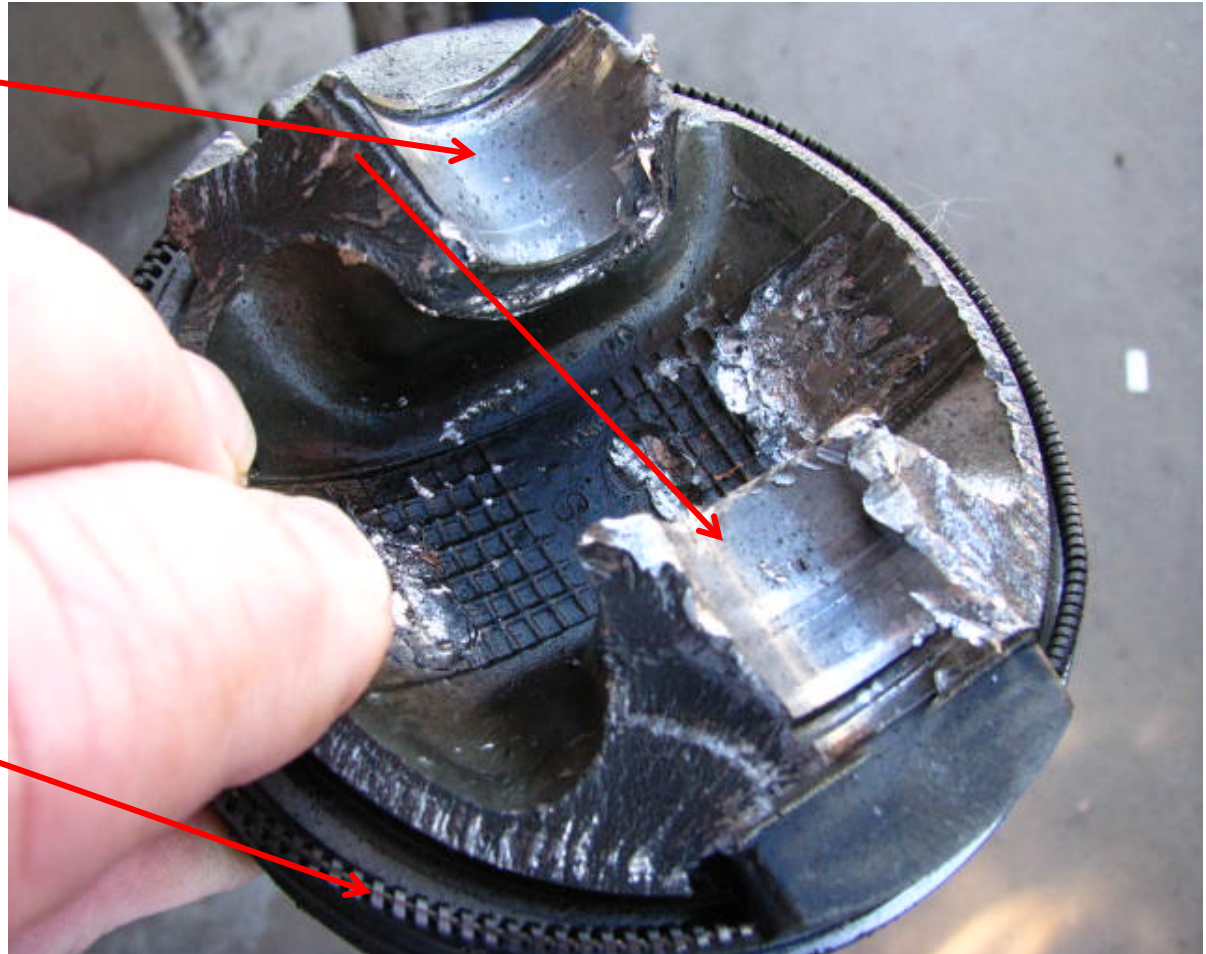
Piston – Wrist Pin Condition

Note the condition of the **wrist pin** bearing area, still in very good shape.

The area between the wrist pin bearing areas receives a constant spray of engine oil to cool and lubricate the piston – **there is no build up in this area.**

This is a great shot to look at the area behind the oil control ring's expansion spring – very clean with **no build up of carbon.**

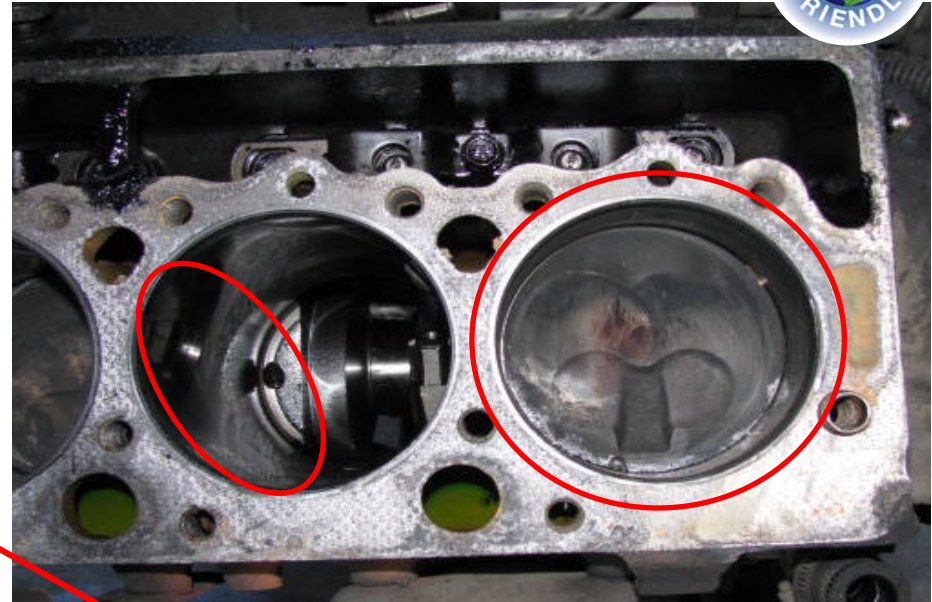
Left Bank – Piston #5

You can see the oil **spray nozzle** and what is left of the **connecting rod**. The **cylinder walls** are still in good shape, considering what it has went through.

Cylinder walls / perfect condition, very little carbon build up above top compression ring contact area. Top of pistons very clean, very little carbon, burning extremely clean (right bank side) crank area for connecting rod clean, smooth and in great shape.

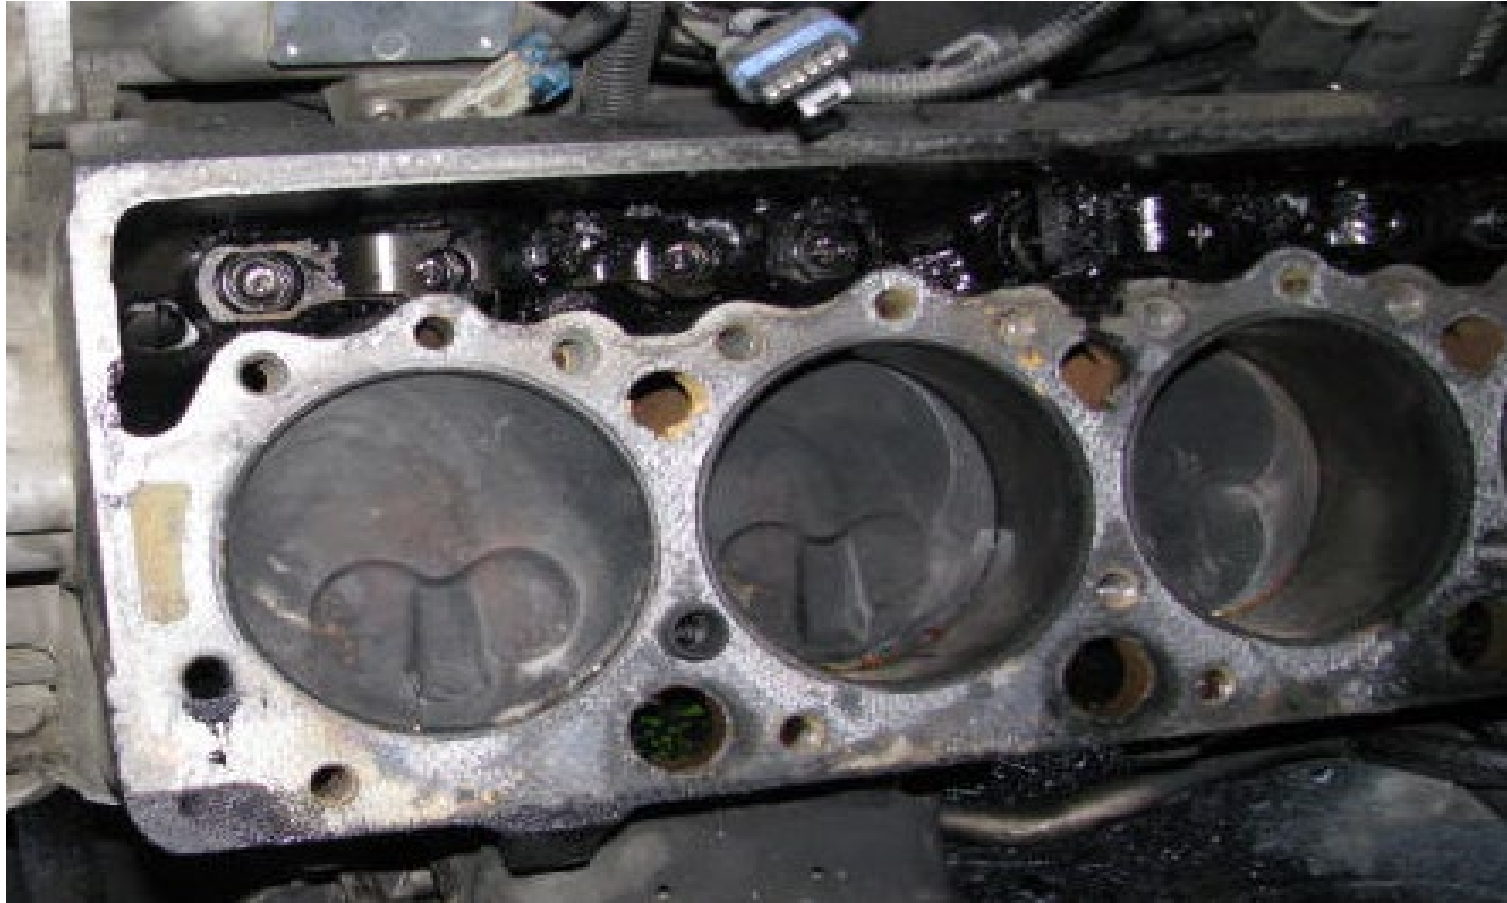
Cylinder Head – Left Bank

Same results on (left bank) cylinders, very clean burning, extremely low carbon deposits on top of pistons, cylinder walls in excellent shape – we have already discussed the condition of engine oil you can see in the lifter valley.

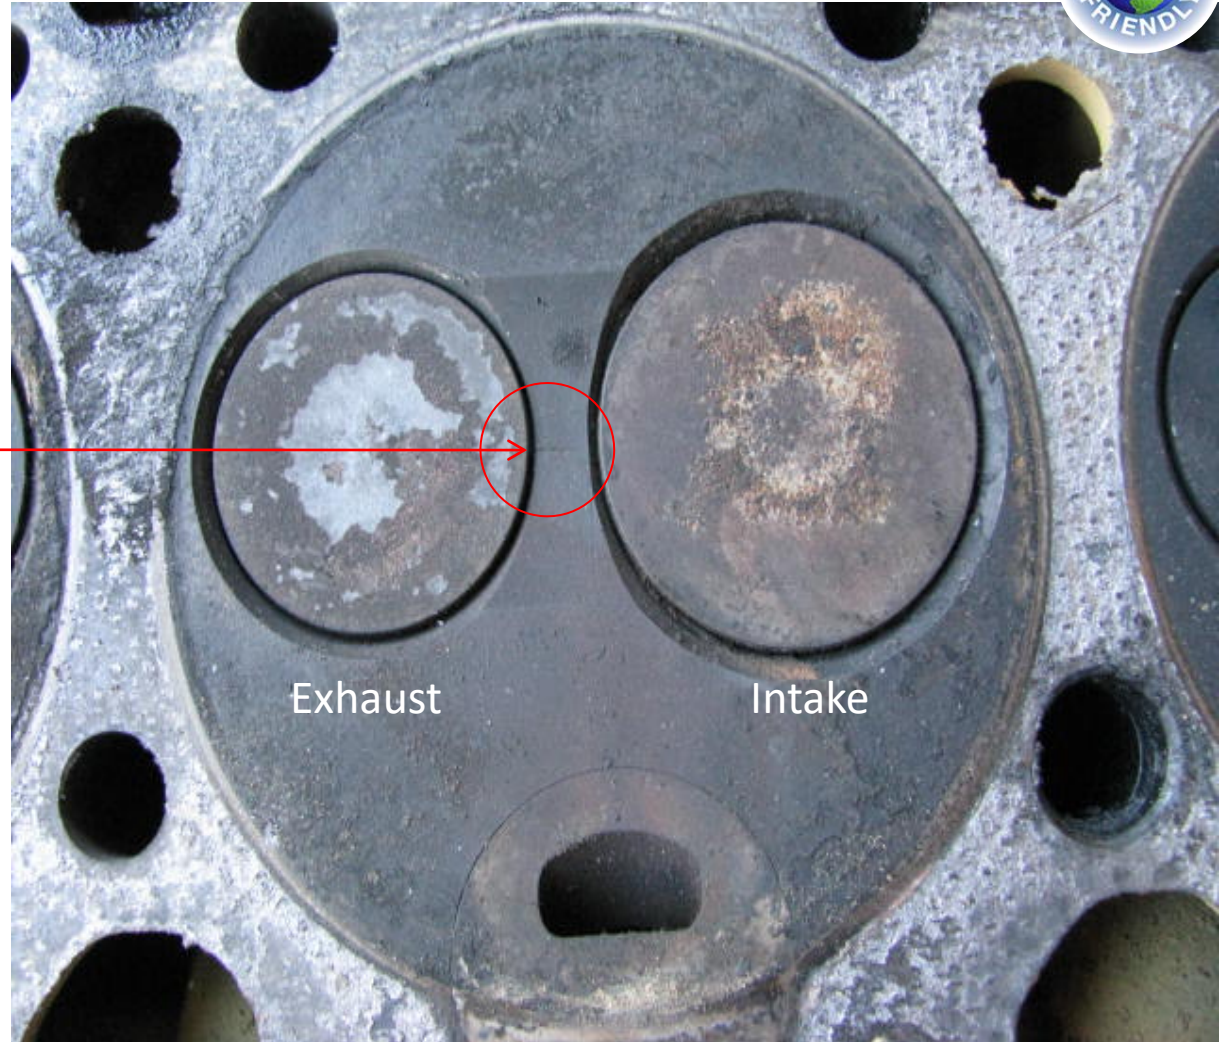
Intake/ Exhaust Valves

Close up of intake and exhaust valve, fire deck surface on cylinder head.

Note the crack between the valves – we will discuss this in a couple of slides.

Extremely low carbon build up on valves, fire deck surfaces and combustion chamber.

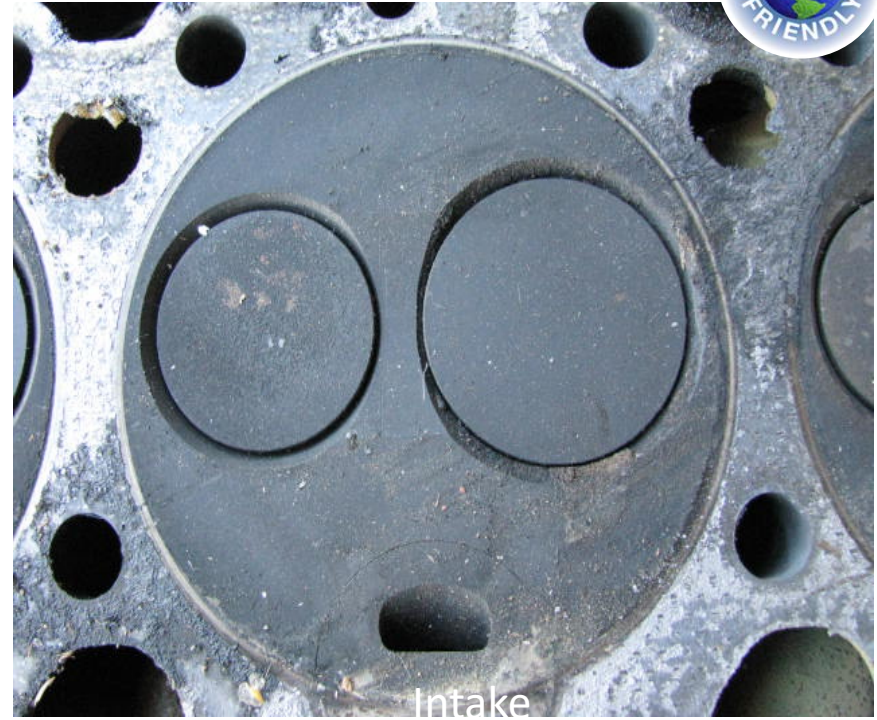
Intake/ Exhaust Valves

This is another close-up of more cylinders, please examine the low build up of carbon deposits on valves and fire deck surfaces.

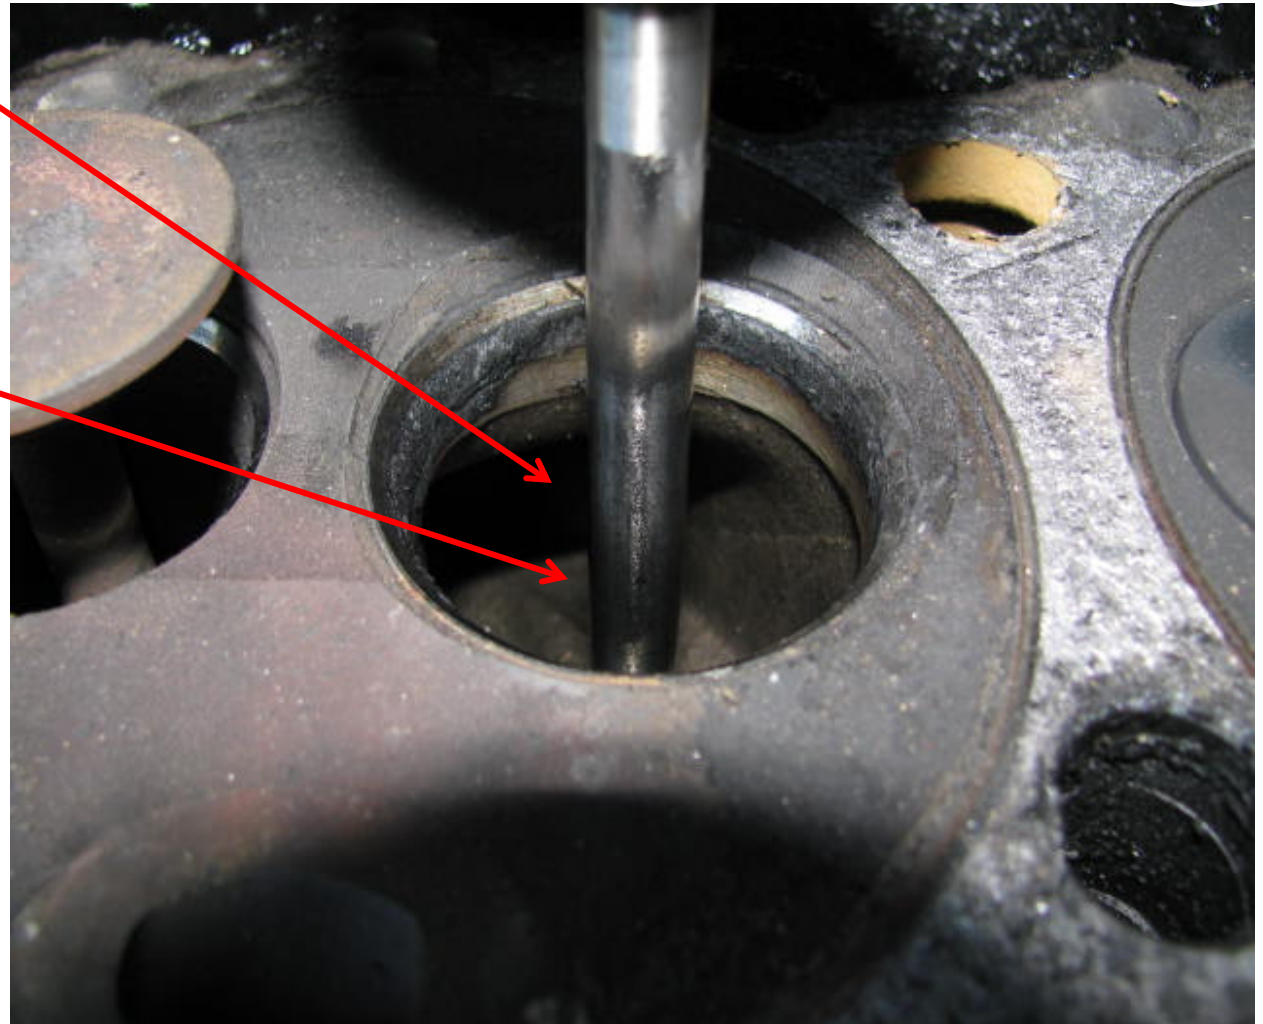
Valve Stem – No Carbon

Close up of the **intake chamber** of an intake valve, there is basically no carbon build up to notice.

Valve stem is unbelievably clean, no carbon, “coke” build up (cooked on oil) in the valve guide area.

Valve seals are obviously in great shape on this engine, or the stem would have oil and carbon deposits on it.

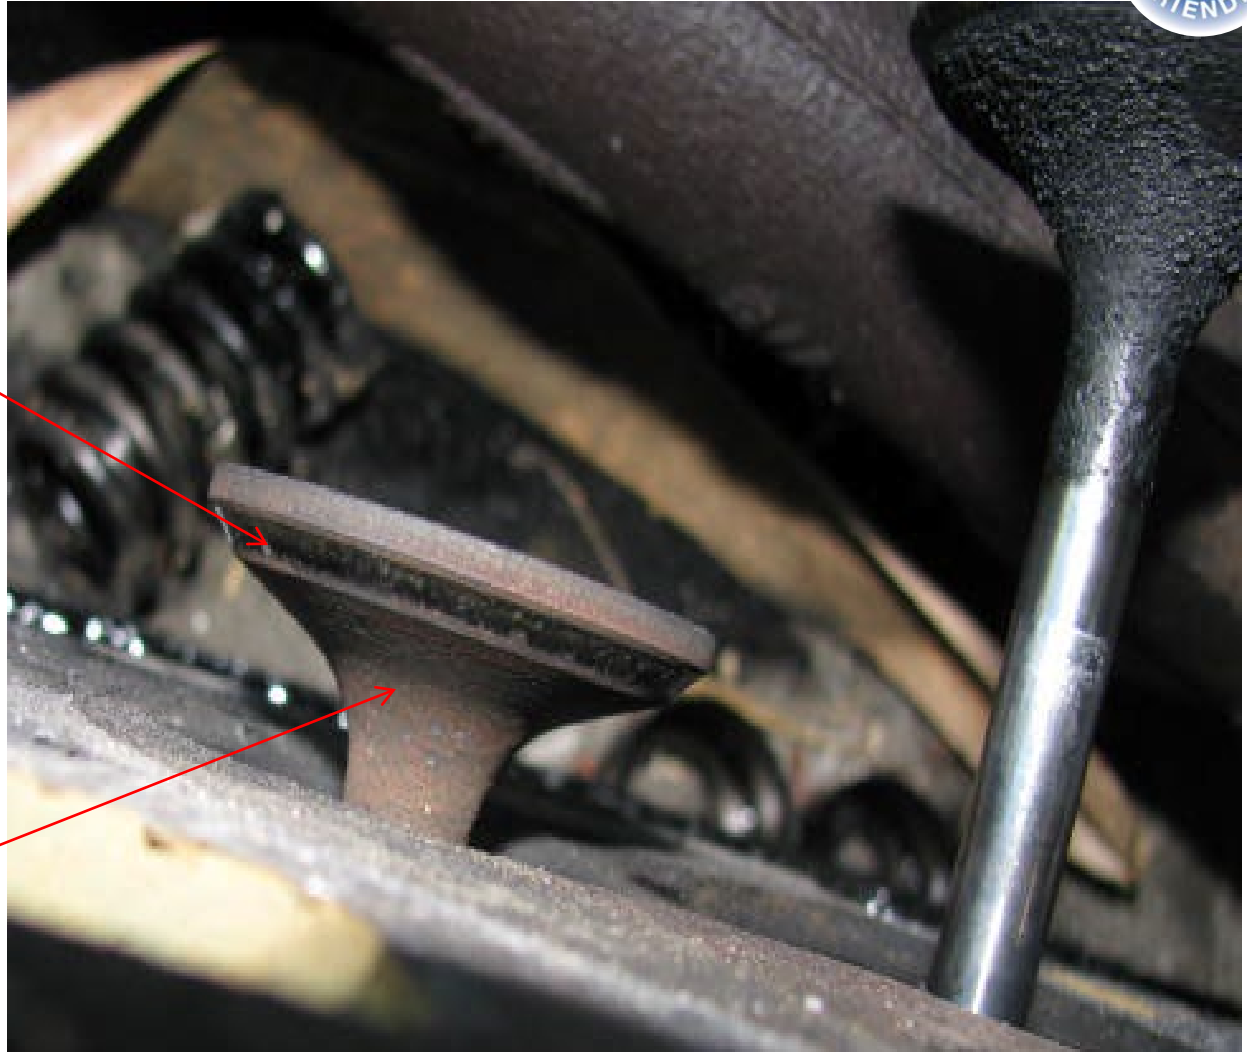
Intake/ Exhaust Valves

This is a close up on one of the exhaust valve seating / sealing area and the bottom of the valve face.

There is basically no carbon on this valve, you can plainly see that the fuel mixture on this engine is burning very well – no build up on the exhaust valve .

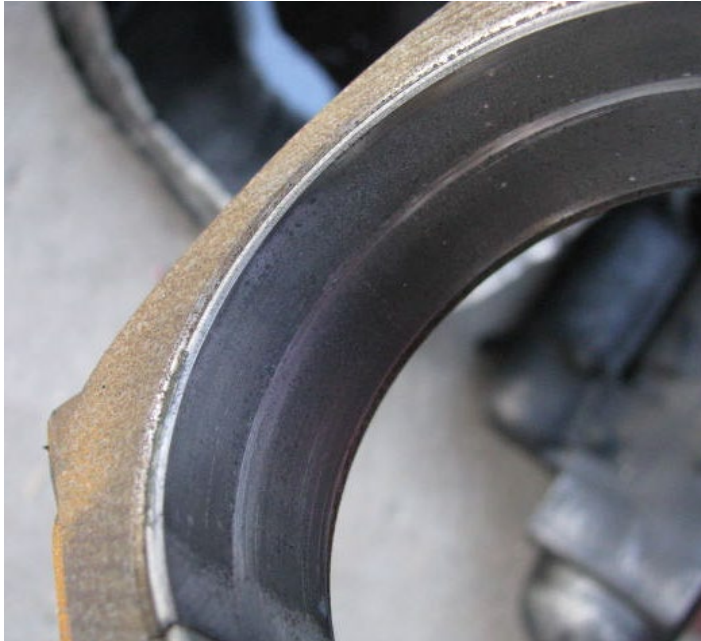
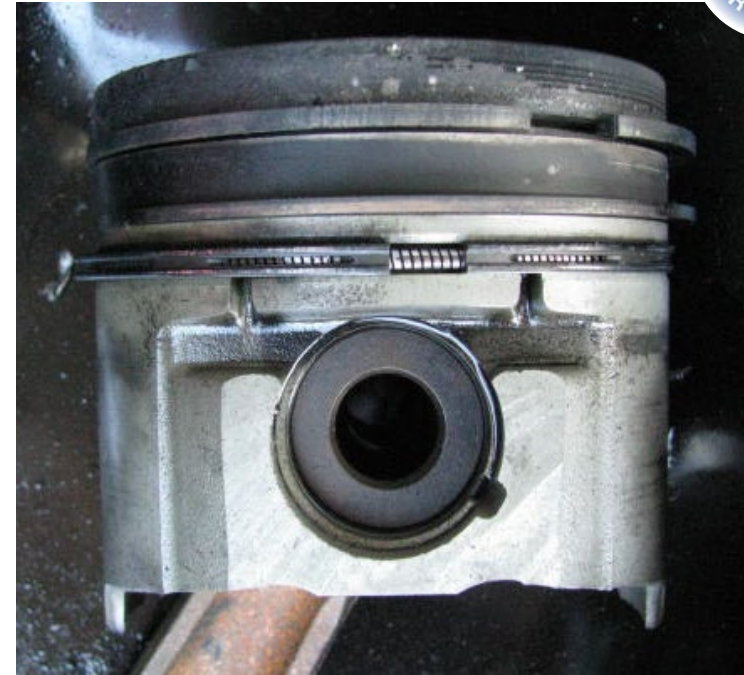
Rod Bearing/ Piston

A close up of one of the rod bearings on this engine reveals extremely minimal wear to speak of. The wall thickness clearly shows a very usable bearing with a lot of miles left on it.

Here is a piston out of this engine, look at the oil control ring (bottom ring) and the expander (spring under the oil control ring). There is no carbon or “coking” in this area. There is very little carbon build up anywhere on this piston.

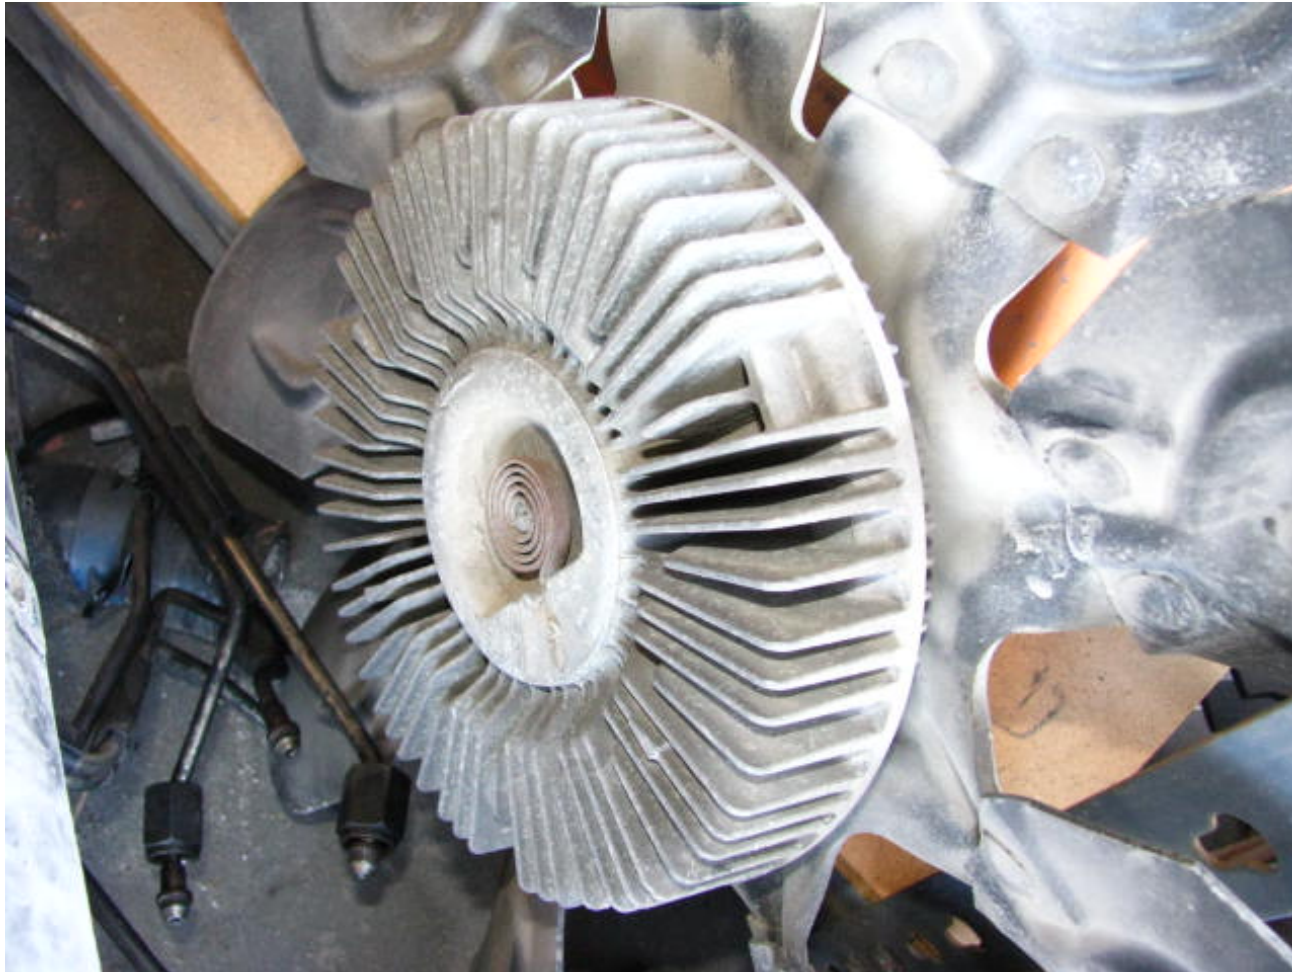
Here is the cause of engine failure
\$95.00 in parts // 1 hour labor
DEFECTIVE FAN CLUTCH
