Model ST108 Rain Shower™ Combination Showerhead

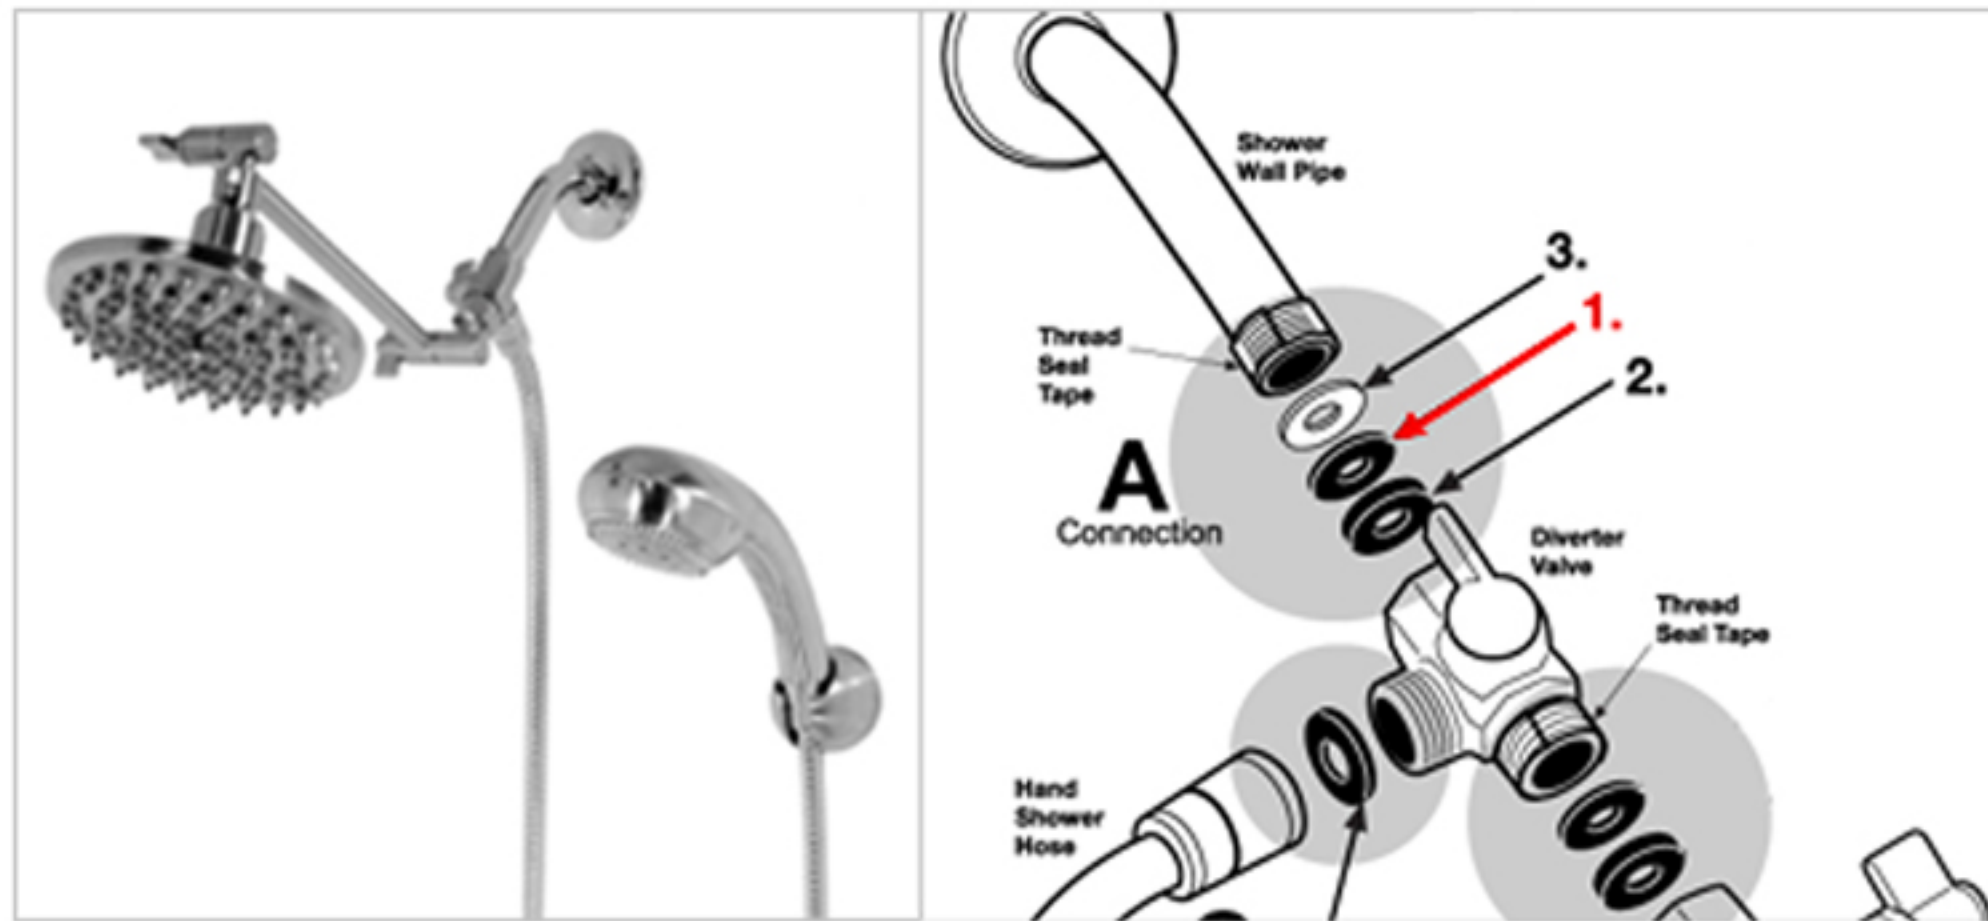
After correct installation of the product, some consumers have experienced extremely low water flow through the showerheads. Due to dimensional differences in some consumers' bathroom wall shower pipe plumbing, the thin rubber washer (washer #1 in the Connection A area) included with this showerhead may become deformed and will actually restrict water flow.

Remove the thin rubber washer # 1 found in Connection A. Unscrew the diverter valve at Connection A from the shower wall plumbing and remove and discard the thin rubber washer shown as # 1 in the instructions. Screw the showerhead parts back to the wall shower pipe, and the water flow should be much improved.

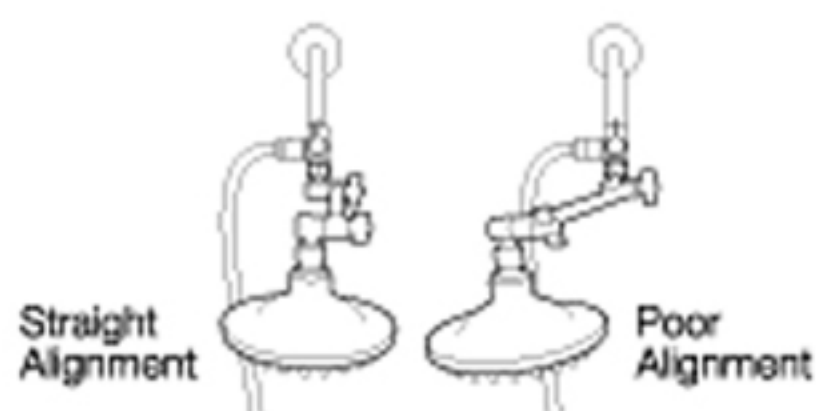
If you experience any problem with the vertical alignment of the showerhead once you have removed the thin rubber washer and reassembled the showerhead to the wall plumbing, you will need to:

Add more thread sealing tape to the shower wall pipe threads - as shown at Connection A. An additional amount of thread sealing tape will help to tighten the threaded Connection A so that it stops and becomes tight at a vertical alignment for the assembled showerhead.
