Electronic Piano Notes

Issued by Wurlitzer Service Dept., DeKalb, Illinois

E.P. NOTE No. 14

CIRCUIT MODIFICATION TO PROVIDE PROTECTION FOR TRANSISTOR "TR-1"

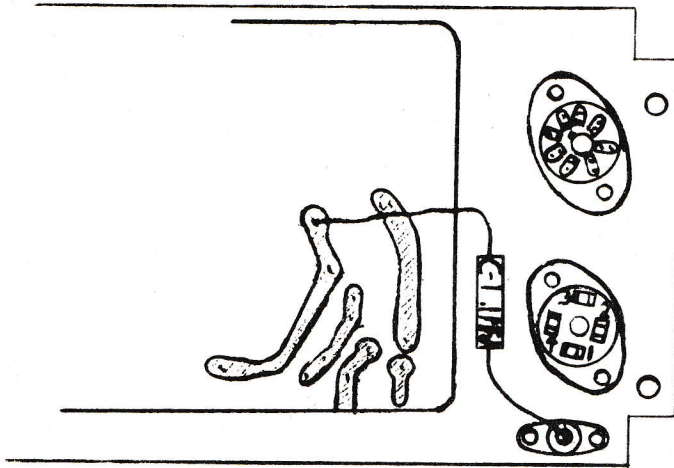
BEFORE

OCCASIONALLY, WHEN TUNING A REED OR SERVICING A REED BAR, AN ACCIDENTAL SHORT CIRCUIT, I.E., LEAD FILINGS, CAN OCCUR WHICH CAUSES A SPIKE PULSE TO SHOCK TRANSISTOR TR-1, RESULTING IN THE POSSIBLE FAILURE OF THE TRANSISTOR.

A 22K RESISTOR IS NOW BEING INCORPORATED BETWEEN THE INPUT PLUG AND C-1. WHENEVER SERVICING THE AMPLIFIER, WE SUGGEST YOU CHECK FOR THIS REVISION, AS ILLUSTRATED BELOW:
