SERVICE BULLETIN # 017

DATE: 02/12/2022

PRODUCT LINE: 50mm Tail Union (950920)

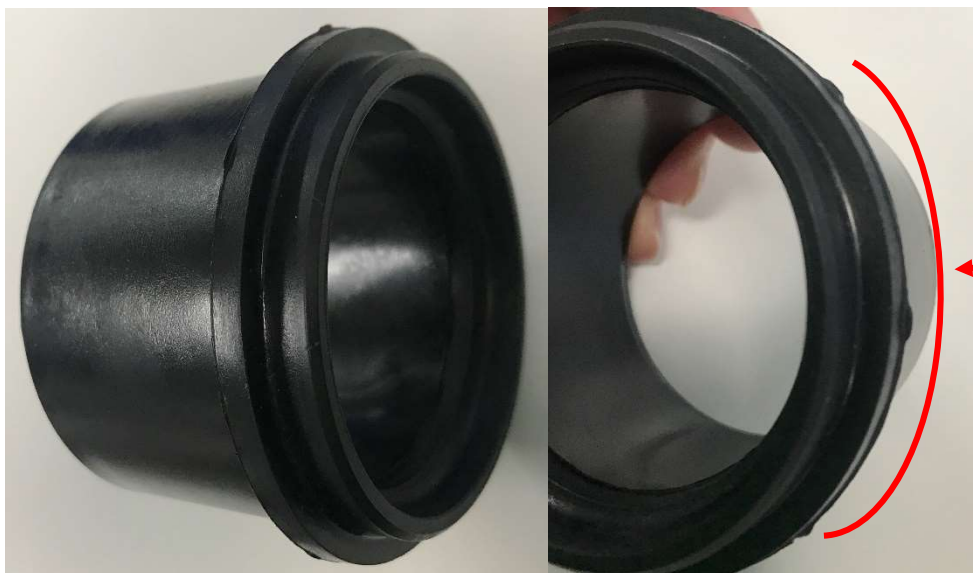
Failure Description: Flash on the outside diameter of 50mm Tail Union. This fault makes it difficult to assemble the Tail Union to the Lock Nut (950919). The fault is in component bags packed from August 1st to December 1st.

Cause: Issue in the moulding process that was not picked up during routine inspections.

An instance of Flash to the Outside Diameter of Tail Union (950920)

- In some instances, the flash must be removed before installation.
- This can be achieved by scraping or filing the flash from the outer diameter.
- **Do Not attempt to cut with a knife, as injury may occur.**
