REPORT

Partial Discharge Survey Examples of MV and HV Assets

Prepared for: Customers
Document Version: 1
Date: 17 October 2016

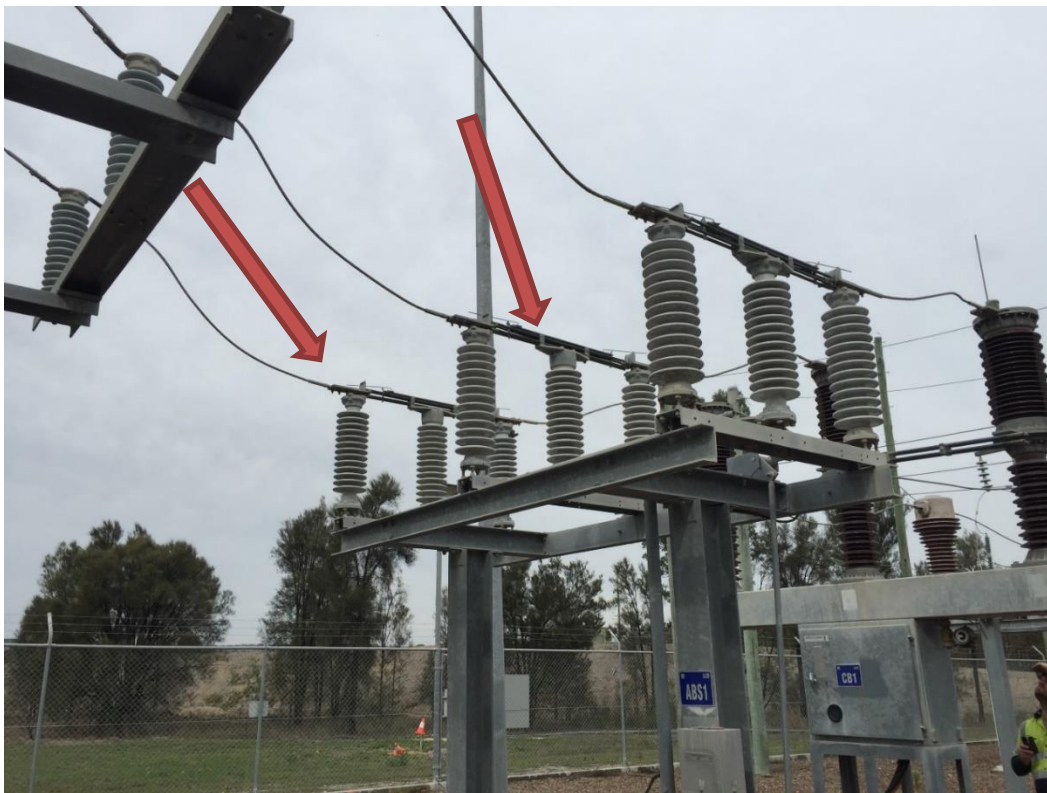
Figure 1 ABS1

The south and center phase insulators on ABS1 were emitting ultrasonic activity that is consistent with non-destructive corona activity. See Table 1Figure 1. Table 1Figure 2 is the trace captured during the scan and does not indicate PD. Given the nature of the exposed metalwork, metallic sharp points and the single cluster of activity on the phase resolve plot, this source is classed as non-destructive corona - no action required.

Figure 2 Ultrasonic trace from ABS1 showing Corona Discharge

- C1. Non-destructive corona found on ABS1 inside SR001 substation.
- C2. Ultrasonic surface discharge activity detected on centre phase of 66kV CB1. This activity was not present after a day of rain in the area – this proves that the surface discharge activity was caused by surface contamination from the atmosphere.

- R1. The corona found on ABS1 inside SR001 is of no concern as it is in open air.
- R2. The surface discharge activity on 66kV CB1 is unlikely to have caused any damage to the porcelain insulation system of the circuit breaker. At the next available shutdown, it is recommended to closely inspect the porcelain for any signs of damage.
- R3. The corona found on ABS3 inside SR001 is of no concern as it is in open air.

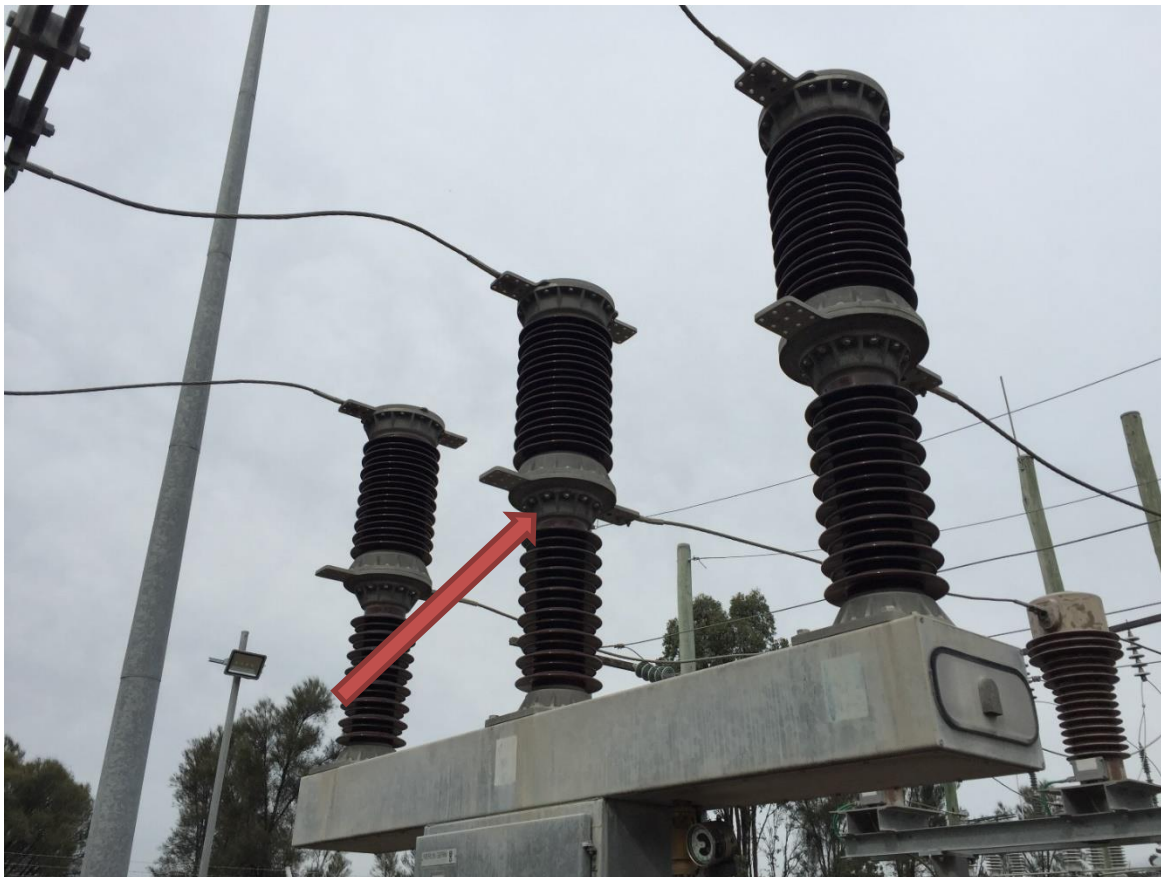
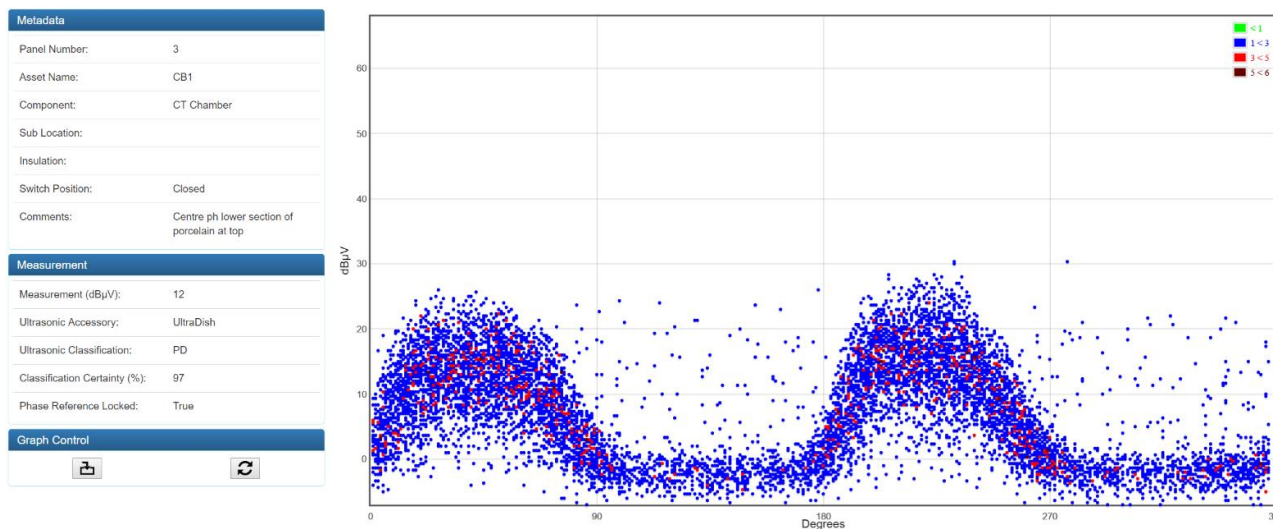
Figure 3 CB1

An ultrasonic source of surface discharge was detected on the middle of the center phase bushing on CB1. See Figure 3. With readings up to 12dBuV which was also phase resolved (activity 180 degrees apart,) this is classed as a strong surface discharge source. See Figure 4. To rule out any internal type PD happening within the 66kV CB. Given that the construction of the CB being porcelain, surface contamination is highly unlikely to degrade the insulation system, however, at the next available shutdown, it is recommended to inspect the CB at this point of discharge.

Two days later, this CB was revisited after heavy rains the previous day. Another ultrasonic scan was performed and all of the ultrasonic activity had disappeared. This confirms the above recommendation – all clear.

Figure 4 Ultrasonic trace from CB1 showing surface discharge activity

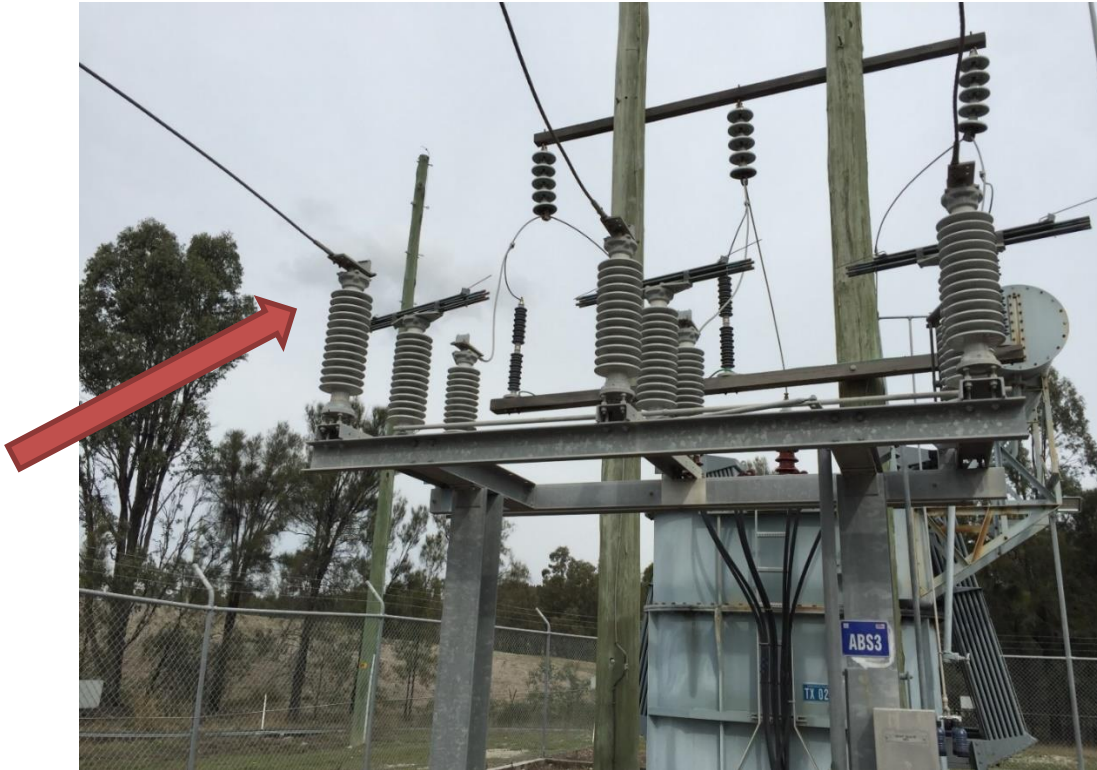
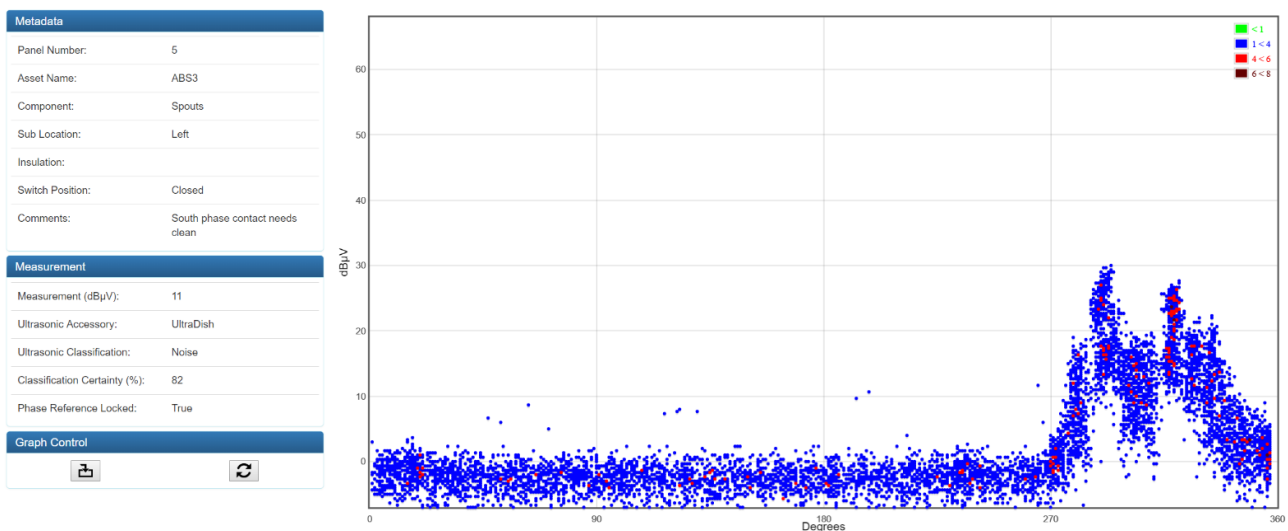
Figure 5 ABS3

An ultrasonic source of non-destructive corona was detected on the top of south phase insulator of ABS3. See Figure 5. The trace in Figure 6 is consistent with corona activity. Given the nature of the exposed metalwork, metallic sharp points and the single cluster of activity on the phase resolve plot, this source is classed as non-destructive corona – no action required.

Figure 6 Ultrasonic trace from ABS3 showing corona activity

- C3. Non-destructive corona found on ABS3 inside SR001 substation
- C4. A rusty nut and bolt at the base of the polymeric 66kV dropper insulator above TX021 on the north phase was located. This nut and bolt is emitting ultrasonic surface discharge activity.

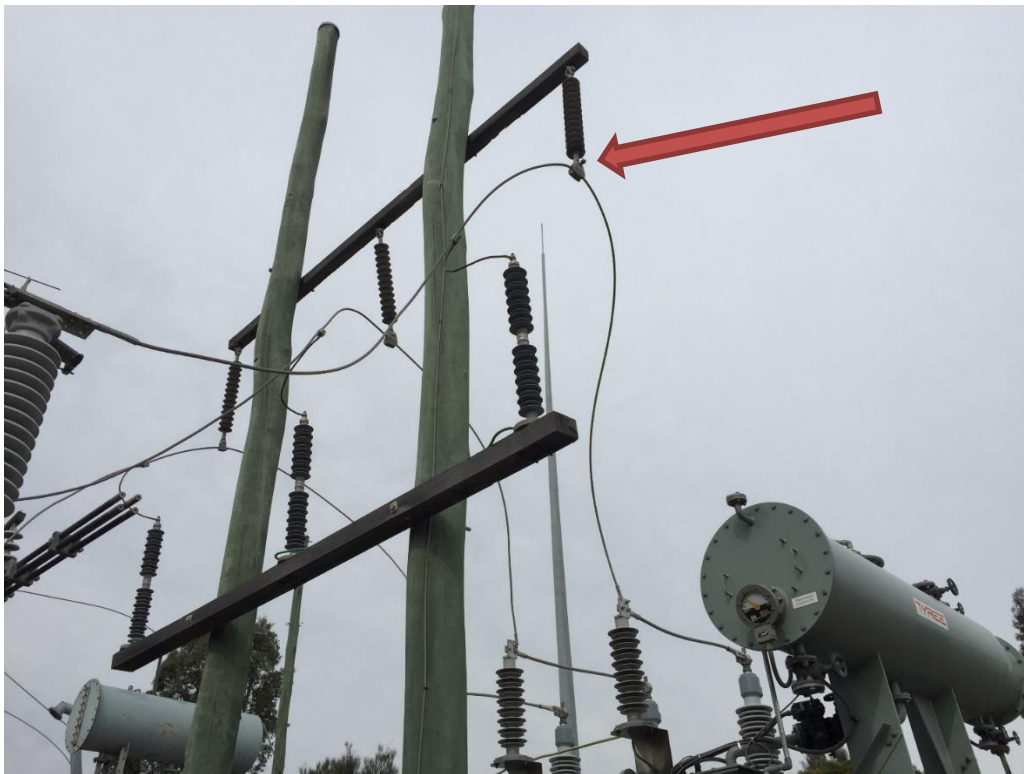
Figure 7 North phase 66kV dropper at TX021

There was ultrasonic surface discharge detected from the HV side of the north phase, 66kV dropper at TX021. See Figure 7. Upon closer inspection with binoculars, it could be seen that the nut and bolt that is holding the conductor clasp are rusty. This is likely giving the surface discharge activity that has been detected. Figure 8 is showing a trace consistent with surface PD. The polymeric insulation on the HV dropper may also be deteriorated because of the activity of the bolt.

Figure 8 Ultrasonic trace from North phase 66kV dropper at TX021 showing surface PD activity

Recommend a close inspection of the polymeric insulator and replacement of the metallic hardware at the end of the insulator.

- R4. The rusty nut and bolt on the polymeric insulator above TX021 may be deteriorating and hence losing its mechanical strength. At the next available outage, it is recommended to replace the nut and bolt, replace any other faulty assets in its vicinity. Also, as polymeric insulation is more susceptible to surface damage than porcelain, the base of the polymeric insulator should be closely inspected for signs of degradation – replace if any degradation found.

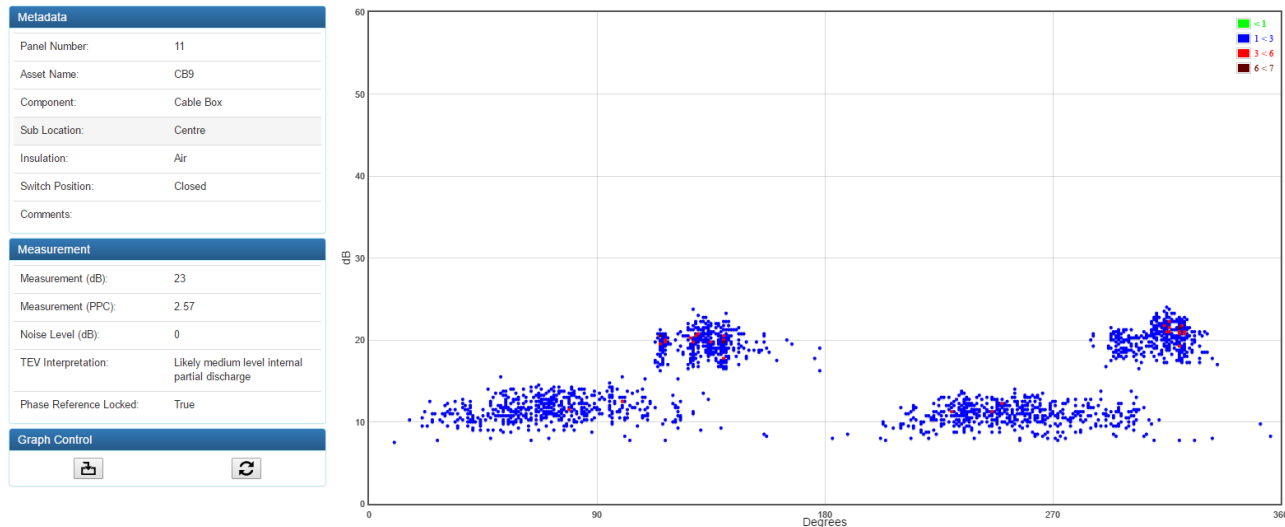
A minor source of internal PD has been detected from within the CB9 HV cable chamber. See Figure 11. This source is around 15dB and 2 pulses per cycle. It is at a low level at the moment so is of no concern in the near future. Recommend retesting in one years' time to compare results and look for any changes in amplitude. The PD trace is consistent with internal void type discharge. A visual inspection during the next shutdown period would be a good idea also but unlikely to see anything wrong as the activity is consistent with internal void type PD. No ultrasonic noise could be heard here which likely rules out surface tracking.

Figure 11 Internal PD results from CB9 HV Cable Chamber

- C6. An internal void type discharge of a low level was detected coming from the HV cable chamber of CB9 inside SR001 substation.
- C7. Non-destructive corona found on CB-Q100 on top of TX045 substation.

- R6. As the PD source within the HV cable chamber of CB9 is an internal void type discharge, it is unlikely that a visual examination will find any defects. However, recommend a visual examination of this chamber if an outage allows. Recommend re-test in one years’ time to compare any changes.

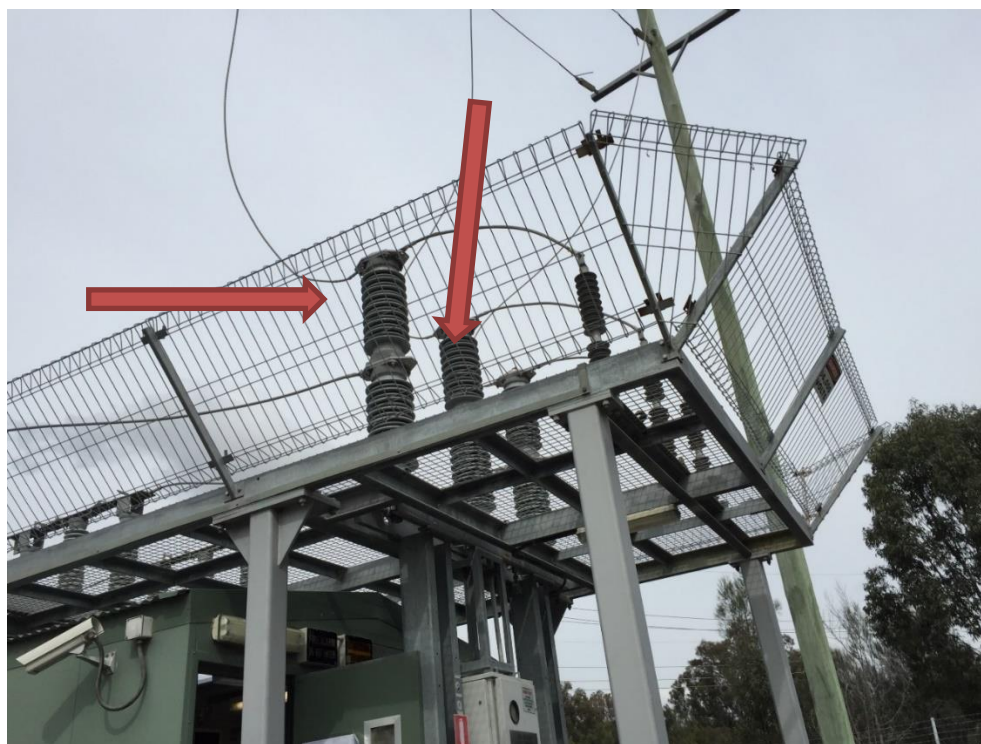
Figure 12 66kV CB-Q100

Corona activity was detected at the top of the two CB bushings as seen in Figure 12. This is of no concern as corona on outdoor switchgear is non-destructive.

Figure 13 Ultrasonic results from 66kV CB-Q100 showing corona activity

- R7. The corona found on CB-Q100 on top of TX045 substation is of no concern as it is in open air.
- R8. The corona found on Rotary switch S100 on top of TX045 substation is of no concern as it is in open air.

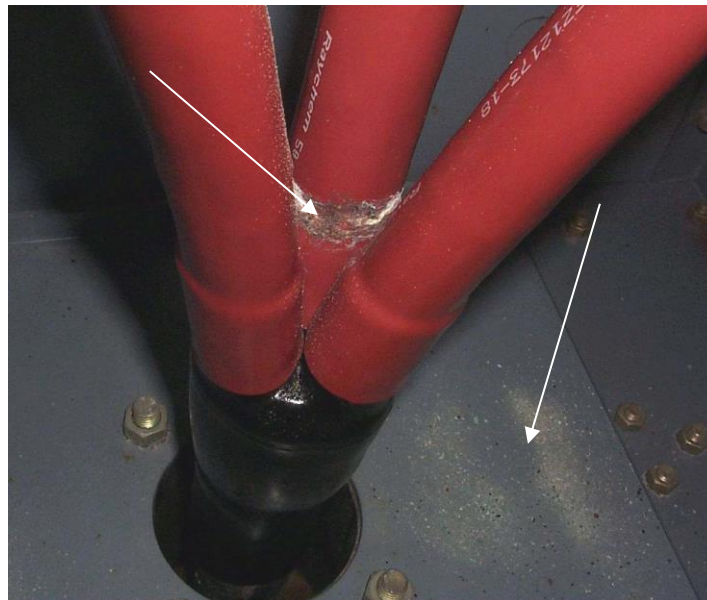
Figure 1 Surface discharge activity between cable phases.

Note that white power in the base of the cable box or on horizontal surfaces is a good indication that discharge activity is present within switchgear.

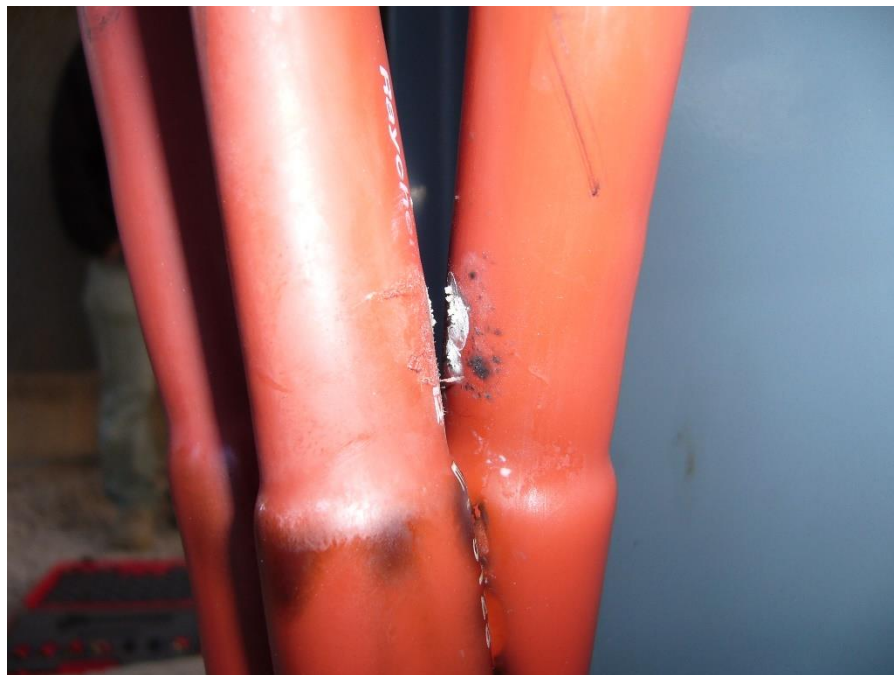
Figure 3 Discharge activity between cable phases within an air insulated cable box.
Note white powder deposit on polymeric surfaces.

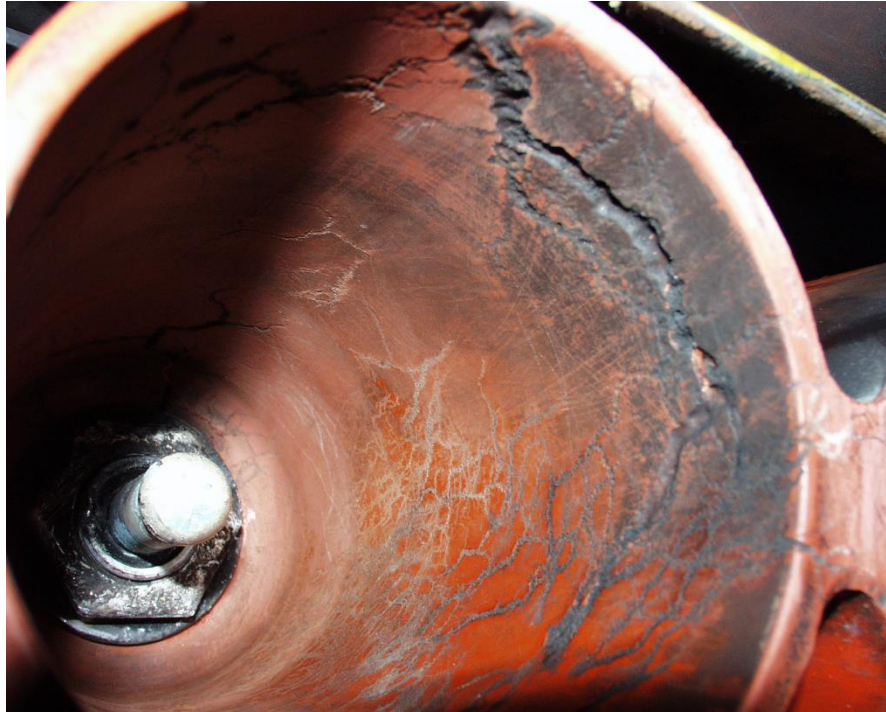
Figure 4 Advanced surface discharge activity within the resin spout of an 11kV circuit breaker.

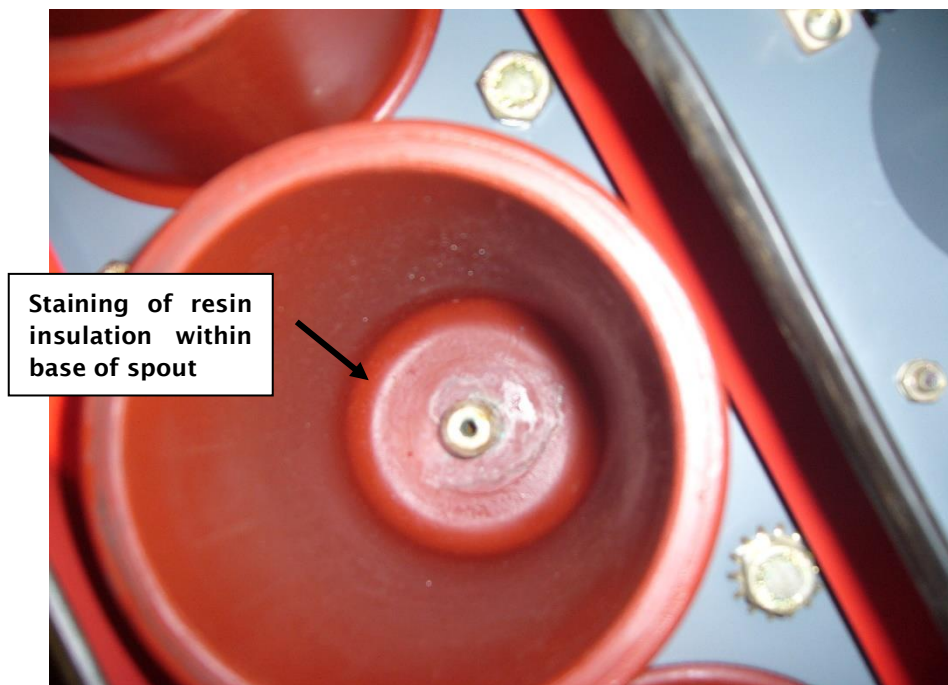
Figure 5 Staining of resin insulation within 11kV circuit breaker spout caused by the effects partial discharge activity
