## GENERAL TEST REPORT

<b>Report Number</b>	LS21-2957 LT	<b>Test Date</b>	29/12/2021
<b>Customer</b>	<b>The Trustee for Blitz Systems Unit Trust</b>		
<b>Customer Address</b>	55 Pendlebury Road, Cardiff NSW 2285		
<b>Requested By</b>	Reuben Allbut	<b>Purchase Order</b>	Reuben
<b>Accredited Laboratory</b>	LMATS Sydney Laboratory		
<b>Job Location</b>	6 Techno Park Drive, Williamstown VIC 3016		
<b>Job Description</b>	Load testing of 4 off Wire Lock Arrangements		
<b>Identification</b>	With Lock 1, With Lock 2, Without Lock 1, Without Lock 2		
<b>Material Specification</b>	Not Specified		
<b>Test Specification</b>	Client's specified activities – Report findings		
<b>Test Method</b>	AS 1391-2020 as a guideline		
<b>Equipment Data</b>	50kN UTM Machine		
<b>Technical Data</b>	The supplied wire lock was held in a Universal Tensile test machine. A preload of 100N was applied to the crimped cable and the distance between both the connectors was measured as reference. The tensile load on the crimped cable was then gradually increased at a constant rate.

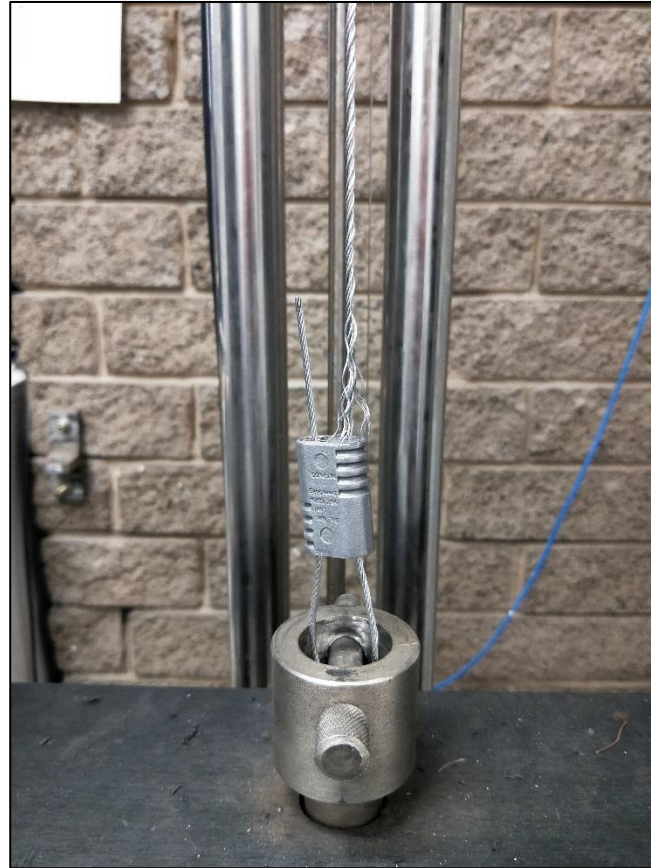
Sample ID	Max Load (kN)	Failure Location
With Lock 1	2.90	In wire
With Lock 2	2.93	In wire
Without Lock 1	2.77	In wire
Without Lock 2	2.66	In wire

Figure 2: With lock 1 failure location

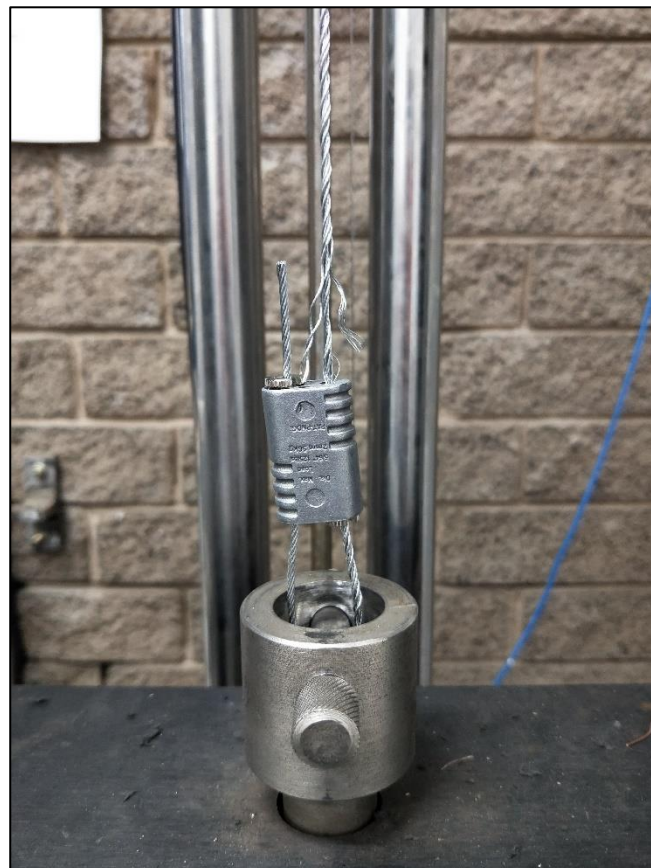
Figure 4: With lock 2 failure location

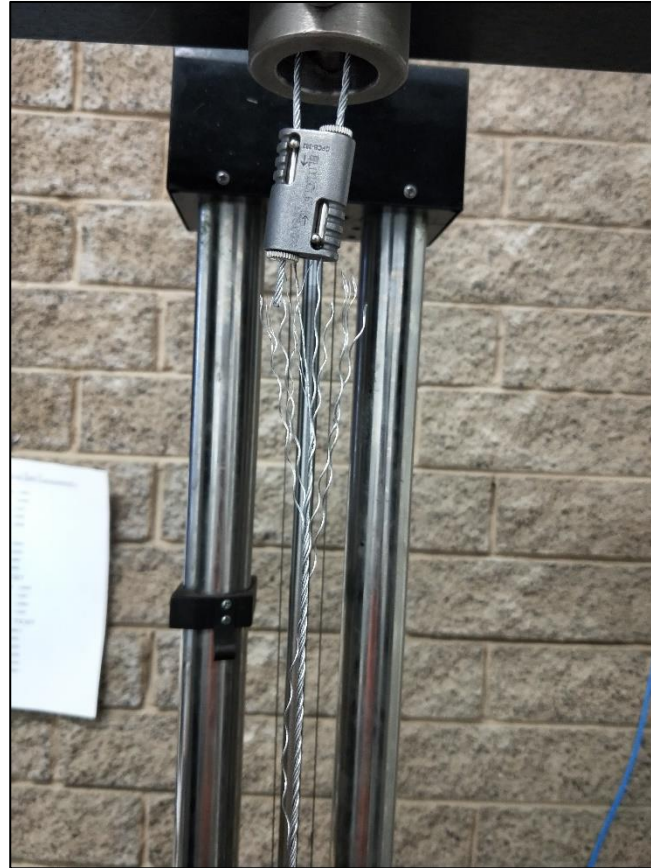
Figure 6: Without lock 1 failure location

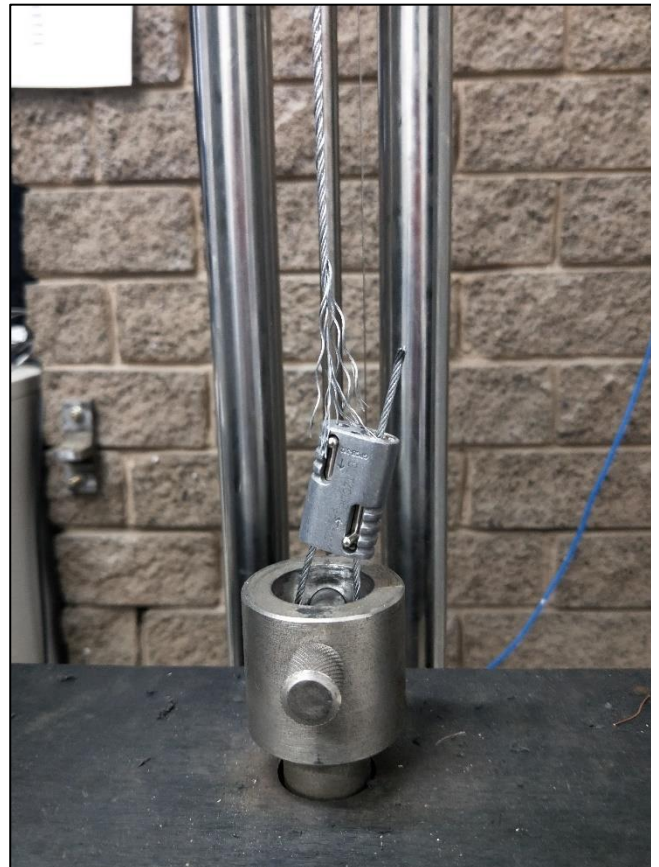
Figure 8: Without lock 2 failure location
