PureThermal OpenMV Hardware Errata

Jan 11, 2024 - Version 2

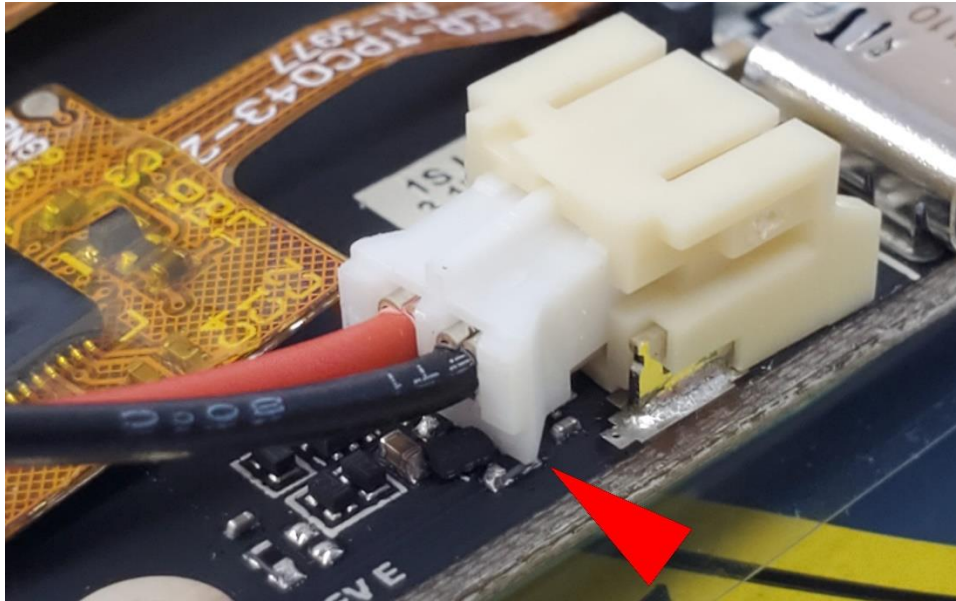
There are components beneath the battery connector which can come in contact with the battery cable end. Removing the cable can take components off the board with it.

Figure 1: This is damage caused by removing the battery connector without special care to avoid damage.

It is recommended to remove the protruding wedge from the battery cable connector before use. This will prevent risk of damage.

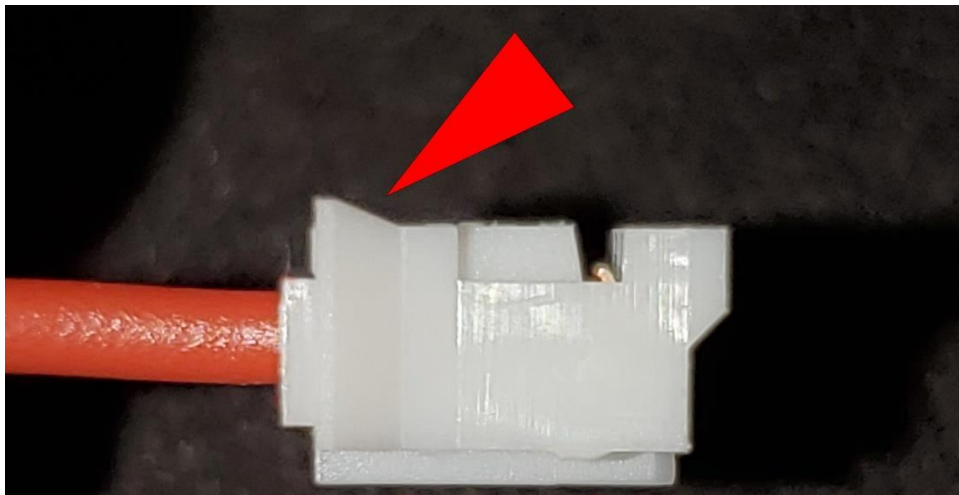
Figure 2: This protruding wedge catches on components and should be removed.

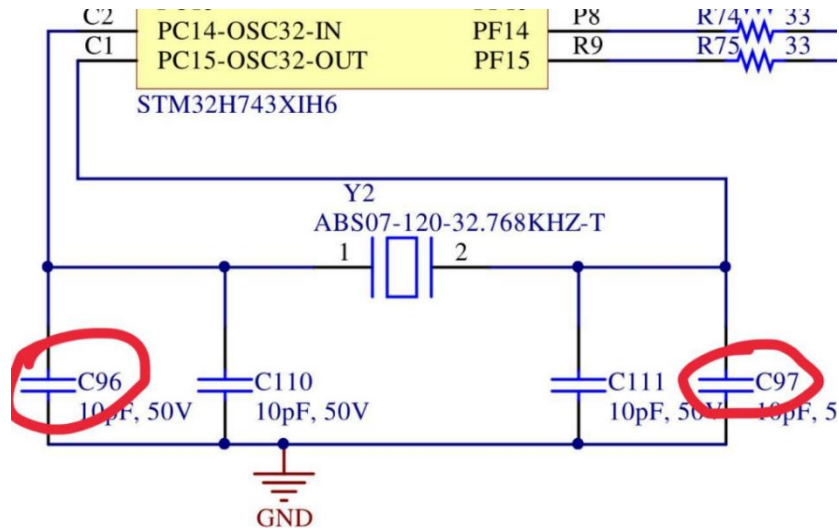
The load capacitance on the Y2 crystal is too high. Removing C96 and C97 can restore functionality to the RTC. These capacitors are already removed on most boards.

Figure 3: C96 and C97 are circled in this schematic view.

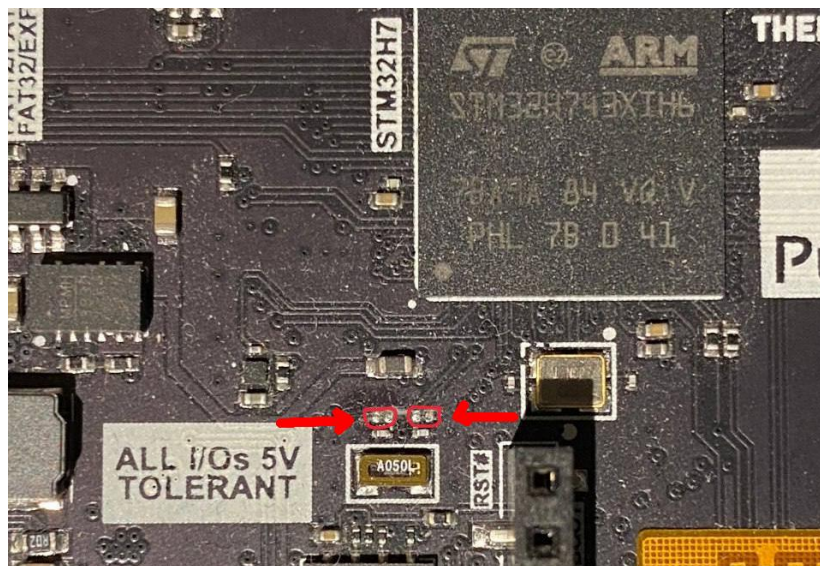
Figure 4: C96 and C97 are located adjacent to the STM32 package as shown.

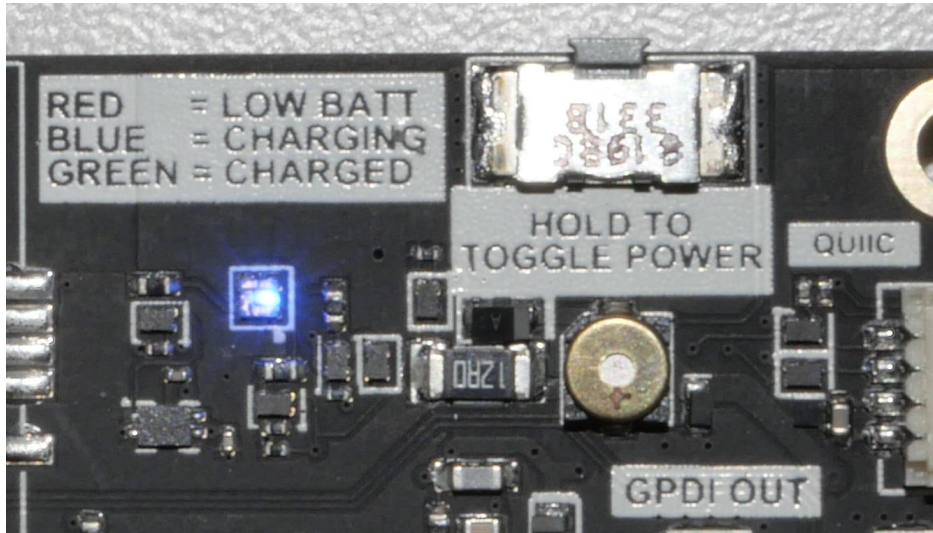
- The charge indicator LED may not turn green when the battery is fully charged.

Figure 5: The LED indicates 'charging' even though the battery is fully charged.

The battery charger may stop charging at 4.15V to 4.19V without triggering the green LED.

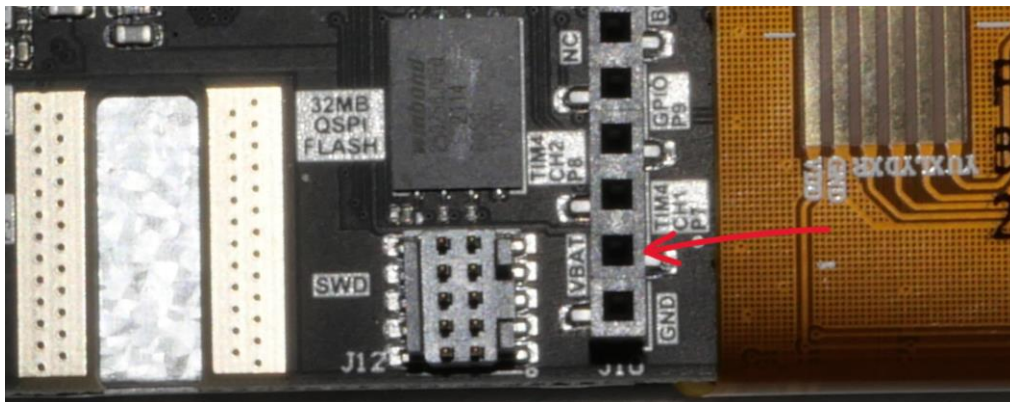
- VBAT is unconnected on the I/Os.

Figure 6: The silkscreen indicates this pin is VBAT, but this pin has no connection.
