URGENT: 2016 Rope Bridge Safety Warning and Free Replacement for Weaver Cougar, WLC-700 & WLC-730 Models

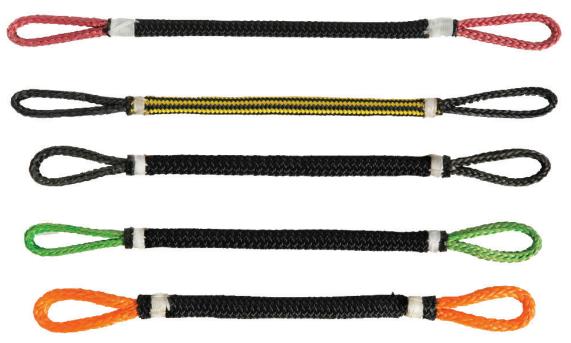
Applicable Rope Bridges:

Over the past several years, there have been a number of failures of the spliced rope bridge component as shown in the pictures below, which was used in 2013 and prior years on the Weaver Cougar, Weaver WLC-700 and WLC-730 model harnesses. Since 2012, we have reminded users that the rope bridges are a replaceable component of the harness and need to be inspected daily and replaced at the first sign of wear. Inspection includes both the cover and rope ends. Also, if the bridge is ever shock-loaded, replace immediately. Due to the rigorous strain and conditions these rope bridges endure, we strongly recommend replacing the rope bridge at the earlier of the first sign of wear or 6 months. (This recommendation applies to all Weaver Arborist rope and webbing bridges, not just the spliced rope bridges previously utilized.)

These spliced rope bridges were no longer used on harnesses sold by Weaver Arborist after 2013. Therefore, if the bridges are replaced every 6 months according to our recommendation, all users should have replaced this bridge prior to now. Below is a photo of the previously utilized spliced rope bridges, when new. Any such bridges which are still in use need to be replaced immediately.

Note: The color on the rope ends may have faded over time to white or grey.

In order to encourage regular replacement if you are still using one of these bridges, Weaver Arborist will provide a free Webbing Bridge replacement. Please follow the below instructions to receive your replacement bridge at no cost:

1. Immediately remove your bridge, fill out the below information and return both to:

2. Weaver Arborist will send a free replacement webbing bridge within 1-3 business days.
