Using FT-IR Microspectroscopy for the Identification of Contaminants in Engineered Plastics

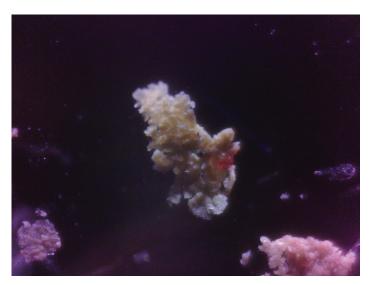
Figure 4: Digital micrograph of excised contaminant

A digital image of an excised contaminant is shown in Fig. 4. This image was recorded with dark-field illumination. Under the microscope, the contaminant appears as an oily-particulate consistence. IR spectra were recorded from contaminants excised from both plastic materials. Fig. 5 illustrates an analysis result from sample #2. A contaminant particle was thinned by rolling onto a KBr window substrate. The IR spectrum of the contaminant is shown at the top of Fig. 5. Spectral match candidates are shown in the middle and bottom of the figure. Clearly a predominant component of the contamination is silica (SiO₂) and very good correspondence is noted between the contaminant and silica gel, a very common synthetic silicate. Silica is not the only component however. Some similarity is noted to the material ethoxylated tallow alkyl amine, which also contains a heavy silica loading. The plastic contaminant exhibits absorption bands at 2924, 2850, 1458, and 1377 cm⁻¹ due to C-H vibrations characteristic of long chain hydrocarbons. Additionally, a carbonyl band is observed at 1732 cm⁻¹ in the ester absorption range. The most probable explanation is that the contaminant is a mixture of silica and natural product oil, such as castor oil or linseed oil. Silica has numerous applications in plastics manufacture including use as filler and a mixing, anti-caking aid. The analysis of the contaminant from sample #1 yielded the same identification.

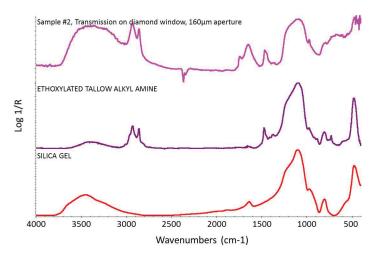
Figure 5: Micro-contaminant analysis results for sample #2 – poly (bisphenol-A) carbonate. Top: IR spectrum of contaminant. Middle: IR spectrum of spectral search candidate – ethoxylated tallow alkyl amine. Bottom: IR spectrum of silica gel.
