LOAD TEST REPORT

| Customer¹ | Munji 4x4 Accessories |
| Report Number | RB20-2401-01 |
| Job Description¹ | Load testing of Qty 1 Belly Plate and Qty 1 Trailer Hitch component |

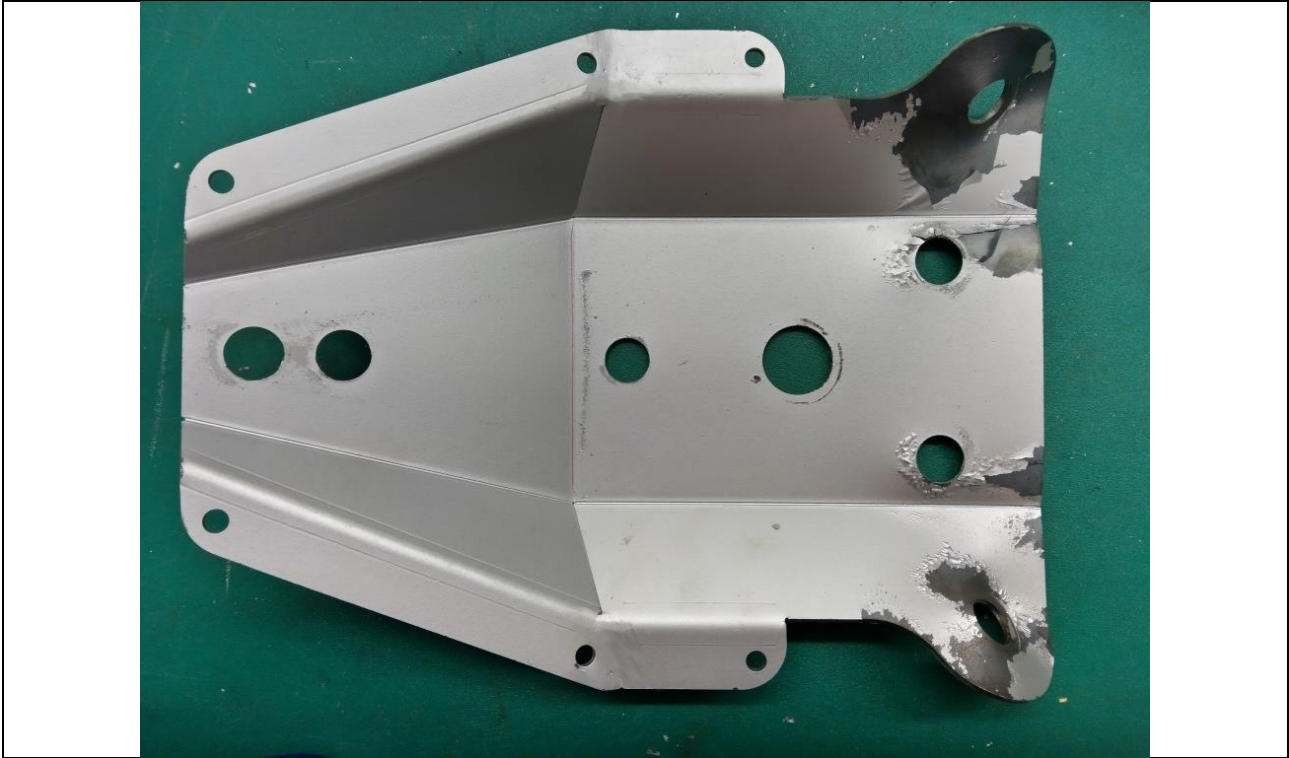
| Sample ID | Applied Load [kN] | Comments |
|---|---|---|
| 01 – Belly Plate | 28.59 | Testing halted due to significant yielding of the holes under test. |

Figure 1: Photograph of the Belly Plate component after load test

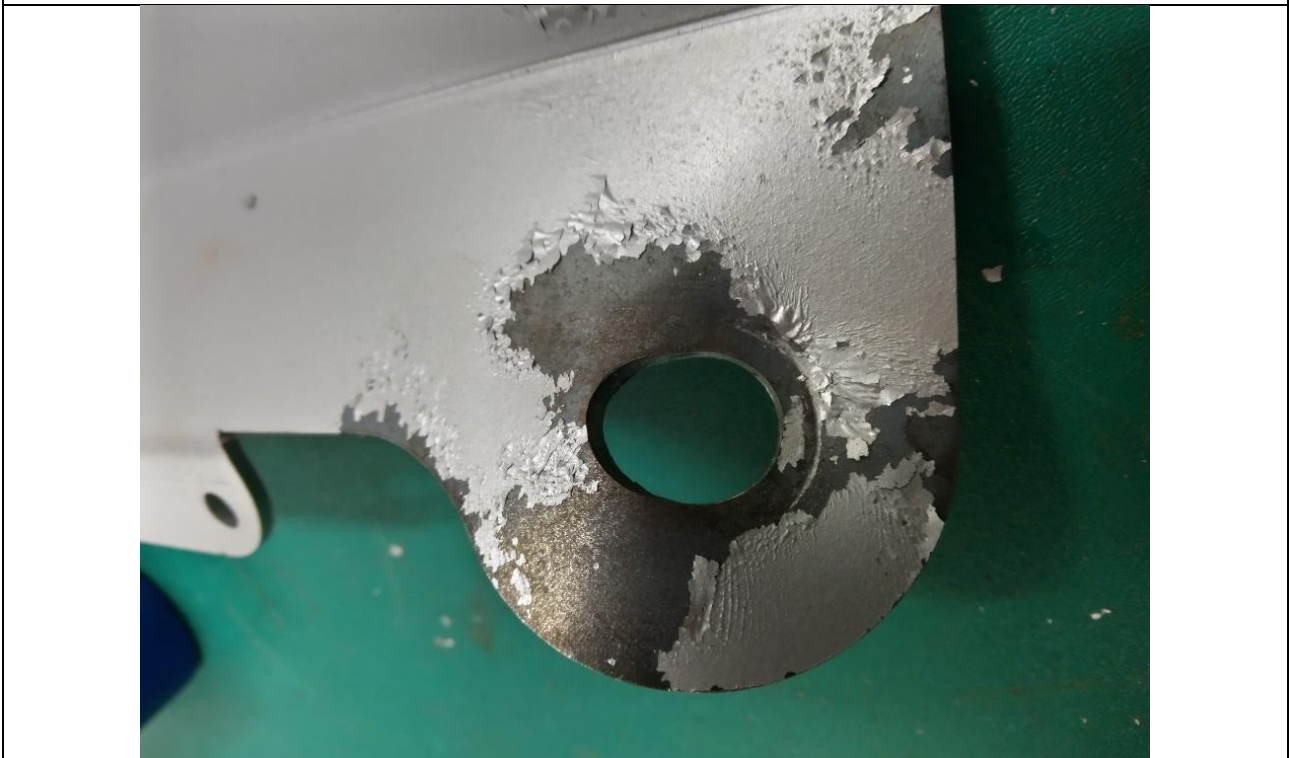
Figure 2: Photograph of the Belly Plate component after load test

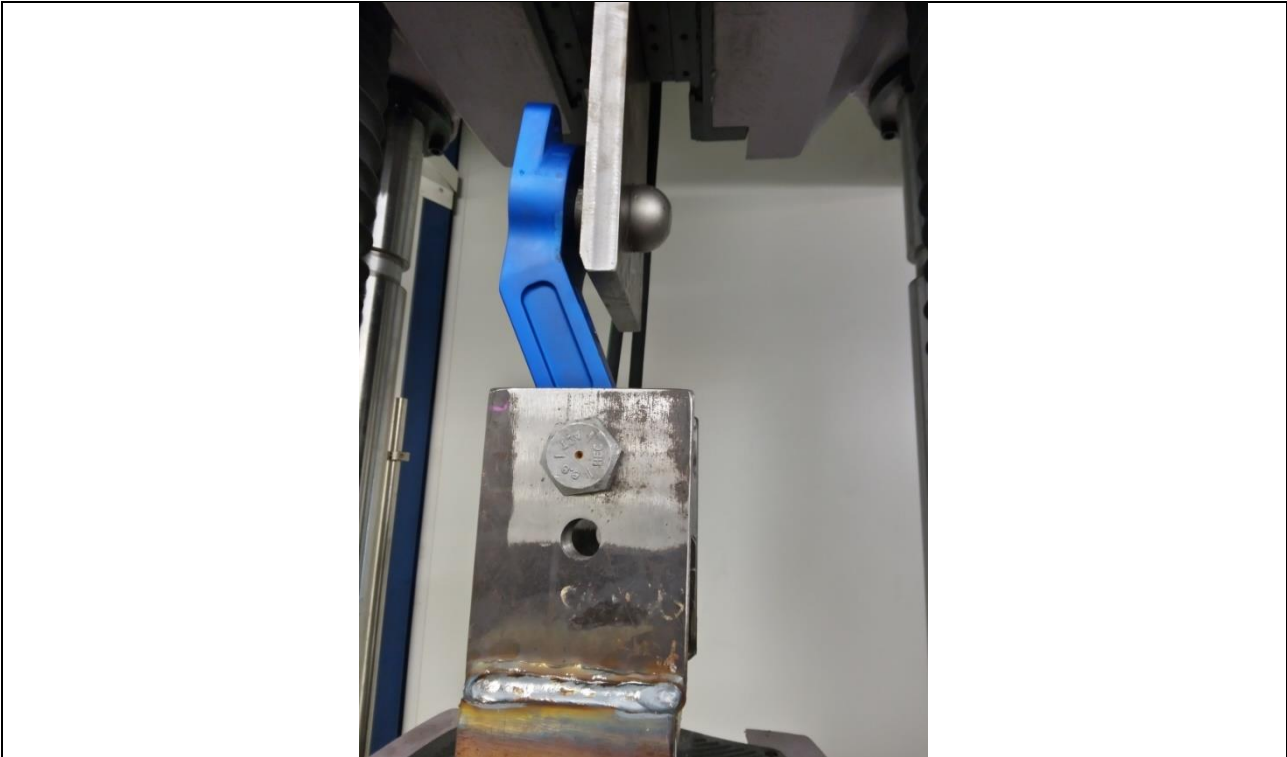
Figure 3: Photograph of the Trailer Hitch component during load test.

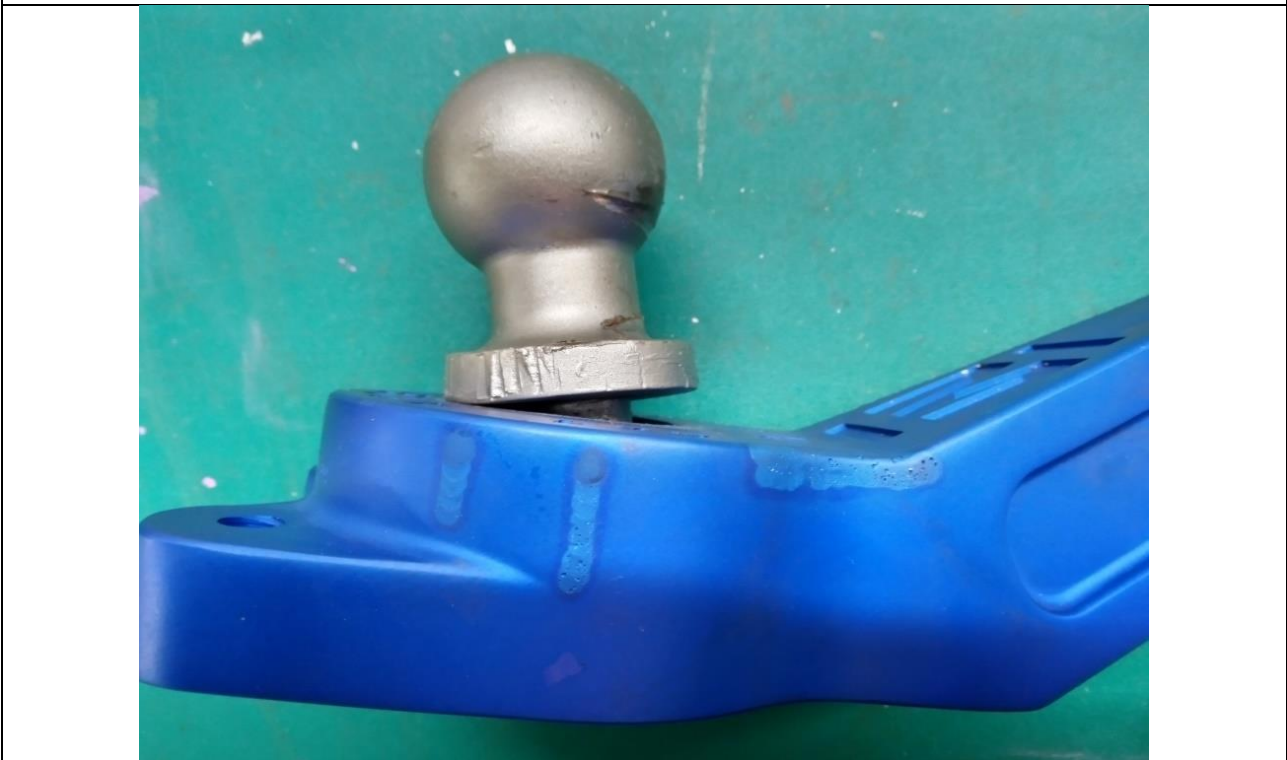
| Sample ID | Applied Load [kN] | Comments |
|---|---|---|
| 02 – Trailer Hitch | 107.61 | Testing halted due to significant yielding of tow ball connection. |

Figure 4: Photograph of the Trailer Hitch component after load test.
