HAVE YOU IDENTIFIED THE ORIGINAL CAUSE OF FAILURE?

RECURRING TURBOCHARGER FAILURES FOR HYUNDAI ILOAD & IMAX

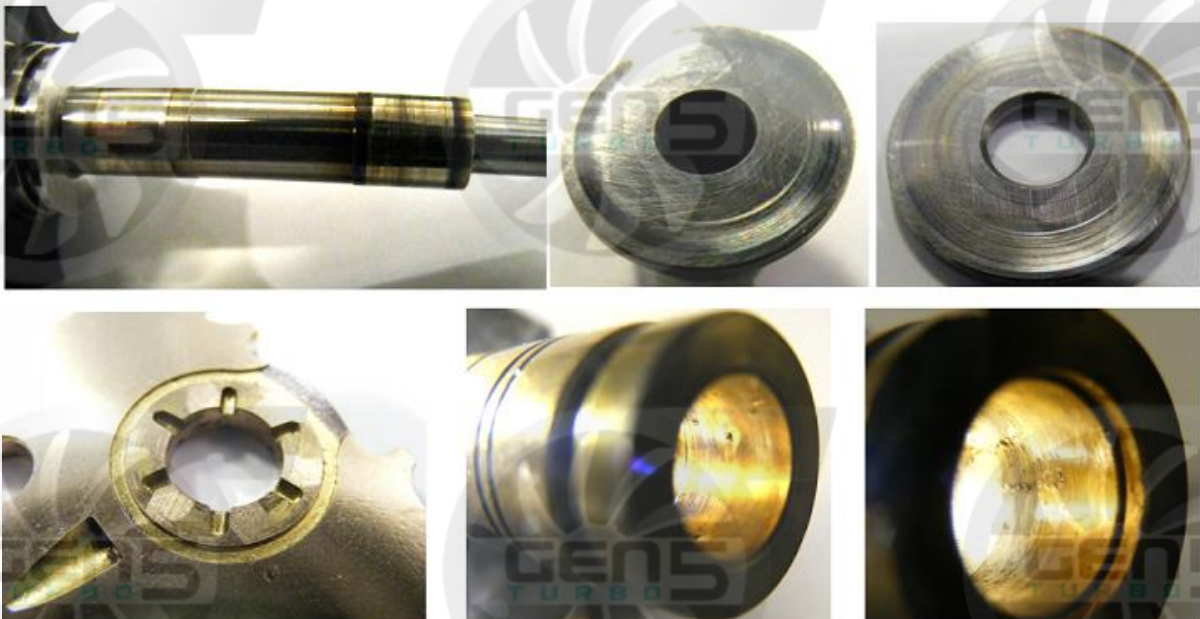
EXAMPLES

Subsequently common recurring turbocharger failures for the Hyundai I-Load & I-Max are typically a result of (but not limited to) insufficient and/or irregular supply of oil pressure to the rotor assembly, bush bearing and thrust component parts. Evidence of reduced oil lubrication to the turbocharger rotor assembly can be identified by heat discolouration to the shaft journals, journal bearing and thrust components. Contact wear is also evident to the thrust bearing pads, thrust collar and contact metal transfer between the journal bush bearing and turbine shaft.

A complete vehicle inspection should be undertaken prior to fitment of a replacement turbocharger.

- i. Remove injectors, clean cylinder head injector ports and injectors of any carbon deposits prior to re-fitment. Replace all injector sealing washers.
- ii. Check for any oil sludge/carbon build up around the air inlet ports in the cylinder head. Clean if necessary.
- iii. Remove the sump, replace oil pickup strainer and replace oil pump.

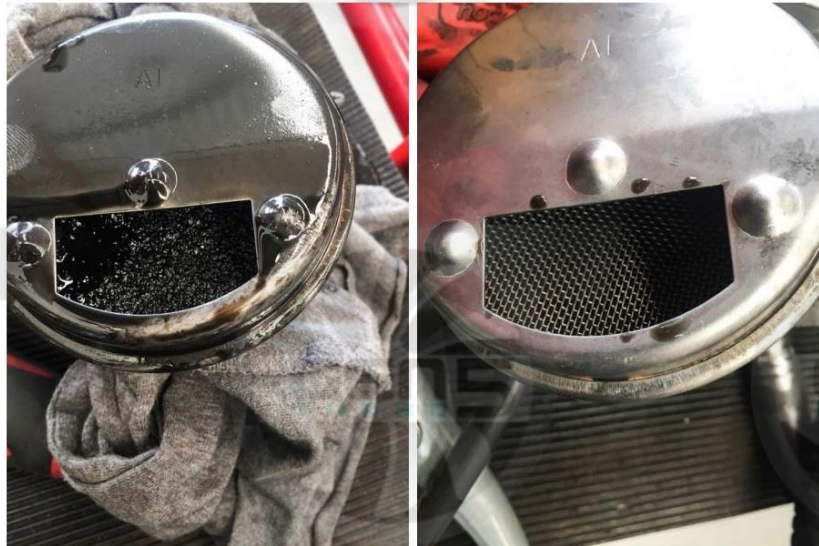
EXAMPLE: [LEFT] CARBON RESTRICTION TO OIL PICKUP [RIGHT] NEW OIL PICKUP

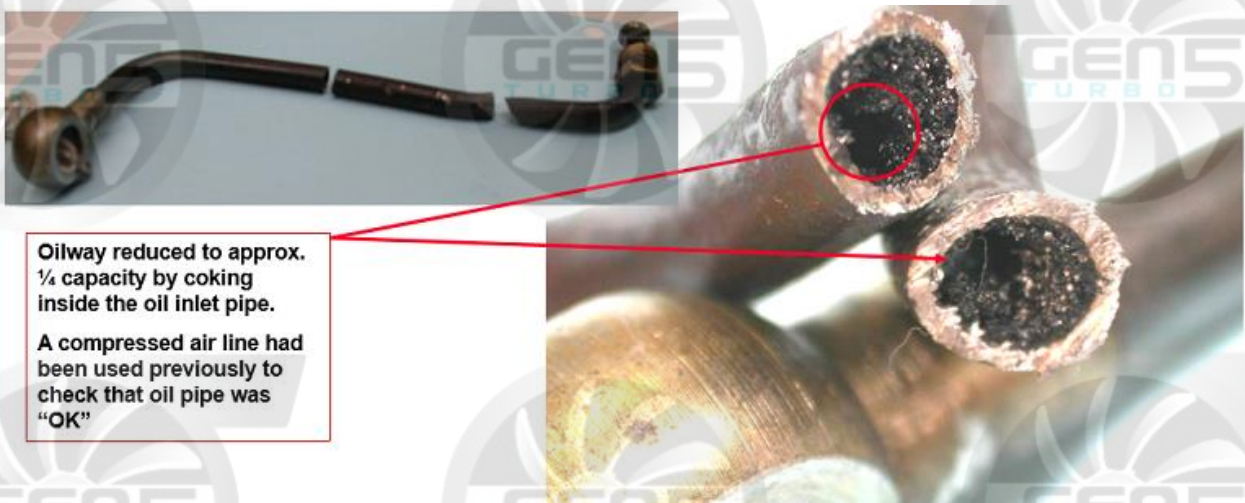
EXAMPLE

Oilway reduced to approx. ¼ capacity by coking inside the oil inlet pipe.

A compressed air line had been used previously to check that oil pipe was "OK"

- iv. Remove and replace the oil supply line and associated fittings from the block to the turbocharger. Do not try to clean the original fittings or the oil supply line only as any internal restriction will result in reduced oil flow to the turbocharger.
