## TOYOTA KUN26 HILUX 1KD-FTV

### DIAGNOSIS ASSISTANCE FOR DAMAGED TURBO MOTOR DRIVER HARNESS

Relevant DTC affected: P0046, P0047, P0048, P1251, P2564, P2565, P2588, and P2589

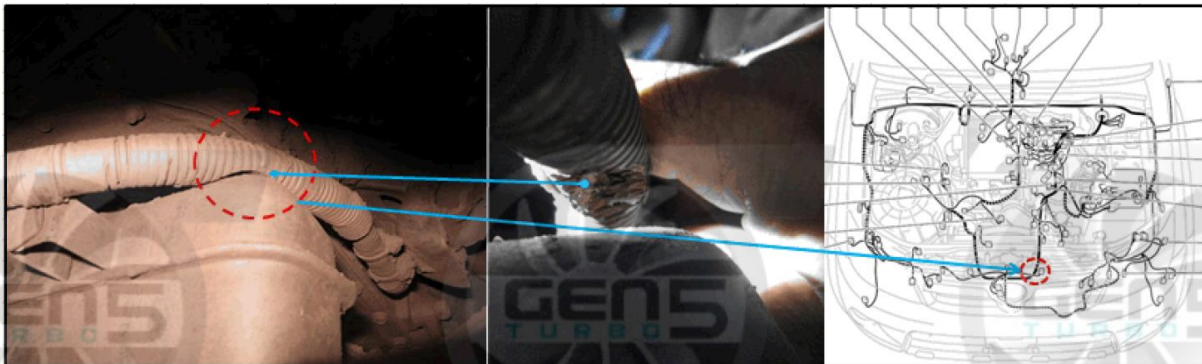
The wiring harness between the turbocharger DC motor and the turbo motor driver (located behind the glove box) has been found to be in close contact to the engine sump on the LHS of the engine, causing it to potentially rub through and consequently cause intermittent short or open circuit DTCs. Testing the resistance of the harness connectors can give a reading within specification however.

After working through the diagnostic flow chart for the relevant DTC to eliminate the turbocharger DC motor and the turbo motor driver from being at fault, inspect the wiring harness at the below point for damage.

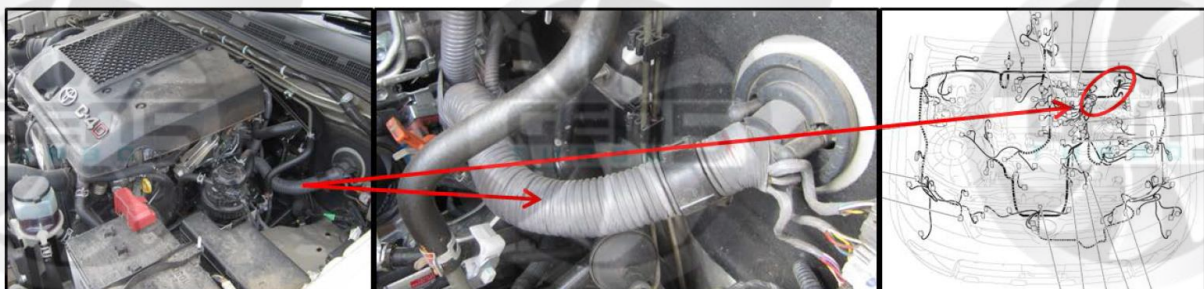
When checking the harness for continuity tests between the turbocharger DC motor and the turbo motor driver, ensure to manipulate the harness. A short or open circuit may only appear once the harness is manipulated and any broken or damaged wires (found between the firewall and engine) are disturbed. No fault may be found during diagnosis if the harness is not manipulated during testing.
