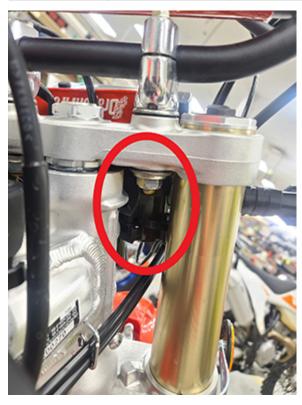
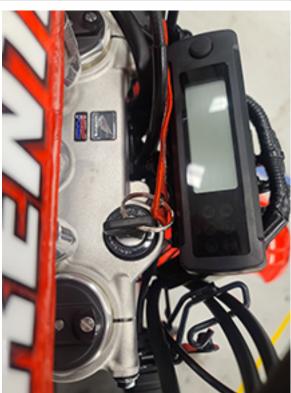
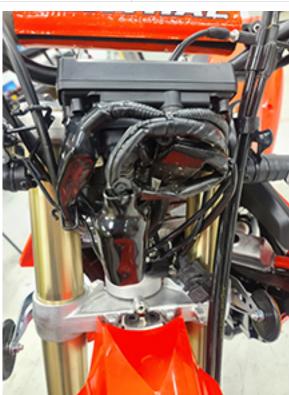
Bike Year	Make	Model	Stock Headlight (Y/N)?	Install Issues (Y/N)?	Describe Issues If Any	Work Around for Issue
2021	Honda	CRF 450RL	Y	Y	Mount will not fit this bike	There is a ton of bulky wiring to work around behind stock headlight. Main problem is the keyed ignition cylinder between forks blocks upper left tube clamp. Will not fit unless keyed ignition is relocated which is unlikely (keyed ignition installed directly into frame. See photos

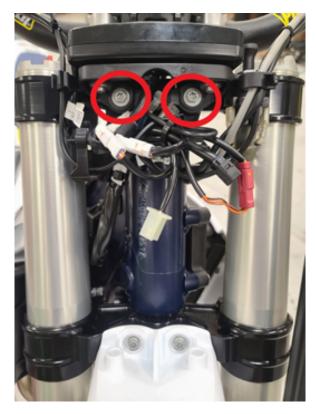
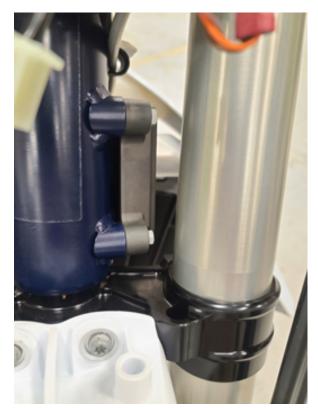
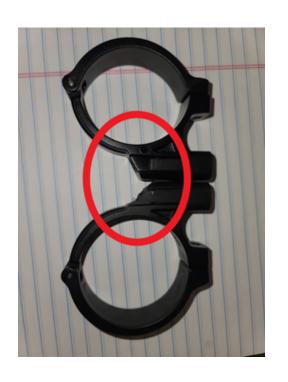
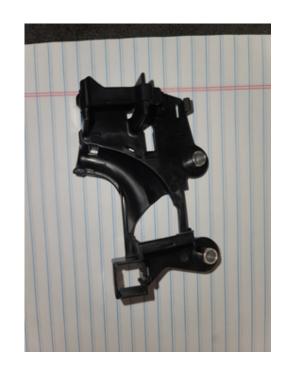
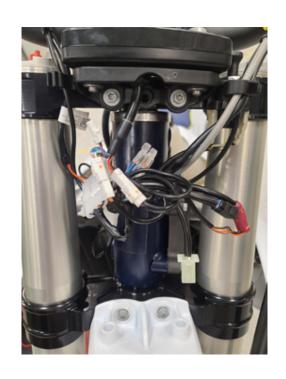
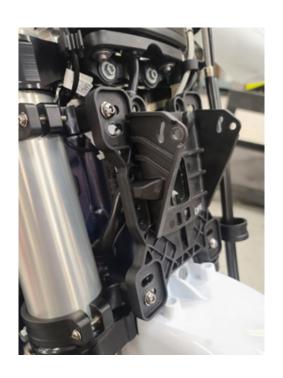
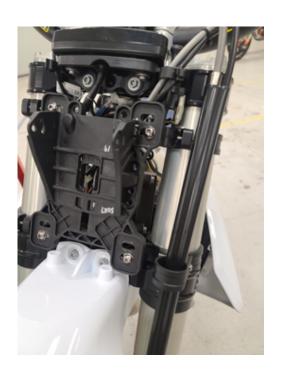
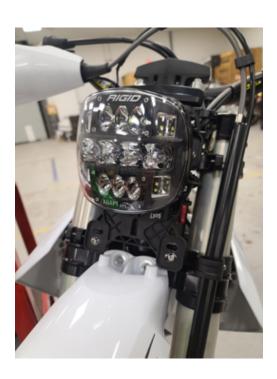
Bike Year	Make	Model	Stock Headlight (Y/N)?	Install Issues (Y/N)?	Describe Issues If Any	Work Around for Issue
2021	Husqvarna	FE501	Y	Y	Plastic plate behind stock number plate that holds wire harness blocks user from installing mount plate (see attached photos).  Regulator installed between center column and fork tube catches bottom tube clamp and prevents bike from full turn.	1. Remove two bolts holding plastic piece in place (see photos). Remove plastic and mount wire harness without this piece (fully turn bike side to side to make sure your new location does not cause wires to pinch). Replace two bolts to secure speedometer back into place. Tube clamp that was blocked previously will now fit.  2. Option 1, relocate regulator to new position which does not block lower tube clamp. Option 2, dremel off some of the material from the tube clamp in that position to allow clearance of the regulator, allowing a full turn (see photos).

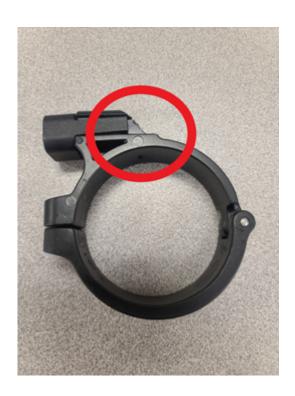
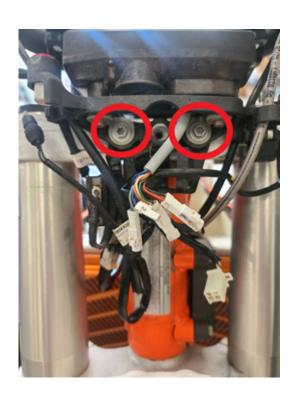
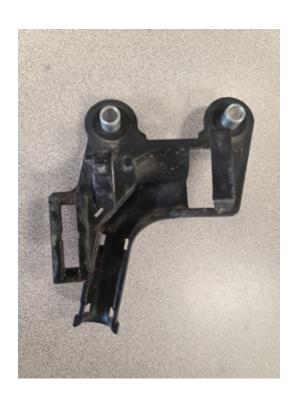
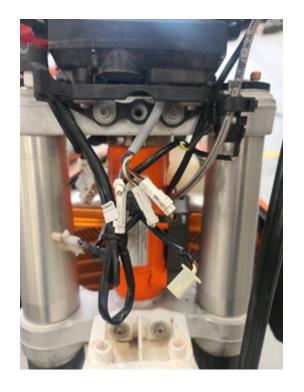
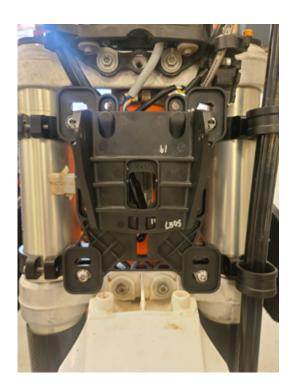
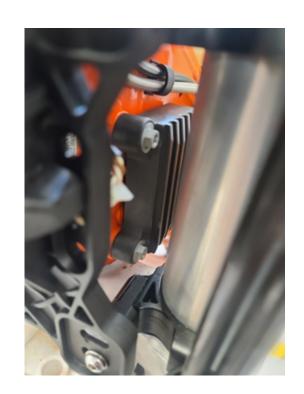
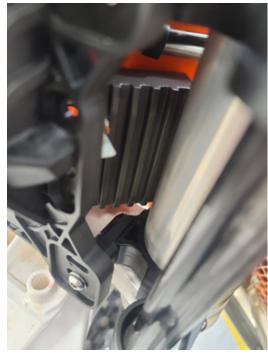
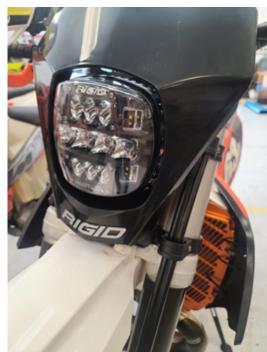
Bike Year	Make	Model	Stock Headlight (Y/N)?	Install Issues (Y/N)?	Describe Issues If Any	Work Around for Issue
2019	КТМ	300 XC-W TPI	Baja Designs	Y	Plastic plate behind stock number plate that holds wire harness blocks user from installing mount plate (see attached photos).      Regulator installed between center column and fork tube catches bottom tube clamp and prevents bike from full turn.	1. Remove two bolts holding plastic piece in place (see photos). Remove plastic and mount wire harness without this piece (fully turn bike side to side to make sure your new location does not cause wires to pinch). Replace two bolts to secure speedometer back into place. Tube clamp that was blocked previously will now fit.  2. Option 1, relocate regulator to new position which does not block lower tube clamp. Option 2, dremel off some of the material from the tube clamp in that position to allow clearance of the regulator, allowing a full turn (see photos).

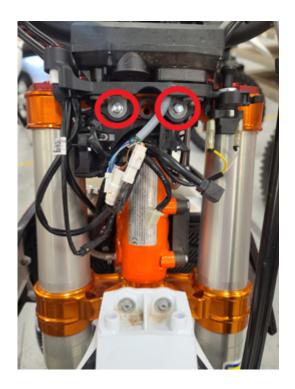
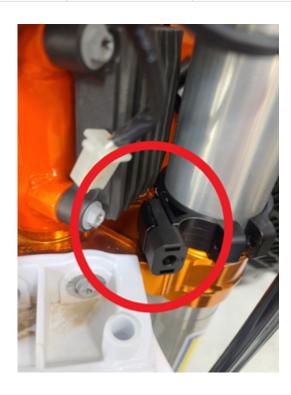
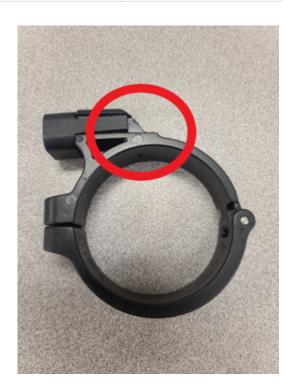
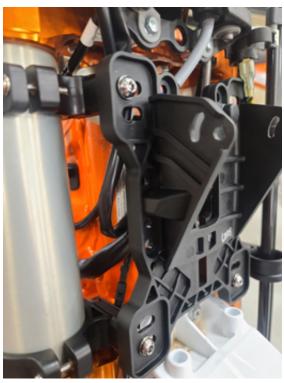
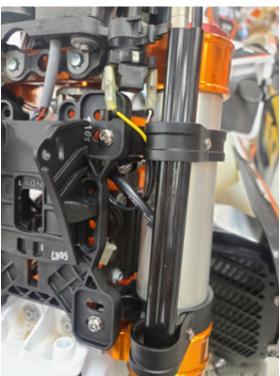
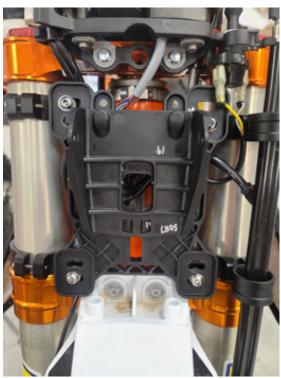
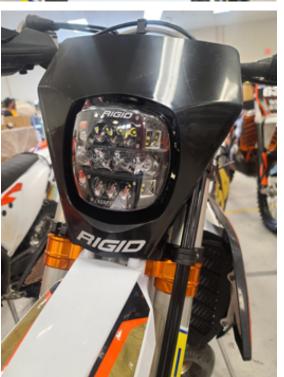
Bike Year	Make	Model	Stock Headlight (Y/N)?	Install Issues (Y/N)?	Describe Issues If Any	Work Around for Issue
2020	КТМ	300 XC-W TPI	Y	Y	Plastic plate behind stock number plate that holds wire harness blocks user from installing mount plate (see attached photos).      Regulator installed between center column and fork tube catches bottom tube clamp and prevents bike from full turn.	1. Remove two bolts holding plastic piece in place (see photos). Remove plastic and mount wire harness without this piece (fully turn bike side to side to make sure your new location does not cause wires to pinch). Replace two bolts to secure speedometer back into place. Tube clamp that was blocked previously will now fit.  2. Option 1, relocate regulator to new position which does not block lower tube clamp. Option 2, dremel off some of the material from the tube clamp in that position to allow clearance of the regulator, allowing a full turn (see photos).
