## IMPORTANT SAFETY NOTICE

### Rolf Prima Free Hub Body Replacement Instructions

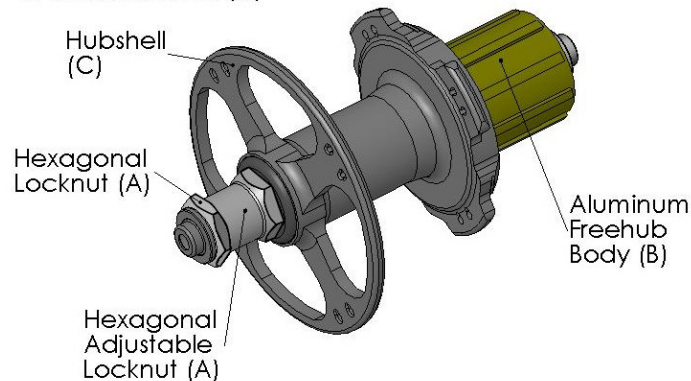
fig. 1

Some Rolf Prima Vigor and Élan model rear wheels sold in 2003 are affected by this safety notice. These wheels can be easily identified by three tell-tale characteristics of the rear hub: [see fig. 1]

- First, there are hexagonal axle nuts at the left side of the rear hub.
- Second, the free hub body is aluminum, with a gray-green color anodized finish.
- Lastly, only black hubs are affected. Silver hubs are not subject affected.

Affected hubs have:  
1. Hexagonal nuts on left (non-drive) side (A)  
2. Aluminum Freehub body (B)  
3. Black hubshell (C)

Older, 2003 Rolf Prima wheels with Loop Spring free hub bodies must be removed from service immediately and updated with the newer, 3-pin freehub engagement mechanism.
