User Inspection Notice – ISC RP074 Zippey

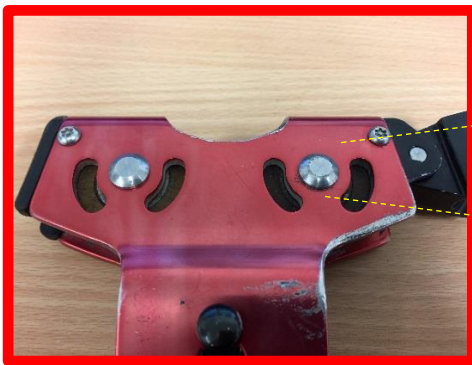
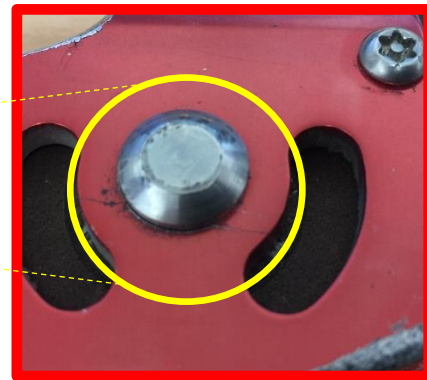
ISC is requesting that all owners of the above listed items continue to conduct their regular product inspections. There has been a report, from a single site, of some small cracks appearing in their frames. There is evidence that a combination of coarse cable, abnormal and high loads at this particular site are introducing unwanted stress into the frame. As a responsible manufacturer, ISC is issuing this notice to alert all users of the possibility of stress fractures.

Following an investigation into the issue raised by this specific customer we concluded that there is significant evidence that the rough cable at the customer's site is accelerating the level of wear seen in these devices. The repeated excessive vibration is subjecting the Zippey trolleys to stresses over and above their intended design, leading to small cracks appearing which, if left unchecked, could become critical and lead to failures. A secondary issue is the effect it is having on hinge pins, causing them to also work loose. ISC are reminding users of the requirement to regularly inspect your safety products for this potential condition.
