| Project name | LOUIS VUITTON DISTRIBUTION CENTER |
| Approximate date of completion | March 2004 |

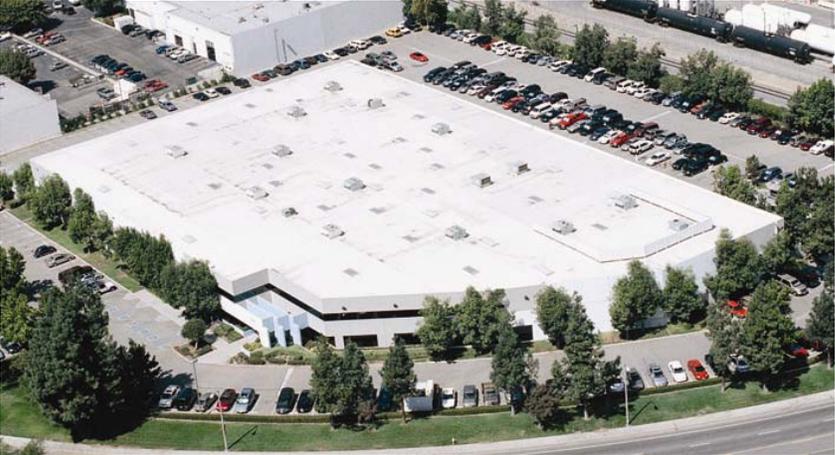
| Project photos | |

| Existing roof problems | Multiple leaks caused by splitting and blistering of existing cap sheet. Leaks around the drains and roof top equipment. Granule loss on existing mineral surfaced fiberglass cap sheet. |

| Products and systems used, and How APOC products solved the problem | System used was AM2-PE-252. Power washed the roof, made necessary repairs to splits, blisters, drains, roof top equipment curbs using APOC #501 Super-Flash Neoprene and fiberglass mesh. Applied APOC #300 asphalt emulsion at a rate of 8 gallons per square with two layers of 40" polyester mesh embedded in a shingle fashion. Once emulsion system was cured applied APOC #252 Sun White Acrylic Coating at a rate of 3 gallons per 100 square feet. |
