Service Bulletin ID: ROLSB-008	Title: Excessive Installation Torque	Type of Bulletin: Technical Bulletin
Name of reporter: Austen Jousma ROL Quality Engineer	Date of creation: 07/26/2017	Affected Dates: N/A

### Description of Problem:

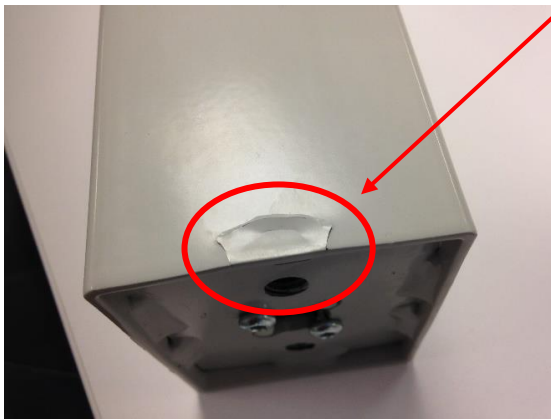
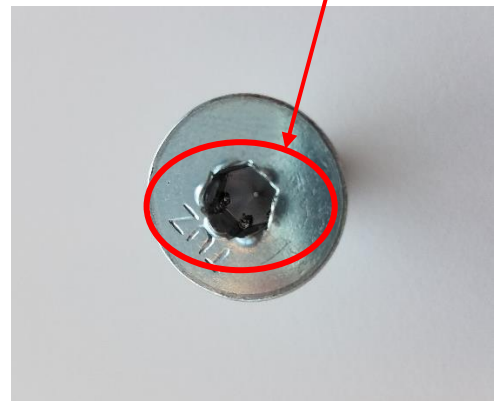
The main damage seen is a cracking of the powder coat layer on the bottom edge of the table leg where it meets the table foot (see below). We have also seen the drive slots of bolts nearly stripped out after being installed.

The root cause of these failures has been identified as the use of impact drivers and/or torque settings that exceed the amount of torque necessary to securely fasten the parts together.

Since the damage is caused during the installation of the parts, ROL's recommended torque range for installing all fasteners is 3-5 foot pounds and should not be exceeded. In addition, no impact drivers or other high-torque equipment are to be used for any fasteners included in the table assembly kits as this creates a high risk for additional damage that is not covered under the ROL warranty.

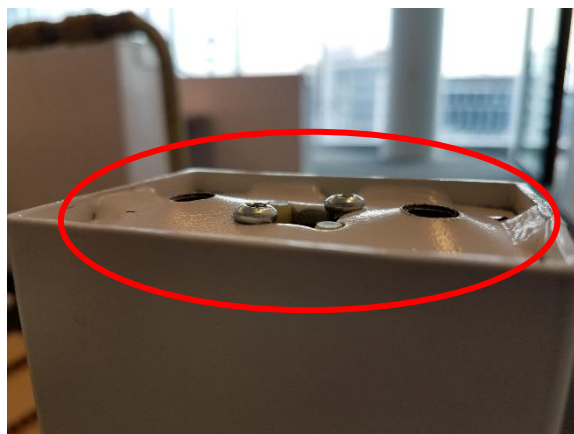
In the case of the powder coat failure, using excessive torque damages the weld plate of the leg and deforms the metal around the thread, stressing the weld locations and causing the powder coat to crack.
