SAFETY RECALL CODE 0807 - 1997/1998 FRONT BRAKE ROTOR DRIVE PINS

B-013

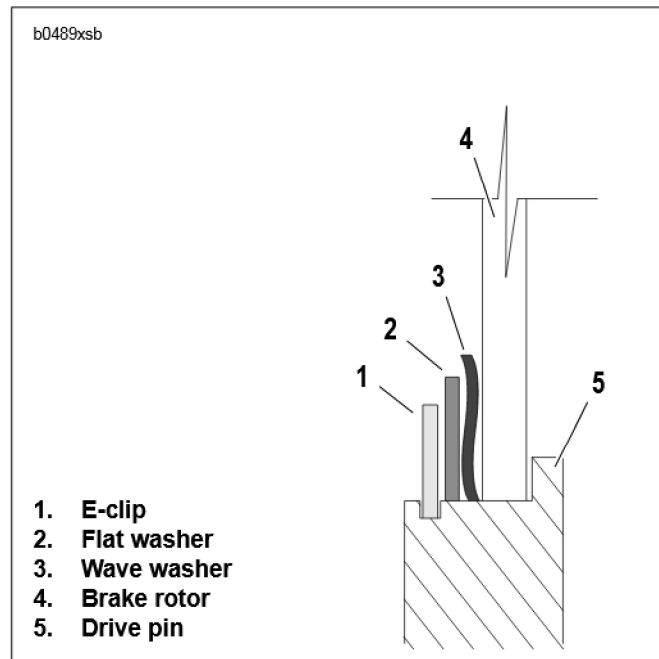
Figure 1. Drive Pin Assembly

Buell has determined that the drive pin(s) used on the front brake rotor could move out of position and come in contact with the front brake caliper. This condition could prevent the front wheel from rotating. This could occur without prior warning.

2. See [Figure 1](#). Remove existing drive pin assemblies two at a time.
 - a. Gently pry E-clip (1) away from drive pin (5).
 - b. Completely remove E-clip using a thin bladed screwdriver. Discard E-clip.
 - c. Remove and discard flat washer (2), wave washer (3) and drive pin (5).
3. See [Figure 2](#). Install **new** drive pin hardware through rotor (5) and carrier (8).
 - a. Place drive pin (6) between rotor and carrier. Shoulder on drive pin faces away from wheel hub.
 - b. Insert bolt (7) through drive pin (6).
 - c. Install wave washer (4) on back side of rotor.
 - d. Install flat washer (3).
 - e. Install drive pin flat washer (2).
