SAFETY RECALL CODE 0813 - SIDESTAND SWITCH

B-023

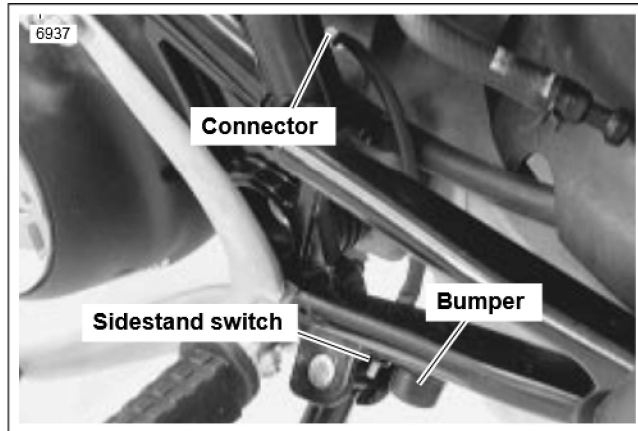
Figure 1. Original Sidestand Switch and Bumper

Buell Motorcycle Company has learned that certain 1996 through 1999 Buell motorcycles were built with a sidestand switch that could become inoperative. This condition could cause the engine to stall or quit when riding which could result in an accident. Accordingly, Buell Motorcycle Company is conducting a voluntary recall campaign to formally recall all potentially affected motorcycles.

See Figures 1, 2 and 3. The current sidestand switch can be differentiated from the replacement one by noting the differences in the plunger. The current plunger is made of white plastic and has a flat tip. The plunger of the replacement switch is made of metal and has a round tip.

1. Disconnect negative battery cable.
2. See Figure 1. Unplug sidestand switch wiring from connector.
3. Remove switch from vehicle frame and discard.

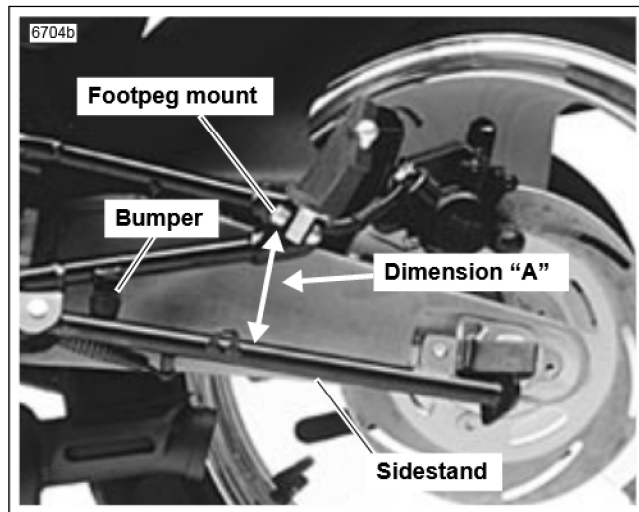
Figure 4. Dimension "A" Measurement

- See Figures 5 and 6. Dimension "B" is determined by measuring the distance perpendicular to the left outside surface of the swingarm to the sidestand dragger mount.
- See Figure 4. Dimension "A" is determined by measuring the distance perpendicular to the top side of the sidestand to the lower edge of the passenger footpeg front mount tab.

1. Remove and discard original sidestand bumper and spacer washers.
2. See Figures 4 and 5. Establish correct sidestand retraction angle by using either the new cylindrical bumper or the new conical bumper in conjunction with up to three spacer washers. The sidestand retraction angle is defined by Dimension "B". Dimension "B" must be within 0.500-0.625 in. (13-16 mm). Keeping Dimension "B" within specifications listed, measure Dimension "A". Dimension "A" must not exceed 3.125 in. (79 mm).
3. Using the bumper and washer combination determined in Step 2, place a small amount of LOCTITE THREAD-LOCKER 243 (blue) on the bumper threads and install it into the frame.
4. Hand tighten securely.

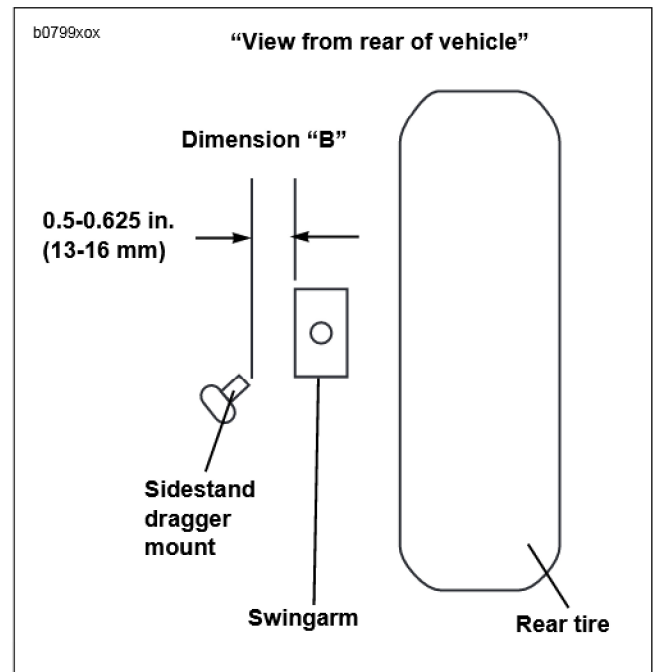
Figure 5. Dimension "B" Measurement

See Figures 3 and 5. The objective of this procedure is to obtain both a **minimum** sidestand switch plunger depression of 0.125 in. (3 mm) and a **minimum** sidestand/swingarm clearance (Dimension "B") of 0.5 in. (13 mm) when the sidestand is in the retracted position.
