# SERVICE BULLETIN **Buell**<sup>®</sup>

B-024B

November 20, 2000

## SAFETY RECALL CODE 0817 - REVISED SHOCK EYE

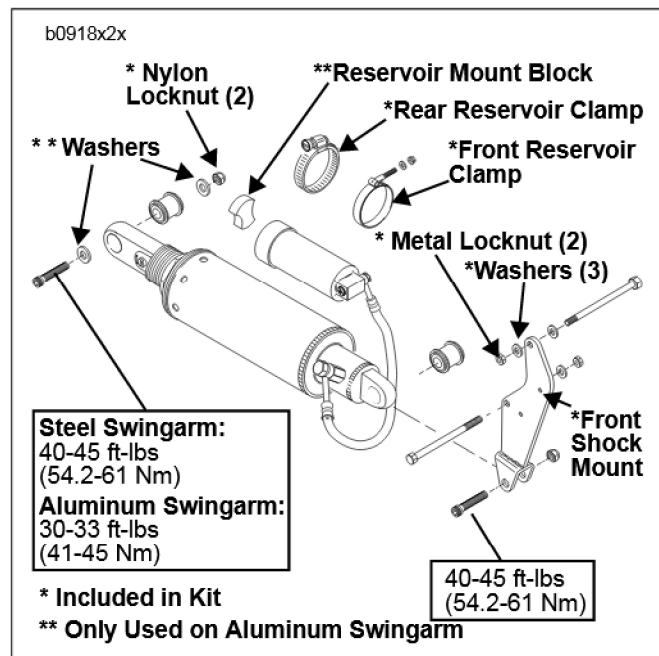
Figure 2. New Shock Absorber Assembly

The new front shock mount **MUST** be used with the new shock absorber. The new shock is 1.77 in. (45 mm) shorter than the previous shocks and requires the new front mount to align and install properly.

4. See Figure 2. Use a flex socket and extension to remove locknut and washer on front reservoir clamp. Discard clamp, locknut and washer.
5. See Figure 2. Loosen rear reservoir clamp. Slide reservoir and mount block out of clamp. Remove and discard clamp and mount block.

1. See Figure 2. Install **new** front shock mount to crankcase with two **new** front shock mount bolts, washers, star washer (on 1997 M2, S3/S3T models only) and metal locknuts. Tighten bolts to 30-33 ft-lbs (41-45 Nm). **NOTE:** Top bolt goes in from the left side, bottom bolt goes in from right side. Bottom bolt does not use washer under bolt head. Star washer (only used on 1997 M2, S3/S3T models) goes on bottom bolt under the washer on the nut side. If exhaust was loosened during front shock mount removal, replace exhaust gaskets and reinstall exhaust. See appropriate Service Manual, Section 2 for instructions.

4. See Figure 2. Position **new** shock absorber from kit in mounting position.
5. Loosely install bolt, washers (aluminum swingarms only) and **new** locknut through rear shock eye and swing arm.
6. Loosely install bolt and **new** locknut through front shock eye and front shock mount.
7. **On 1996-1998 vehicles only:** Loosen header tie bar from collector.
8. Position front clamp over reservoir. Loosely install **new** front reservoir clamp to front shock mount (and install **new** header tie bar spacer between front shock mount and header tie bar on 1996-98 vehicles only) with **new** washer and **new** nylon locknut.
9. See Figure 3. Loosely install **new** rear clamp around reservoir and oil feed line.
10. **All Models:** Install **new** reservoir mount block between oil pump fitting and remote reservoir.
