SERVICE BULLETIN **Buell**[®]

B-044

January 9, 2002

SAFETY RECALL CODE 0824 - SHOCK ABSORBER BRACKET

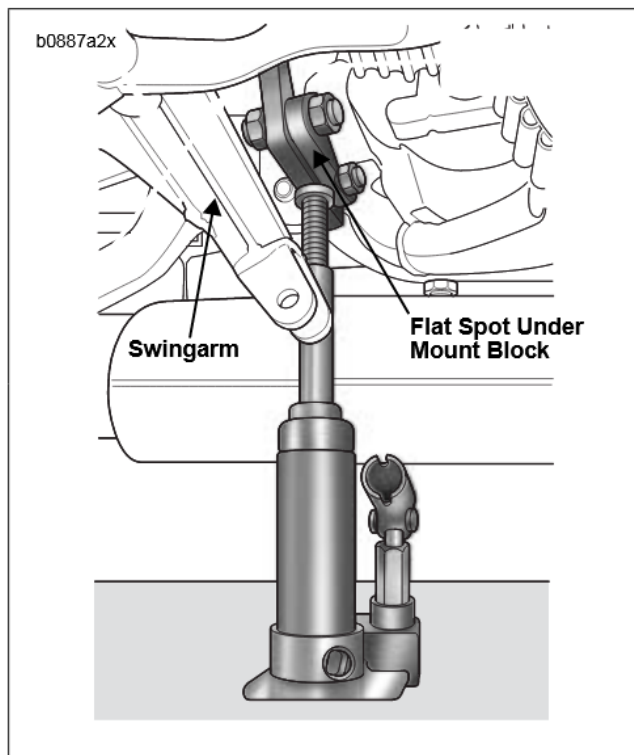
Figure 1. Jack Location on Mount Block (Shock Removed for Clarity)

4. See Figure 1. Place a suitable jack under the swing arm mount block and raise until crankcase is supported by jack for the purpose of unloading the shock absorber.
5. Remove button head screw that secures voltage regulator bracket to front shock mount. Leave bracket in place.

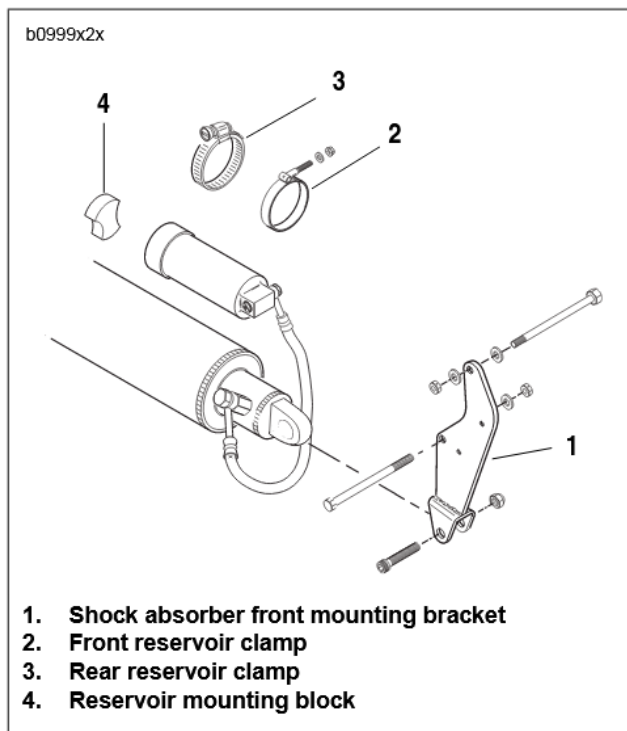
Buell Motorcycle Company has learned that certain 2002 Buell X1, M2, M2L, S3T motorcycles were manufactured between September 12, 2001 and November 14, 2001 with a rear shock front mount, Part Number K0407.01A1, which could be cracked. This condition could cause the shock mount to break, which may allow the suspension to drop unexpectedly. This sudden change in suspension height could cause a loss of control of the motorcycle without prior warning and could result in an accident. Buell Motorcycle Company has voluntarily declared this a defect related to motor vehicle safety (Campaign 0824) to allow us to formally recall all potentially affected motorcycles. The purpose of this bulletin is to announce the release of the proper shock absorber front mounting bracket for the affected motorcycles and to provide installation instructions.

Figure 2. Front Shock Mount

6. Use a flex socket and extension to remove locknut and washer from front reservoir clamp. Discard locknut.
7. Loosen rear reservoir clamp. Slide reservoir out of clamp.
8. See Figure 2. Remove allen screw (metric) and locknut on front shock eye. Discard locknut.
9. Remove (2) crankcase bolts securing the front shock mounting bracket. DO NOT discard locknuts.
10. Remove front shock mounting bracket by pulling down and towards the front of the vehicle.

1. See Figure 2. Loosely install **new** front shock mount to crankcase with original front shock mount bolts, washers and locknuts. Do not tighten fasteners at this point. NOTE: Top bolt goes in from the left side, bottom bolt goes in from right side. Bottom bolt does not use washer under bolt head.

6. See Figure 2. Position front clamp over reservoir. Loosely install reservoir clamp to front shock mount with washer and **new** nylon locknut.
7. Install reservoir mount block between oil pump fitting and remote reservoir.
